FACILITY ANALYSIS

Pine Bluffs Elementary School

Laramie County
School District #2

July 31, 2013

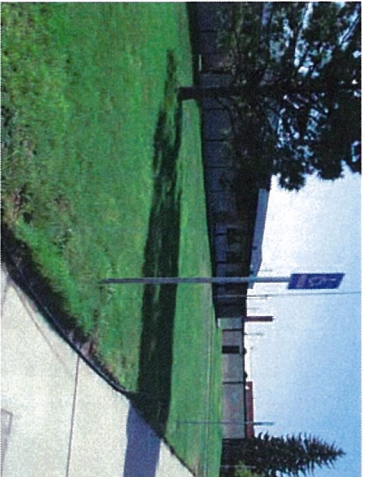
There are no physically separated bus, pick up, or drop off areas, other than those demarcated by curbside signage. Off street parking is an unpaved area located south of the building.

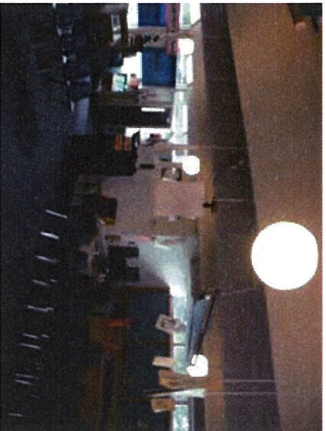
Art Education: The Art suite at PBES is grossly substandard and it meets few of the requirements identified in the WSFD Educational Specifications. Finishes, equipment, shelving, plumbing, lighting, and electrical power are all deficient. Teacher Planning, Work, Resource, Kiln, Clay Storage, and Material Storage are all lacking entirely.

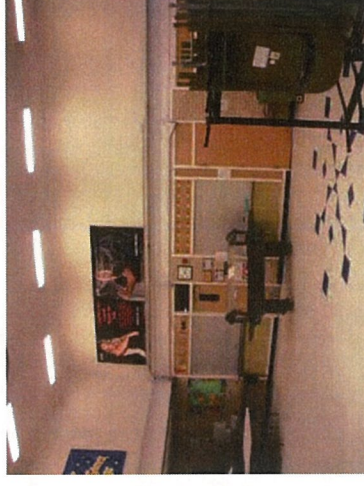
Cafeteria/Multi-Purpose Room: The PBES Commons room is intended to serve as the Cafeteria/Multi-Purpose room but due to its central location it functions more as a lobby and primary corridor to the south portions of the main building. The room is too narrow to effectively serve its intended purpose and traffic patterns aggravate the situation, forcing many activities into the adjacent Multi-purpose Room. The space is not suitable for meetings or conferences as intended by the ed spec. A proscenium-type curtain separates the Cafeteria/Multi-Purpose room from the Multi-purpose "Gym", but this falls far short of providing a viable performance area. The curtain alone cannot be considered a safe barrier between active and passive functions.

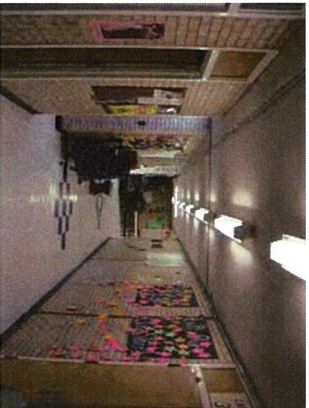
The PBES Lobby is too small and narrow to function as anything more than a corridor. There is no display case and no lockable security gates.

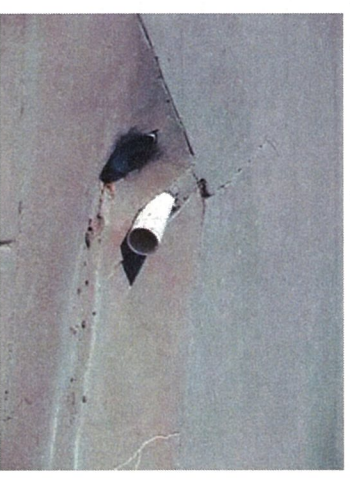
The playground to the south of the building is generally paved with concrete and is also used to provide drainage for the adjacent Junior/Senior high school site. There is a playground to the south of the paved area which contains play apparatus for the elementary students. A small grass playfield is located to the southeast of the school building, and is not adequate for organized play. For organized activities, elementary students are lead to the high school athletic fields for outdoor team play. The Kindergarten and first grade students share the playground with the older students.

The east end of the concrete play area is sloped to drain the site to the south and east of the area, including portions of the high school site. It contains some of the drain pipes accommodating off site improvements.

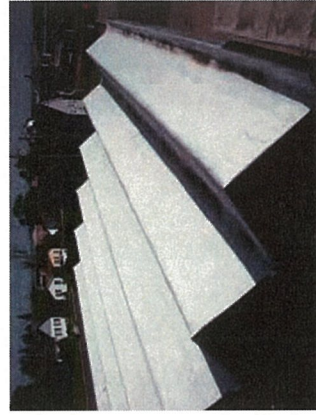
The roof membrane was replaced in 2010 after a hail storm damaged the roof. Observations on the roof indicated that the membrane is in excellent condition. However, there needs to be walkway pads added at access points to the mechanical equipment. There is a loose cable running over the roof that will need to be secured. There was also one area of the roof that was observed to be blistering. This area should be removed and re-roofed. It is recommended that the manufacturer or installing roofer be contacted to determine if this is warranty work.

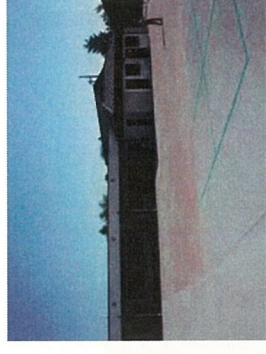
The roof over the music room is a “saw tooth” structure that appears to have a white rubber (EPDM) membrane adhered over a spray on insulation material. This membrane is mechanically fastened at the roof edges. All roof structures on the original buildings appear to be plywood over 2x dimensional framing. Based on information received, insulation was not replaced during the roof membrane replacement. There are also some areas of the serrated roof soffits that are showing signs of deterioration in the painted plywood material.

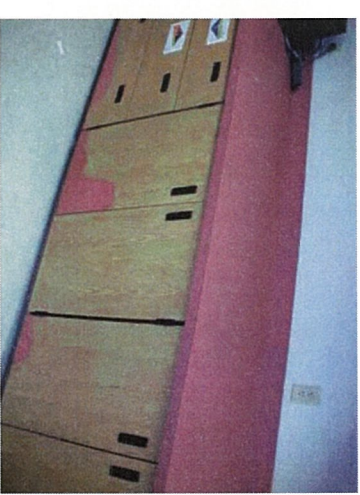
Casework in classrooms is generally substandard. The countertops are plastic laminated particleboard, and are showing signs of deterioration. The plastic laminate is broken and/or delaminating and the cabinet doors are “peg board” hardboard panels with recessed finger pulls. Most cabinets are worn and do not allow for ease of sliding. In many instances, such as the art classroom, residential casework was installed. In the 1989 additions, the casework is delaminating and breaking off, causing an unsightly condition in a high profile area. This is typical in a few of the classrooms of the 1989 expansion program.

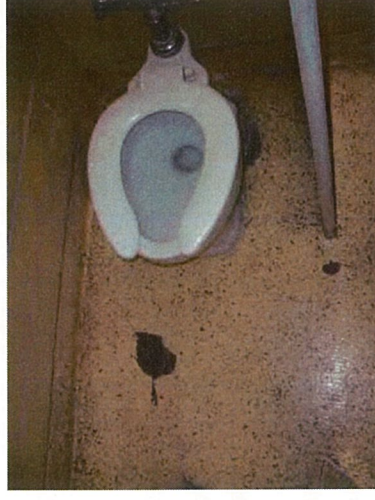
Finishes are generally in good condition and well maintained in the public and classroom areas. There are several areas where the finishes require attention. The ceiling tiles were addressed previously and pose a definite safety hazard. In the original bathrooms, there is an epoxy or seamless flooring that is in need of repair. The condition is unsanitary at best. Some of the block walls are cracking, however, it appears to be only a cosmetic issue. Some of the exposed floor tile observed in the classroom areas is 9"x9" tile which generally indicates that ACM is present. It has also been observed that the ceiling tile, in the 1989 addition bathrooms, is a 2x4 lay-in tile that is not suitable for wet areas.

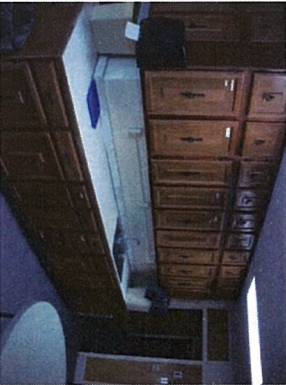
| Component | Material | Comments | |
|---|---|---|---|
| Special Notes | | No kiln or flat storage | |

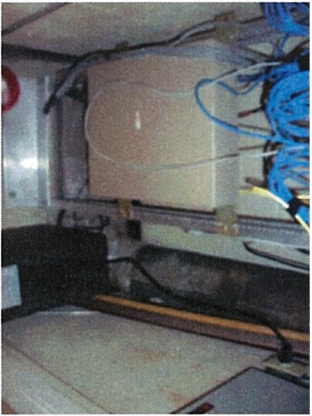
| Component | Material | Comments | |
|---|---|--|---|
| Special Notes | | This is a server rack and server. It appears that the plumbing tunnel is vented in this closet | |
