Best Western Facility Report

Hot Springs State Park
Facility Condition Assessment Project
November 1st, 2015

**Hot Springs State Park
Facility Condition Assessment Project Index
Best Western Hotel Building
Project #1521**

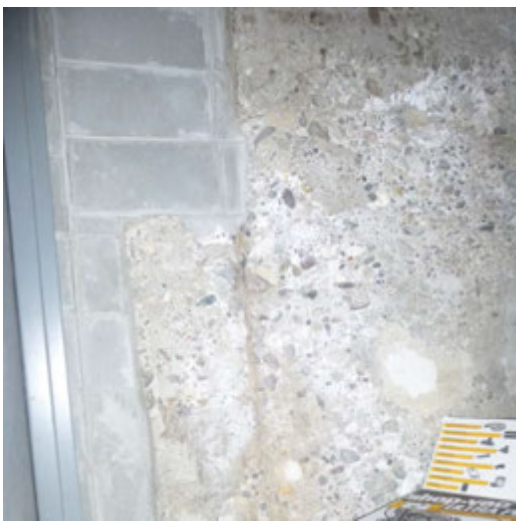
View of interior basement wall, typical of perimeter foundation walls, and concealed footings (Items S1 & S2).

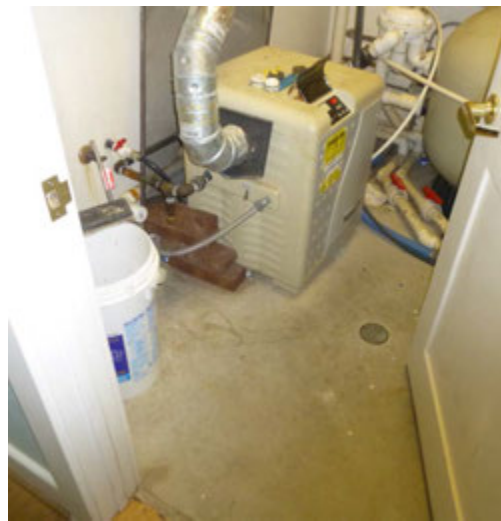
View of typical main floor slab on grade with basement slab similar (Items S3 & S5).

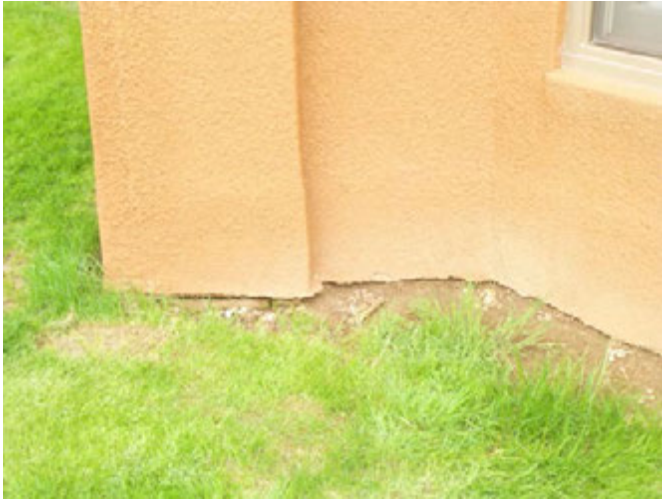
View of typical site grading around building with potentially poor drainage (Item S4).

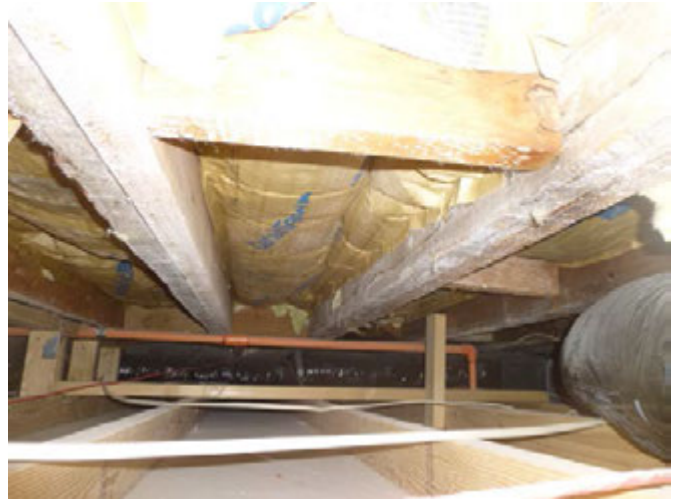
View upper floor framing exposed above dropped ceilings (Item S6).

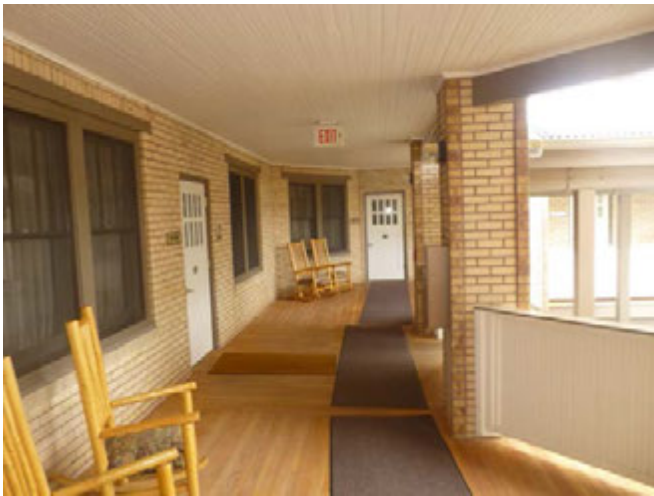
View of upper deck framing area and egress route. (Item S7).

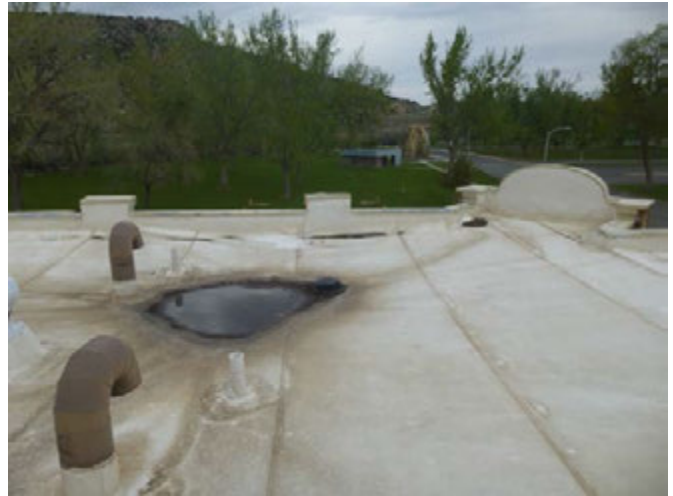
View roof membrane with standing water visible (Item S8).

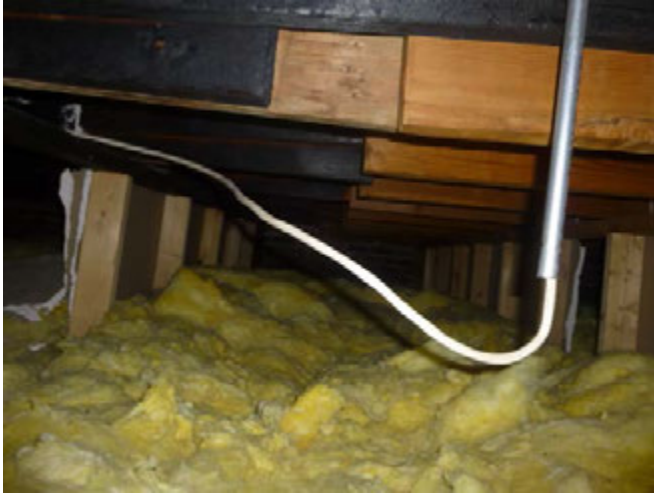
View of roof framing with charred wood visible from past fire (Item S8).

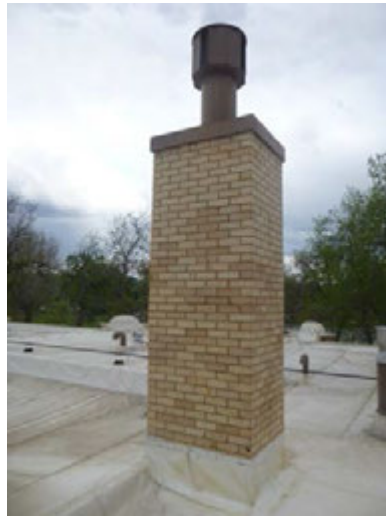
View of larger chimney above roof structure (Item S9).

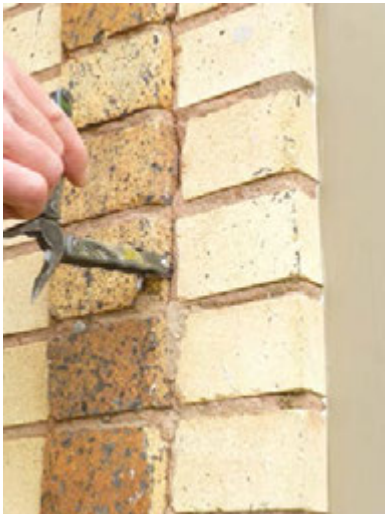
View of soft mortar joints at exterior walls (Item S10).

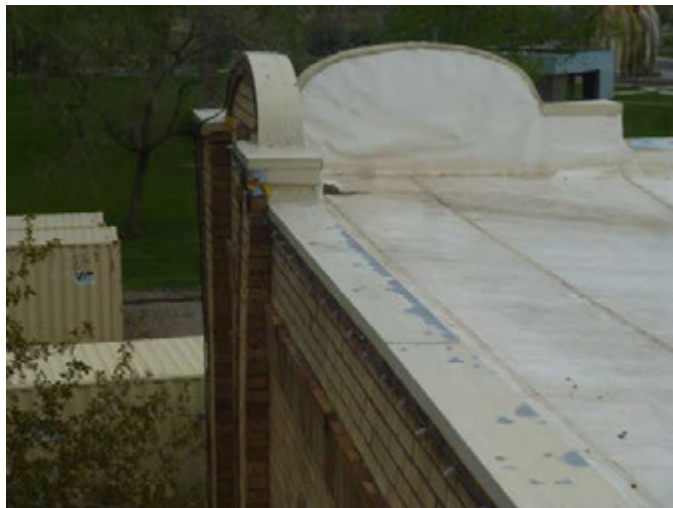
View exterior parapets with areas of canted wall visible (Item S10).

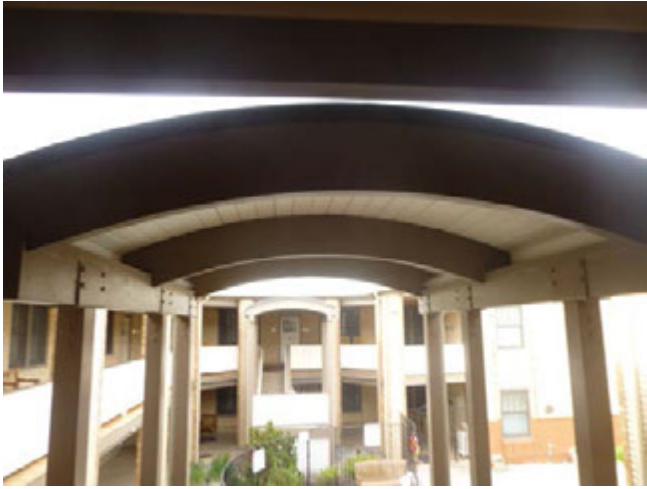
View of roof framing over stairs and wood post supports (Item S10).

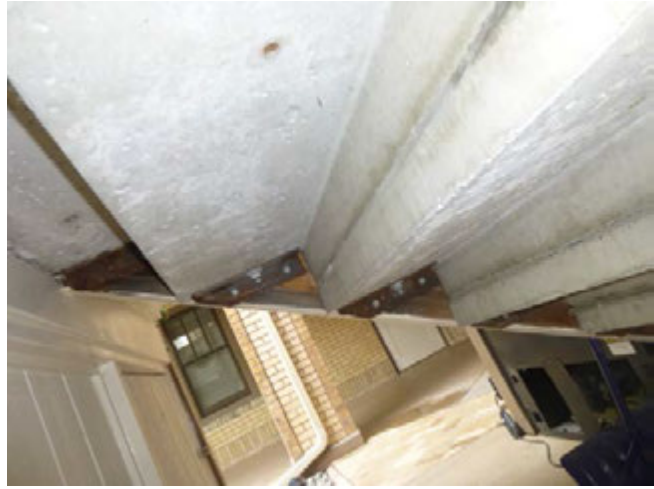
View exterior concrete stair treads and connection to glulam wood stringers (Item S12).

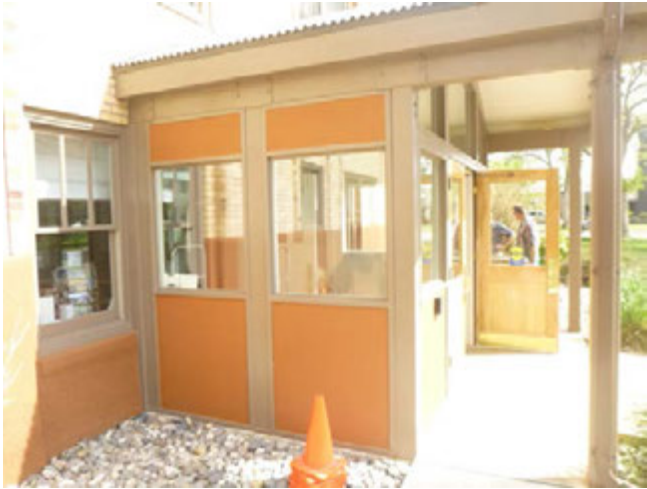
View of entry post and beam structure with infill wall and windows visible (Item S13).

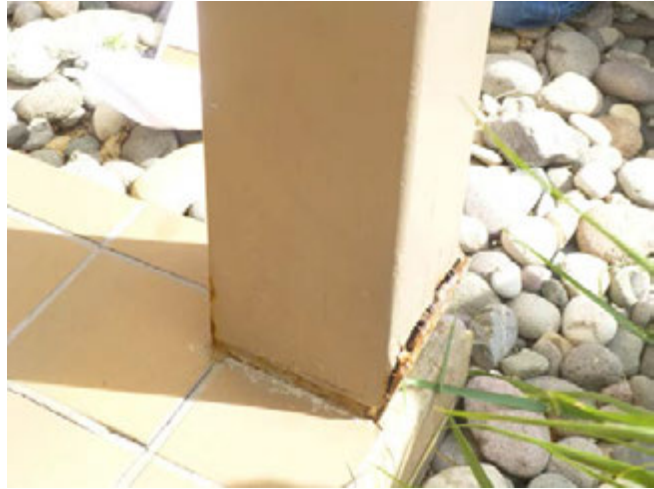
View of corrosion at entry post base connection (Item S13).

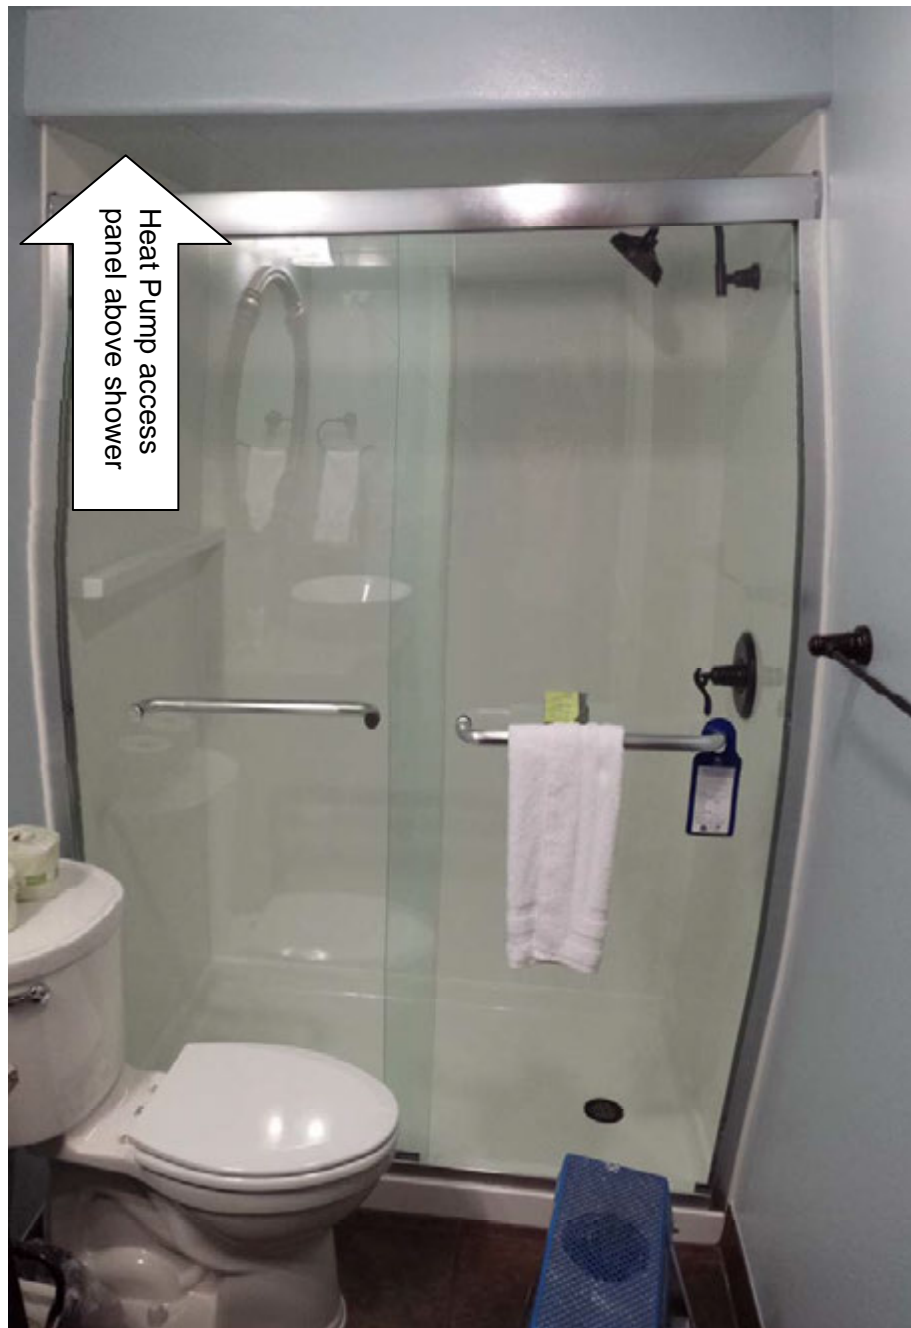
The result of this inaccessibility is as follows:

1. Filters are not changed
2. Units are not frequently inspected or maintained.
3. Unit troubleshooting and maintenance is a much larger task.

Heat pump inaccessible without removing shower door and frame.

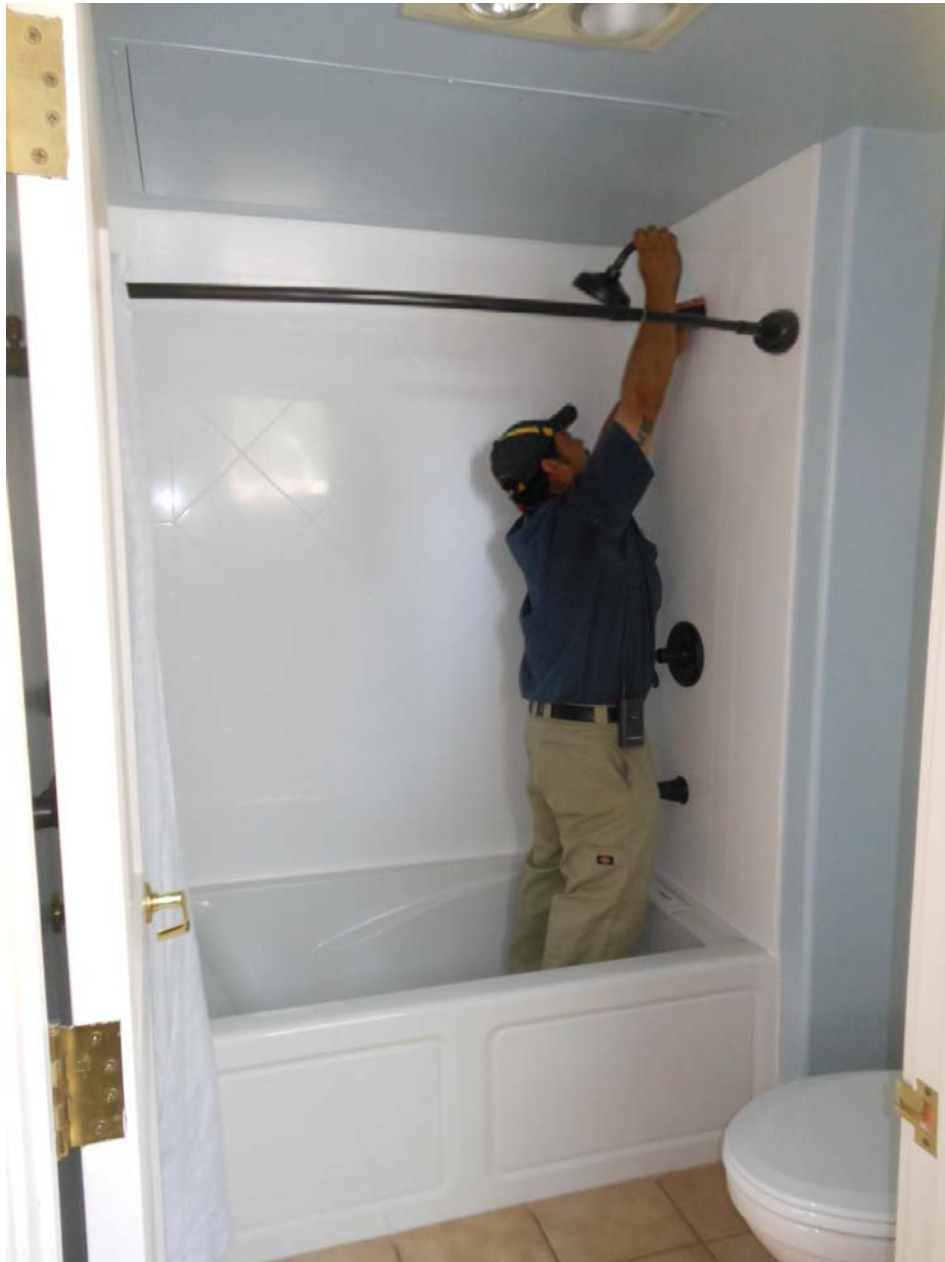
Heat pump access in rooms with tubs requires removal of shower head and arm.

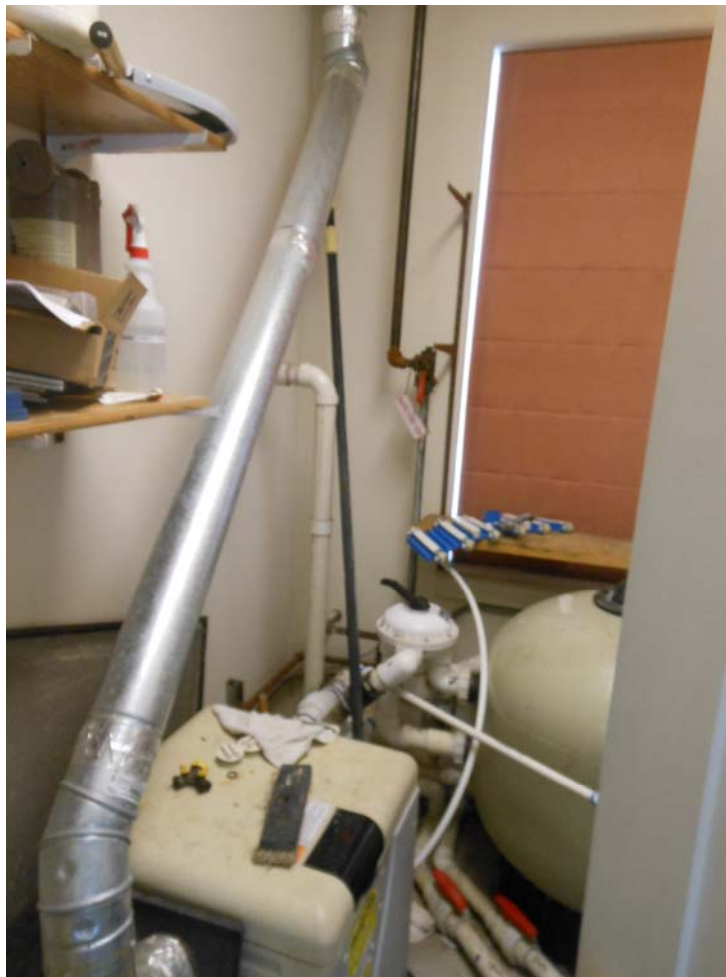
Pool heater and venting

Item M103: : The pool heating room is poorly ventilated and the pool boiler appears to be corroded by the chlorine fumes in the room.

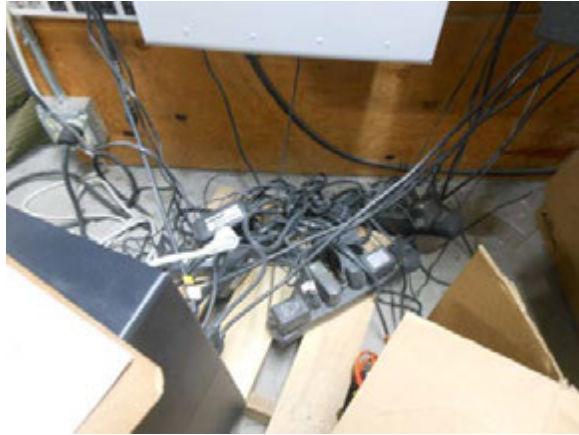
Plug Strips for UPS

There are many plug strips connected to the back of the UPS which consist of 6 receptacle plug strip units. The plug strips should be eliminated and new data rack style power distribution units should be installed on the TBB and connected to the UPS to clean up the quantity of devices connected to the UPS and to better organize the items plugged in.

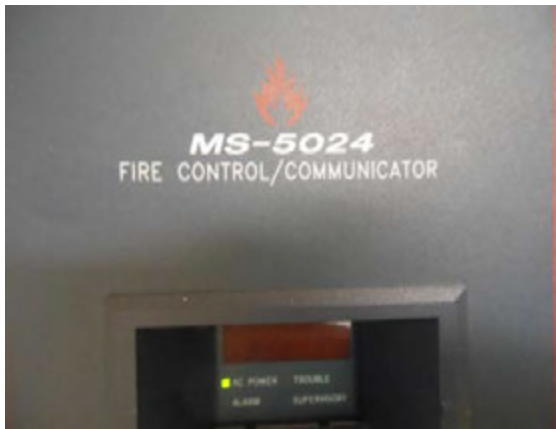
Fire Alarm Panel

The circuit breaker serving fire alarm panel is sourced from electrical panel "A". The code requires that the breaker providing power to the fire alarm panel be clearly identified with marking, red handle/ body. The breaker handle or body of the breaker needs to be painted red.
