MEMORANDUM

Subject: Departments of Health and State Construction's response on the Veterans' Home of Wyoming

This report provides a high level assessment of Structural, Architectural, Mechanical, Plumbing, Electrical, Information Technology, and Civil systems for the buildings and grounds. This assessment includes a high level assessment for compliance with Building Code, the American Disabilities Act, and Clinical standards. Finally, the buildings were reviewed for their capability to be adapted to meet requirements or accommodate renovations. Below is a summary of the assessment work, with very general classifications of "Good," "Fair," and "Poor." An overall "General Building Condition" is provided based on the team's collective comments (Table 1.1.1). This assessment is weighted for the building's purpose. Example: if the boilers are in "Poor" condition for a building dedicated to boilers, but the structure and architecture are "Fair" condition, the overall building condition will give priority to the boilers and the building will be marked as "Poor." An asterisk denotes information that is not available. Admittedly highly subjective, additional information on these assessmen

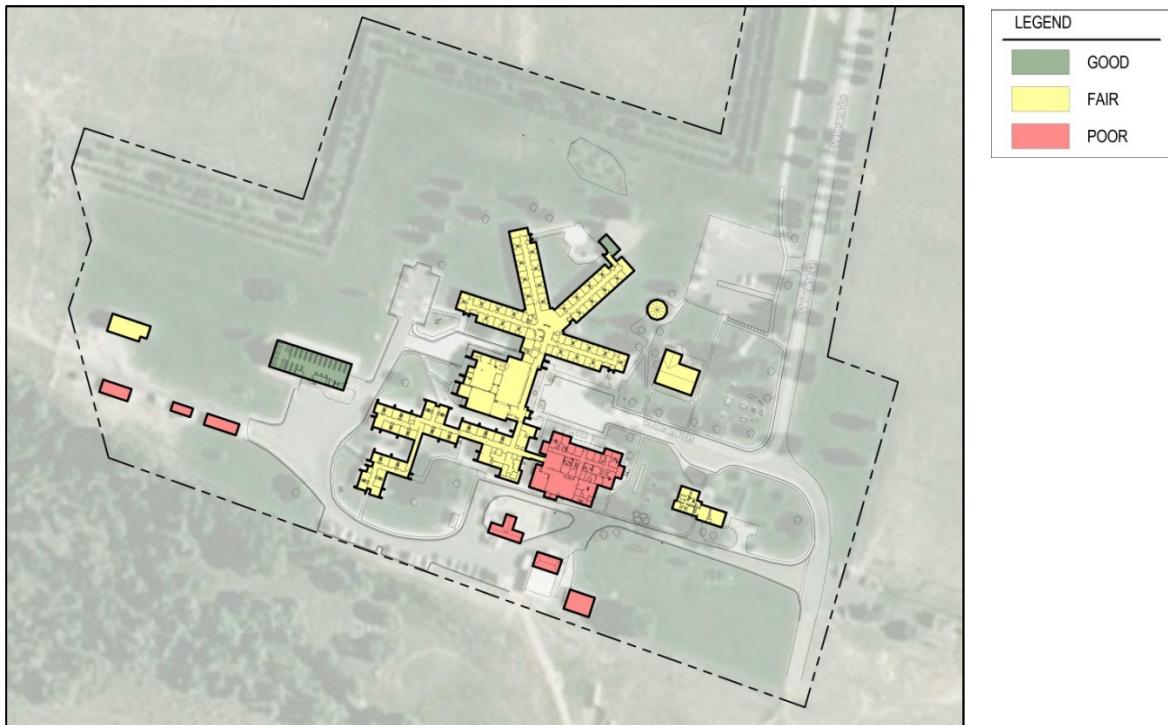
Figure 1.1.2: VHW Facility Analysis – Building Condition

Whereas the main building has the appearance of being in “Good” condition, the team has assessed the primary housing buildings as “Fair” due to concerns with the kitchen, boiler room, and ADA issues (Figure 1.1.2). With due respect to the very nice restoration of this historic structure, the Old Hospital is “Fair” because of Structural concerns. The Workshop, Greenhouse and surround maintenance buildings are also of particular concern due to Structural concerns and deteriorating exterior systems.

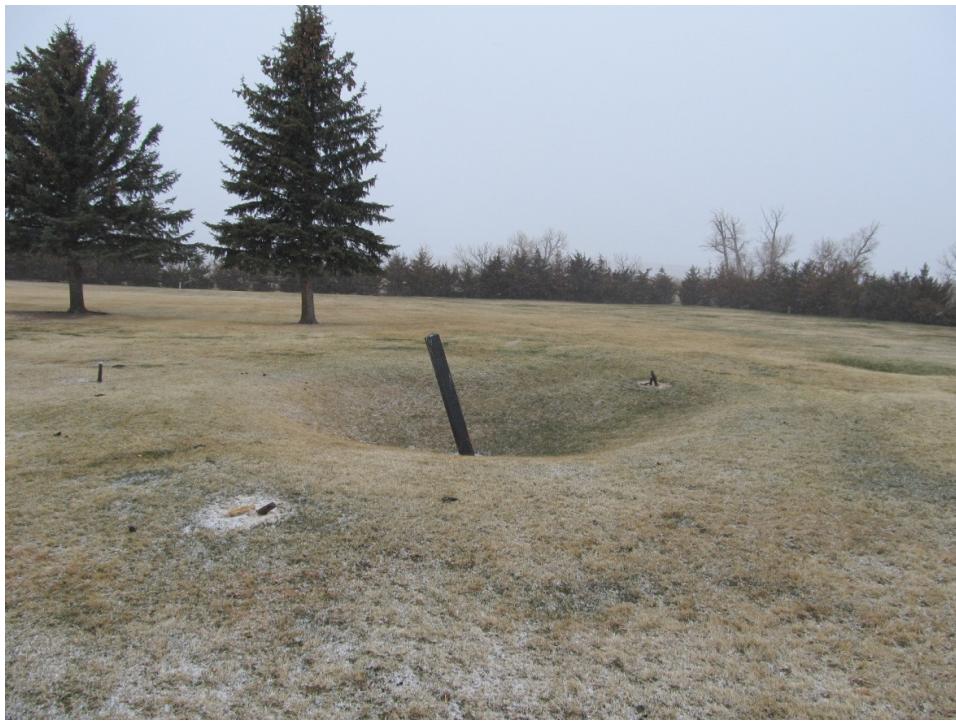
Figure 2.1.1: VHW Depressed area north of '83 building, location of flag pole at Ft. McKinney

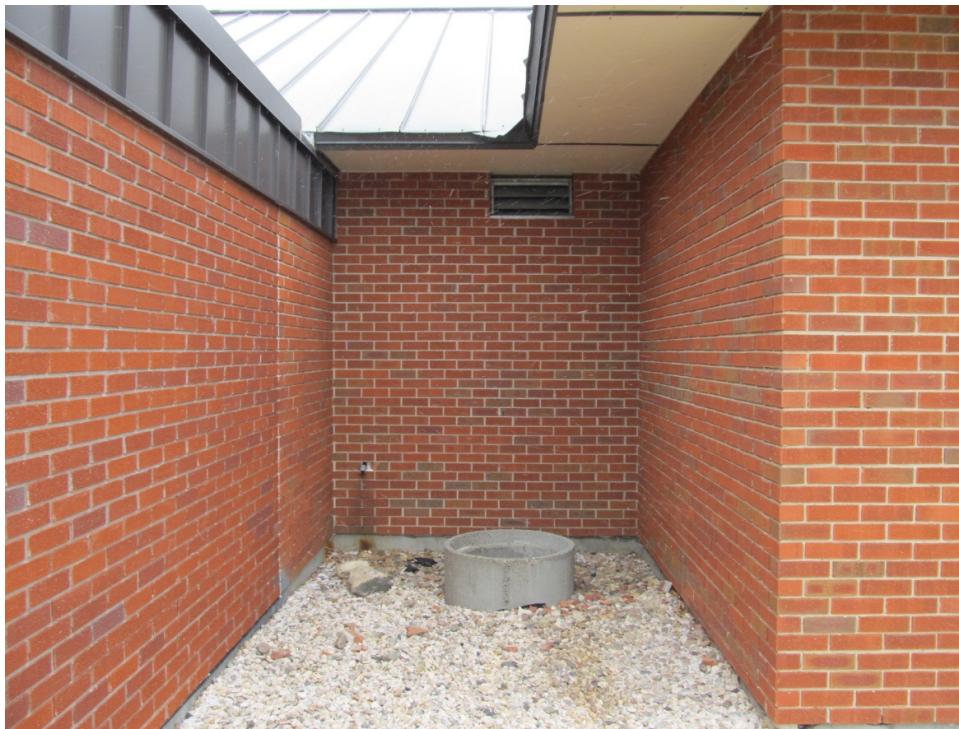
Figure 2.1.3: VHW Vertical concrete pipe section used to catch roof run-off

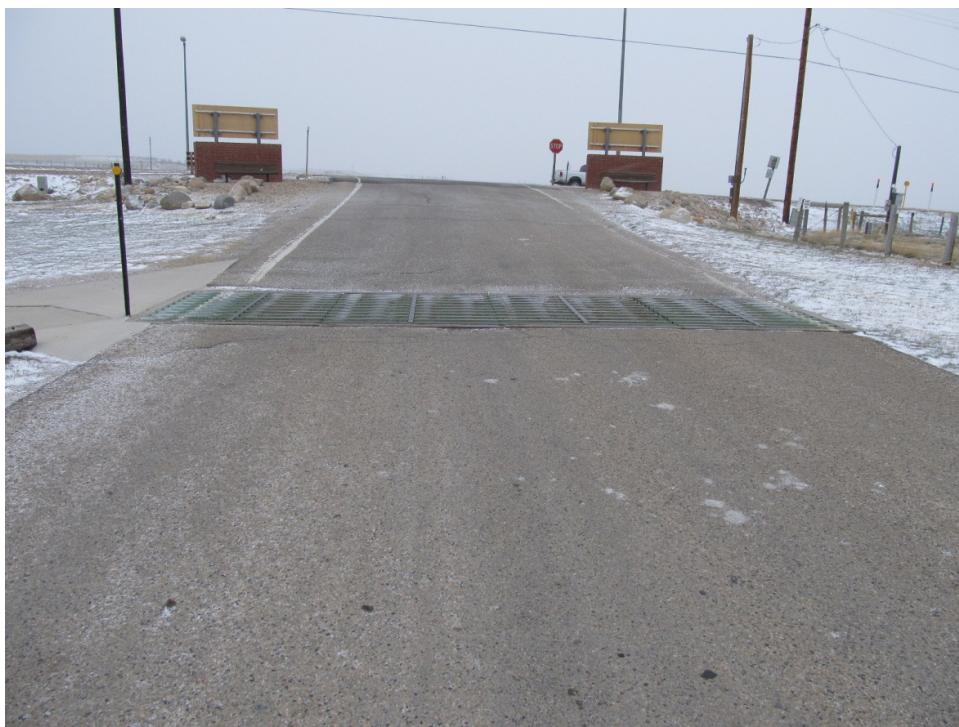
There is currently one access point onto the campus, with an existing cattle guard. It was requested by staff that this cattle guard be removed. Roadways and parking lots are paved, and in fair condition, although cracks throughout should be sealed. Existing roadways should be extended to allow Emergency access around the 1983 building. Parking is currently adequate for staff, visitors and residents on the campus, including areas used by other agencies. Sidewalks appear adequate; however, Signage should be updated. Bicycles are currently parked on the porch of the 1941 building; a better location may be considered.

Figure 2.1.4: VHW Cattle guard at entrance

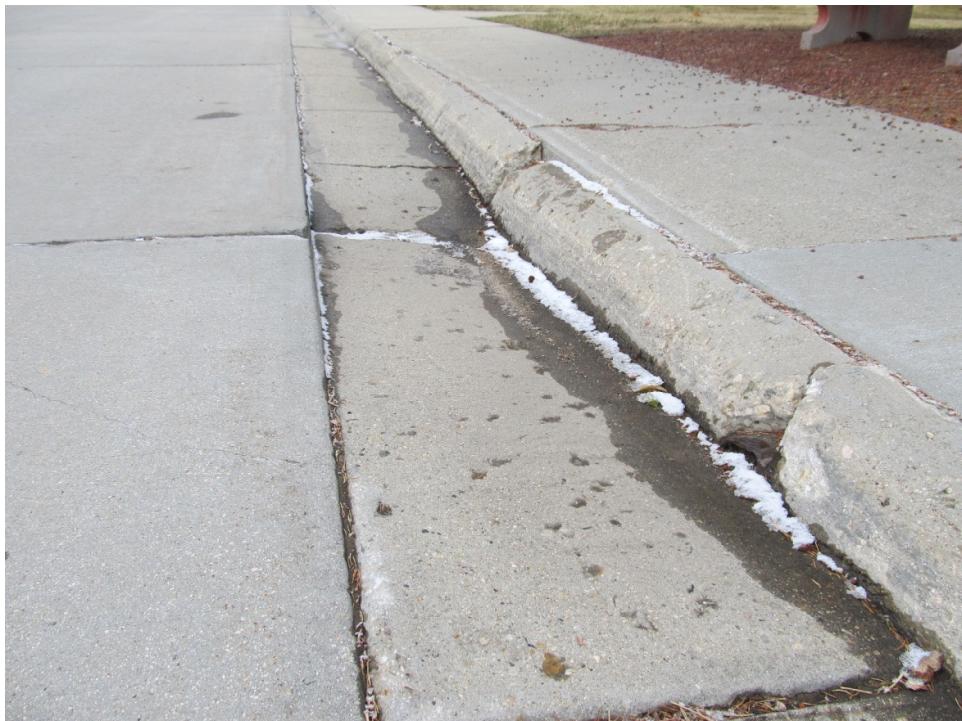
Figure 2.1.5: VHW Settled curb and gutter section

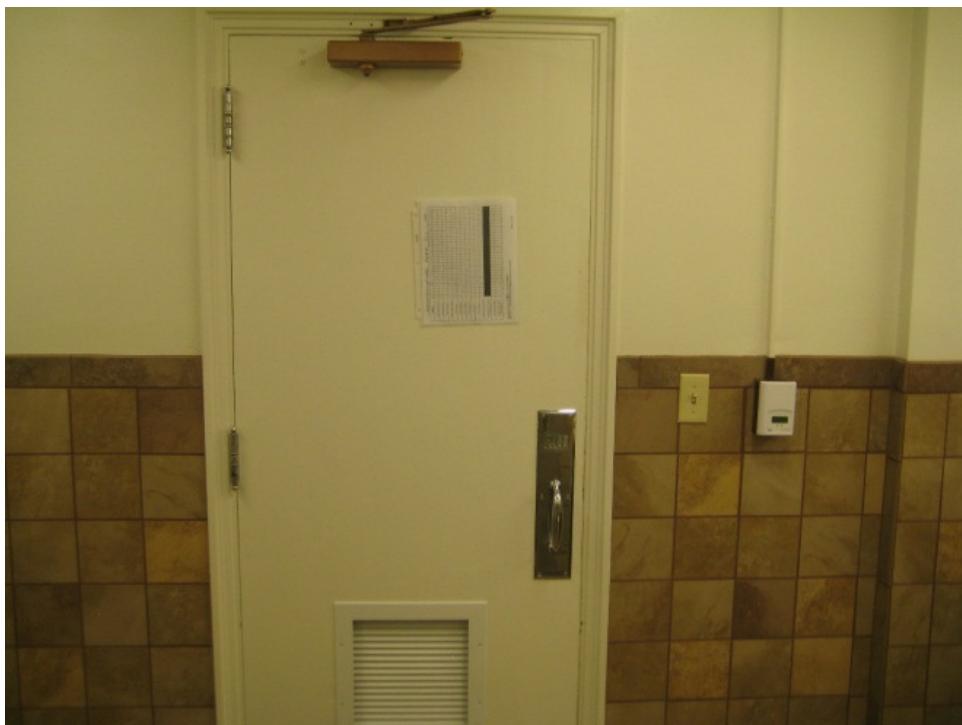
Figure 3.2.1: VHW Non ADA toilet room door

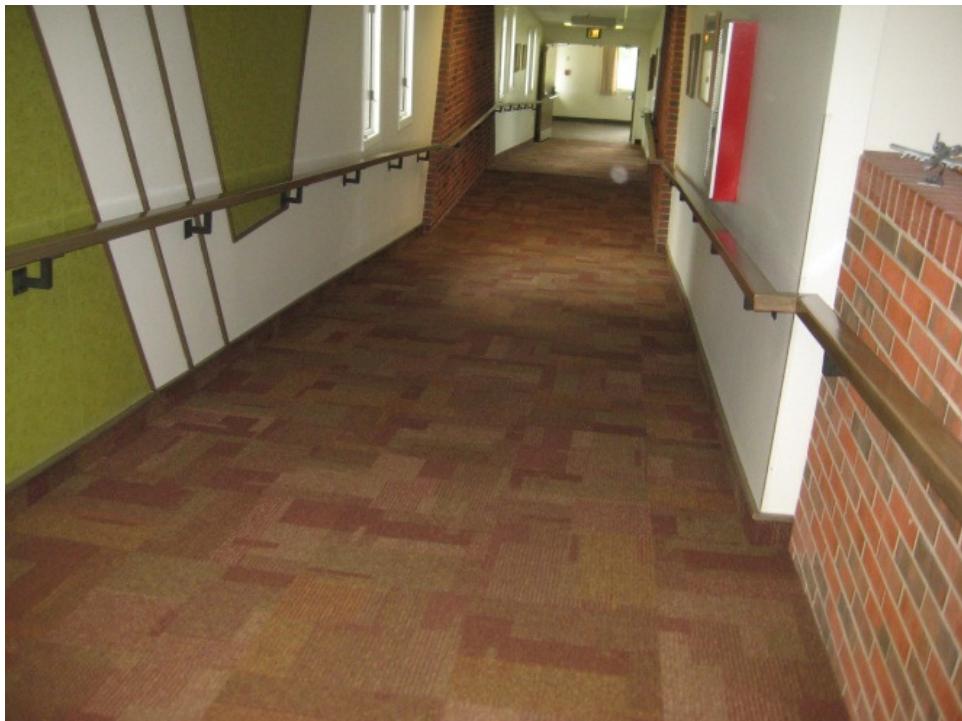
Figure 3.2.4: VHW Interior ramps need to be checked for ADA compliance

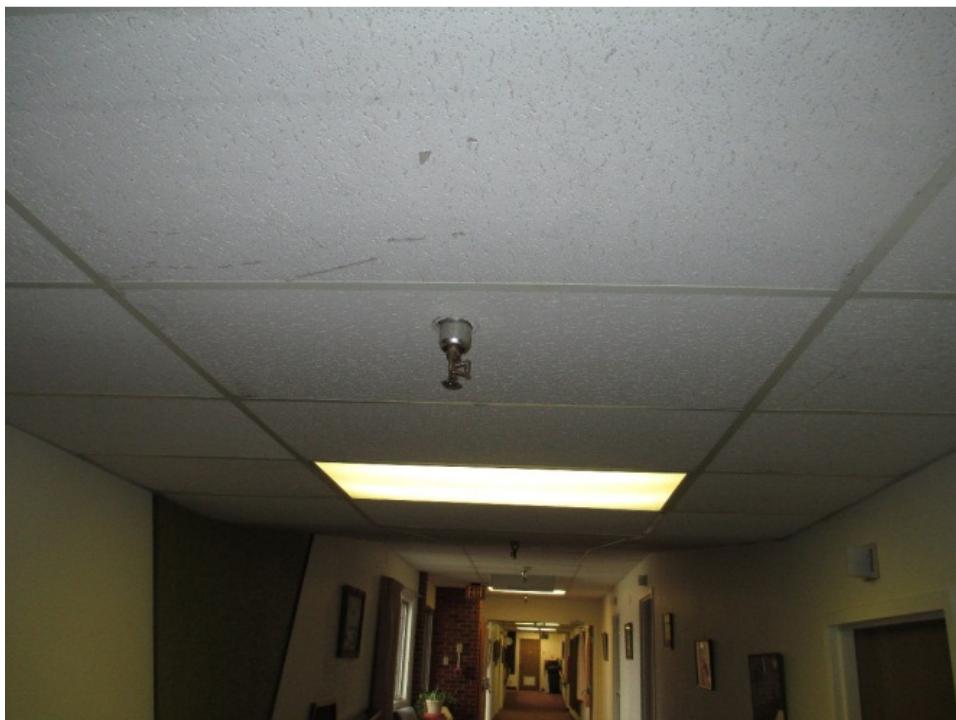
Figure 3.2.5: VHW Corridor ceilings in need of replacement

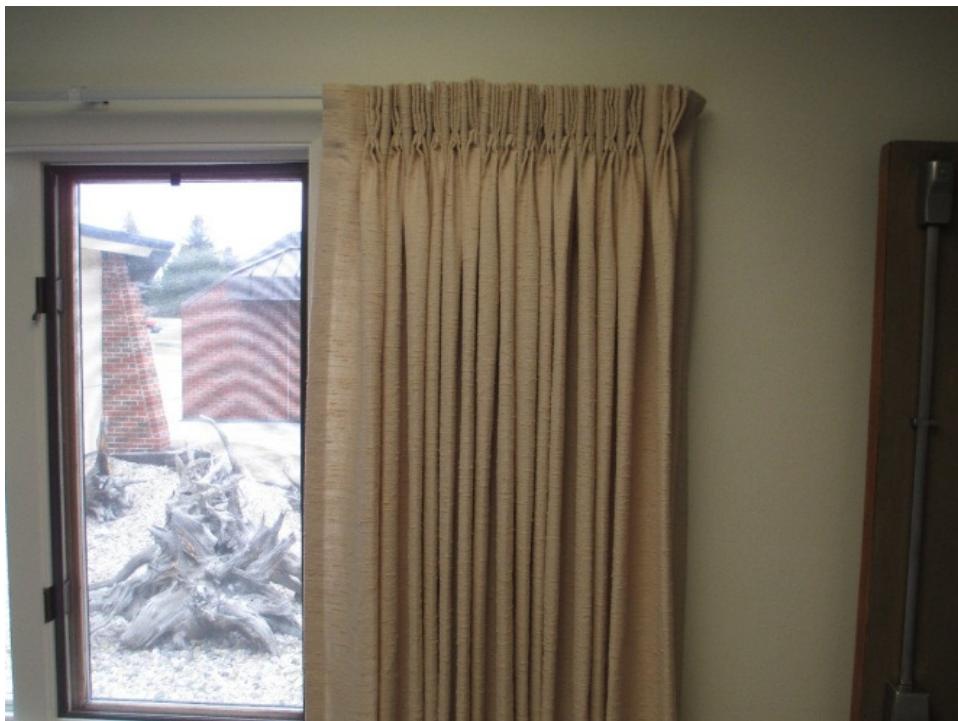
Figure 3.2.6: VHW corridor window treatments in need of replacement

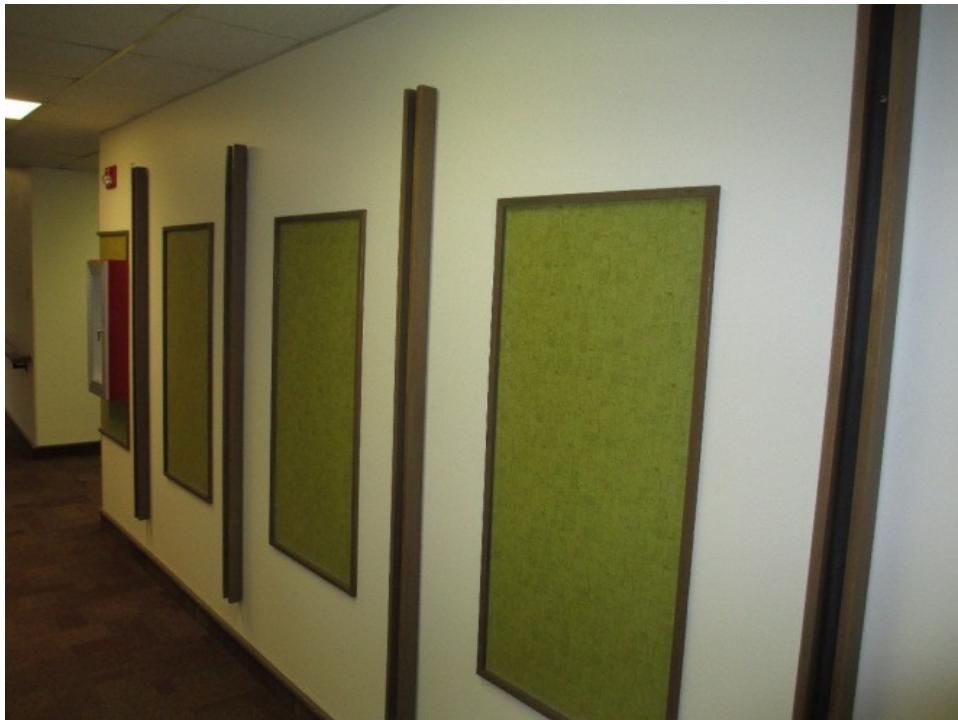
Figure 3.2.7: VHW corridor wall treatments in need of modernization

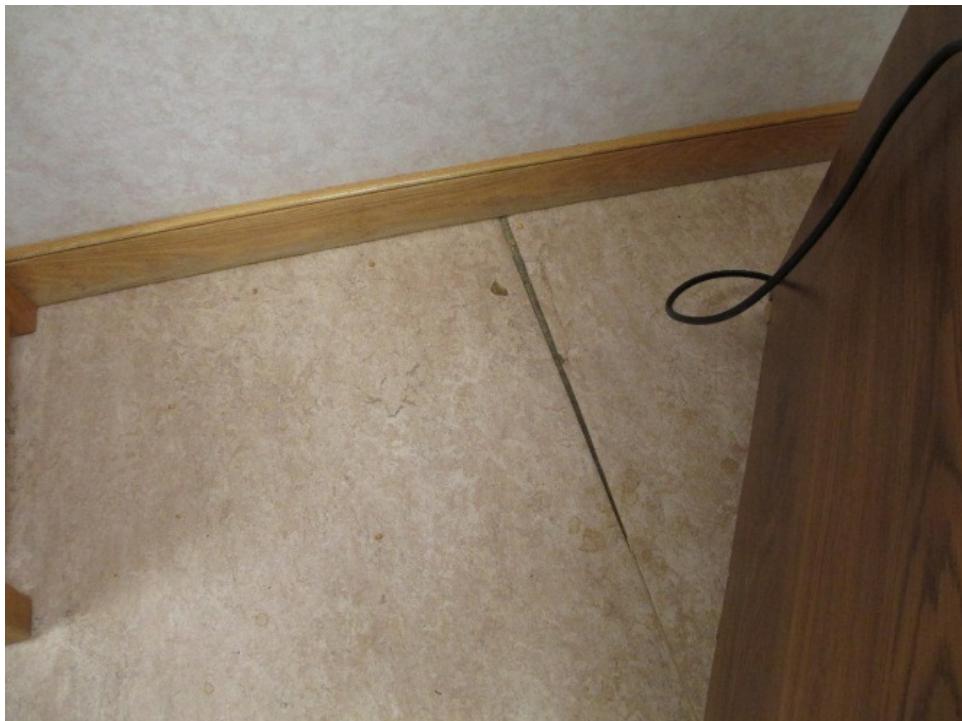
Figure 3.4.8 VHW Linoleum flooring with split seam

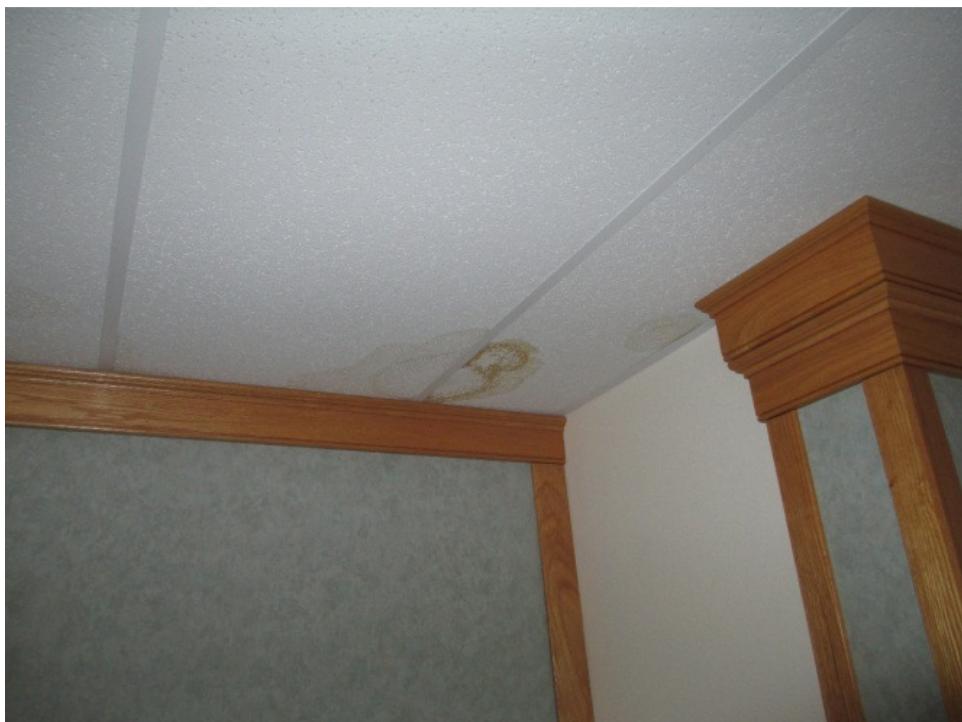
Figure 3.4.9: VHW Roof Leak
