Capitol Square Project History and Status

*Report of the Oversight Group on
Capitol Rehabilitation and Restoration*

Prepared January 2016

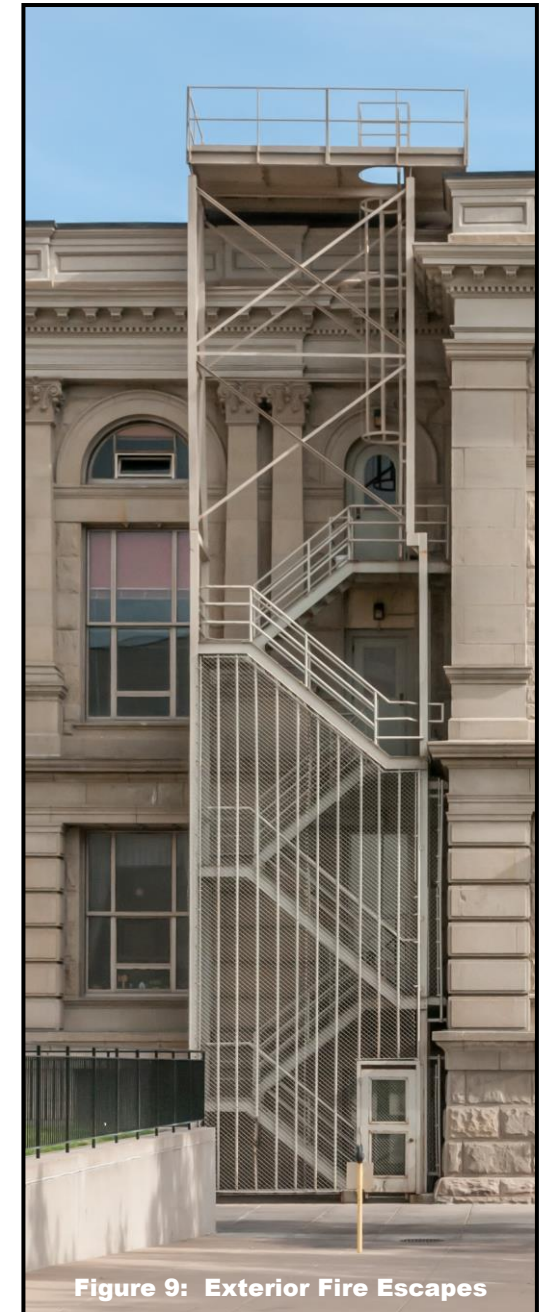
- ▶ **Exit signs are not installed throughout the building** and no emergency power source is provided for the emergency lighting systems.
 - ▶ There are **tripping hazards** in the Chamber galleries with ramps and stairs throughout these areas.

Figure 9: Exterior Fire Escapes

- Smoke detection, smoke evacuation, and fire suppression systems will be installed.
- The **exterior fire escapes will be removed** and the interior staircases connecting the north side of the third floor public galleries to the Chambers will extend to the garden level, providing another means of egress.
- Tripping hazards around the Chamber galleries will be fixed by taking out unnecessary risers.
- **Elevators will be replaced** and moved out of the historic monumental corridors, which will widen the corridors to allow for more efficient traffic flow.
- The location of the new elevators will **allow access to all levels of the building**, including the varying floor levels at the third floor gallery lobbies, without the need for a secondary lift.

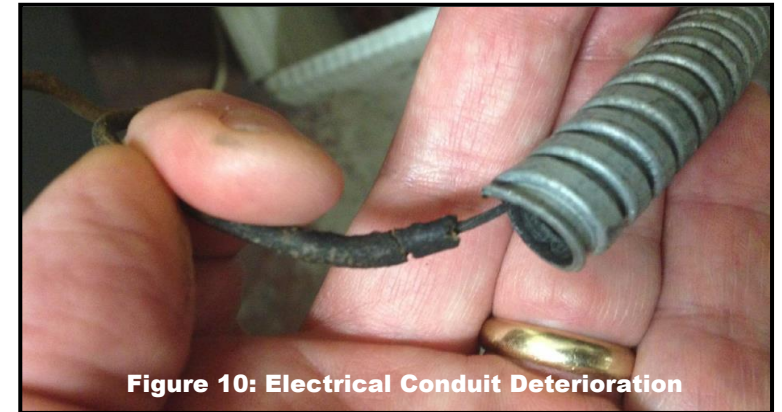
- The entire electrical system is obsolete, considered hazardous, and in need of replacement.
 - ▶ Wiring inside of **conduit is old and brittle**, insulation on the wires has deteriorated significantly, and the wiring does not meet current codes.

Figure 10: Electrical Conduit Deterioration

- All mechanical, electrical, and plumbing systems will be replaced and organized into logical routing systems.
- The existing HVAC system will be replaced and will extend throughout the building.
- **Public restrooms** will be located in both east and west wings of the Capitol on the garden level, first floor and third floor. The restrooms and other plumbing systems will stack vertically from one floor to the next.
- Building system distribution will be located in, and adjacent to, existing chimney flues to minimize impact.

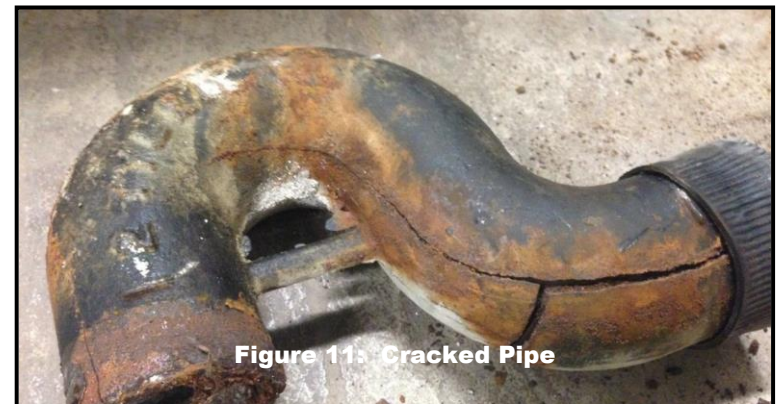
- The building's plumbing and steam systems are badly corroded. Water and sewer pipes suffer **frequent leaks** causing substantial damage.

Figure 11: Cracked Pipe

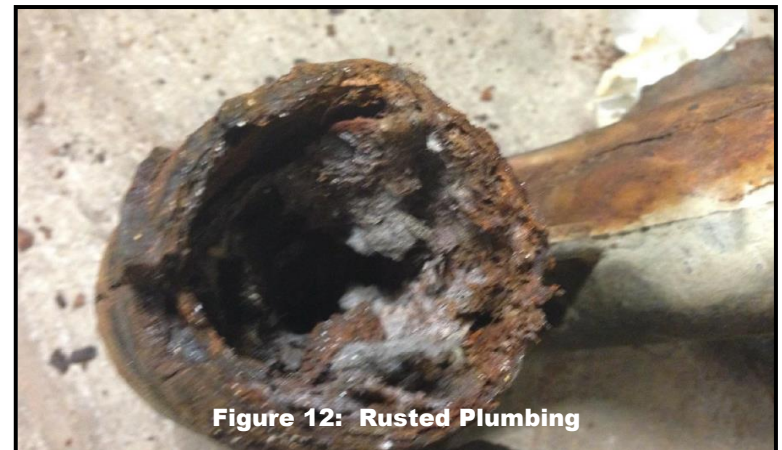
Figure 12: Rusted Plumbing

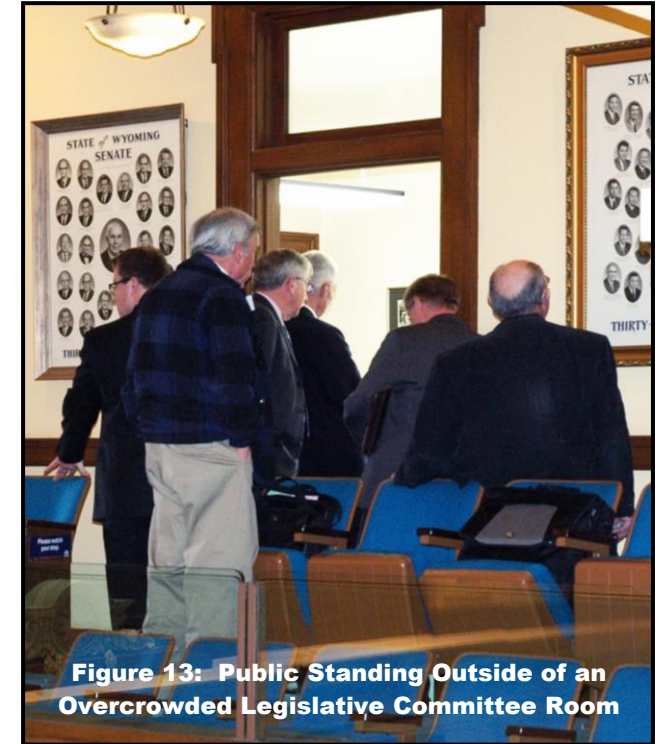
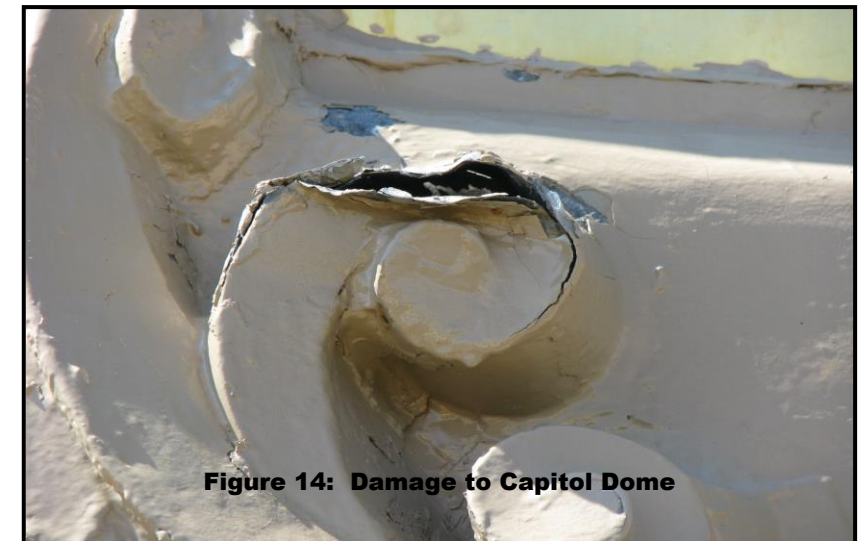
Damage to the Capitol Dome

- The Dome appears to be generating cracks at the Rotunda, which allows water to enter and cause damage.
- There are coating failures over large portions of the exterior of the Dome.
- There are dents, tears, and punctures in virtually all of the metal surfaces across the exterior of the Dome and **water infiltration occurs in several locations.**
- There is moisture damage in the interior of the Dome, which is degrading the building fabric.

- The existing paint will be removed on the Dome, the metal will be repaired and replaced as necessary, and then the surfaces will be re-primed and re-painted.
- The design team is currently engaged in an evaluation to prioritize masonry work for repair and replacement.

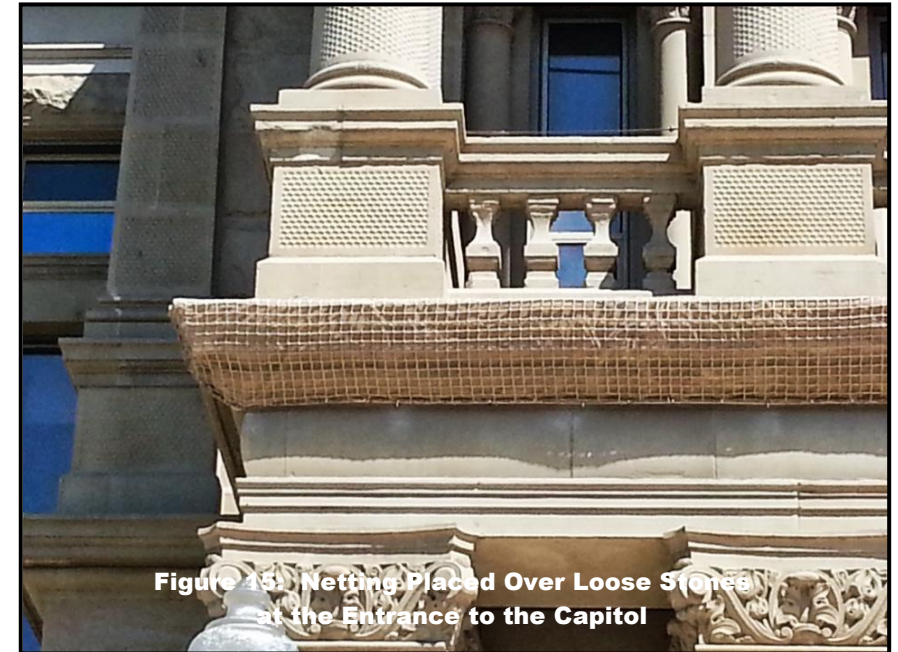
- **Many stones are damaged and loose.** In 2013, a loose stone was discovered over the front steps. The main entrance into the Capitol was closed for several weeks until the stone could be secured with netting.
- Cracks, spalls and voids, along with blistering, delamination, erosion, and discoloration have been identified.
- There are **open and deteriorated mortar joints** in the masonry.
- Most of the severe masonry damage exists in locations where there has been continual **water infiltration**.

Figure 15: Netting Placed Over Loose Stones at the Entrance to the Capitol

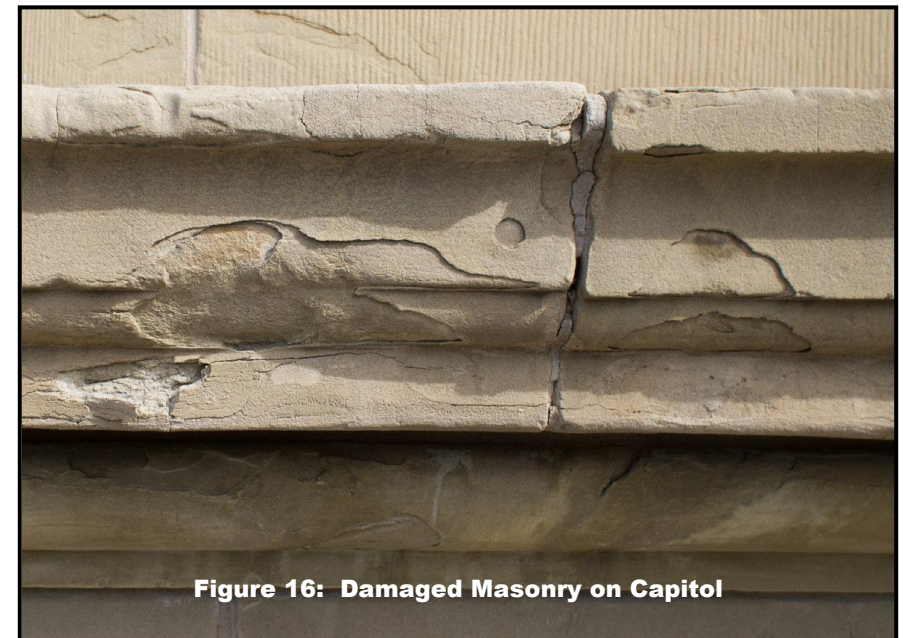
The stone on the Capitol exterior walls is generally sound, however significant localized issues exist. In some locations, the masonry is over 125 years old and periodic maintenance does not appear to have been performed. Repairs have been poorly executed or have failed.

Figure 16: Damaged Masonry on Capitol

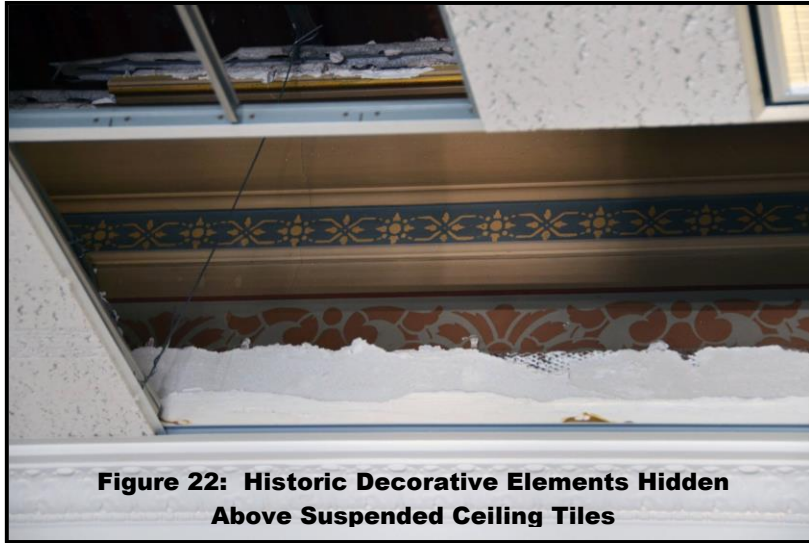
Suspended tile ceilings have been added throughout the building covering up historic details and significantly lowering ceiling heights. Restoring the original ceiling heights is **actually a cost savings**. By adopting a fan coil heating/cooling system, ceiling-mounted ductwork and stepped ceilings are avoided, lowering construction costs. Significant foundation underpinning reductions were also obtained by using this system.

Figure 22: Historic Decorative Elements Hidden Above Suspended Ceiling Tiles

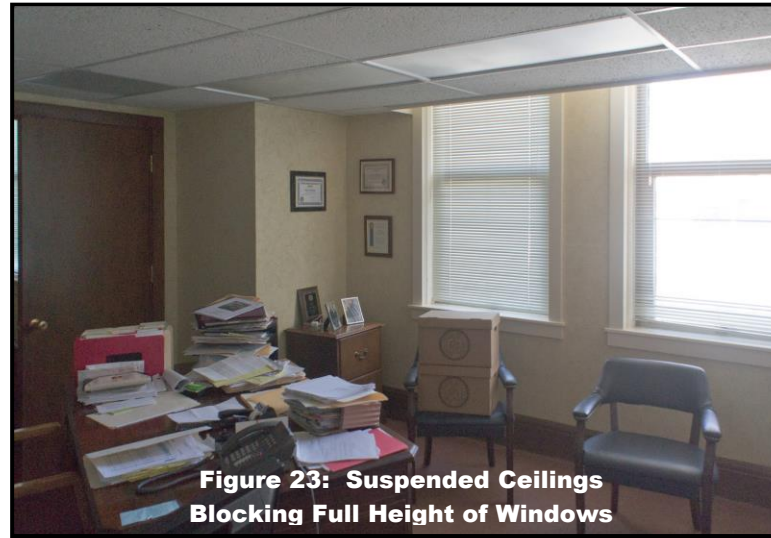
Figure 23: Suspended Ceilings Blocking Full Height of Windows

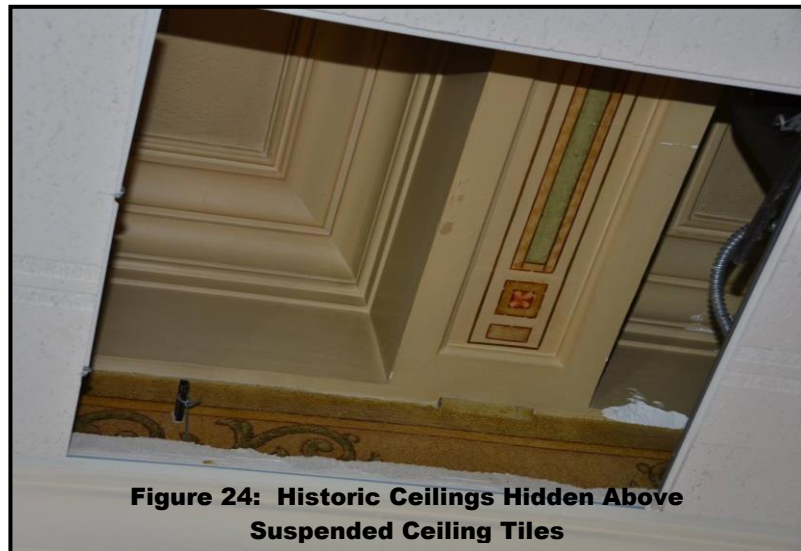
Figure 24: Historic Ceilings Hidden Above Suspended Ceiling Tiles

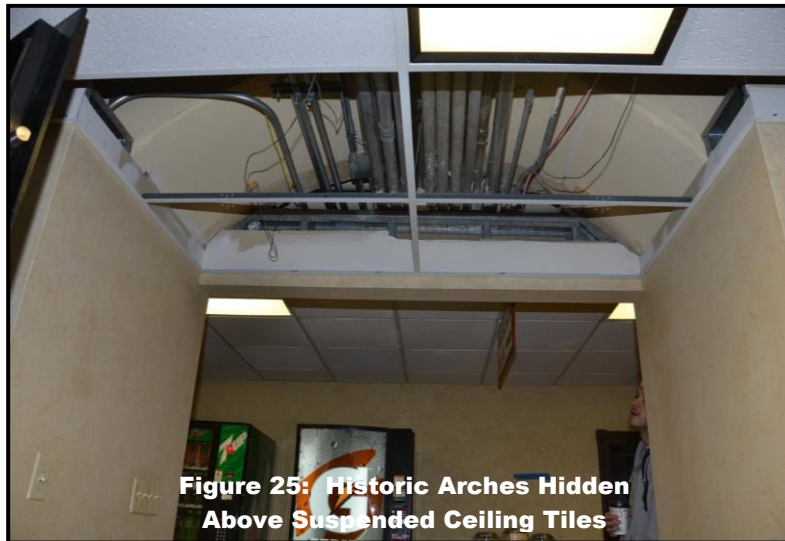
Figure 25: Historic Arches Hidden Above Suspended Ceiling Tiles

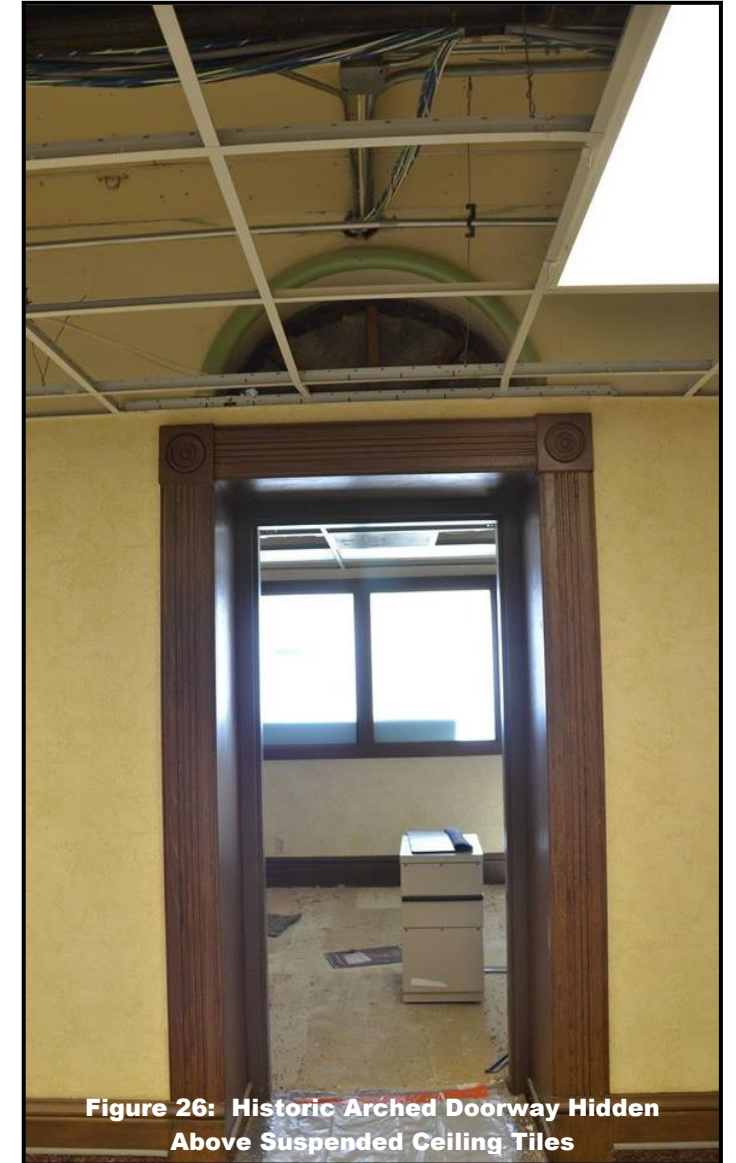
Figure 26: Historic Arched Doorway Hidden Above Suspended Ceiling Tiles

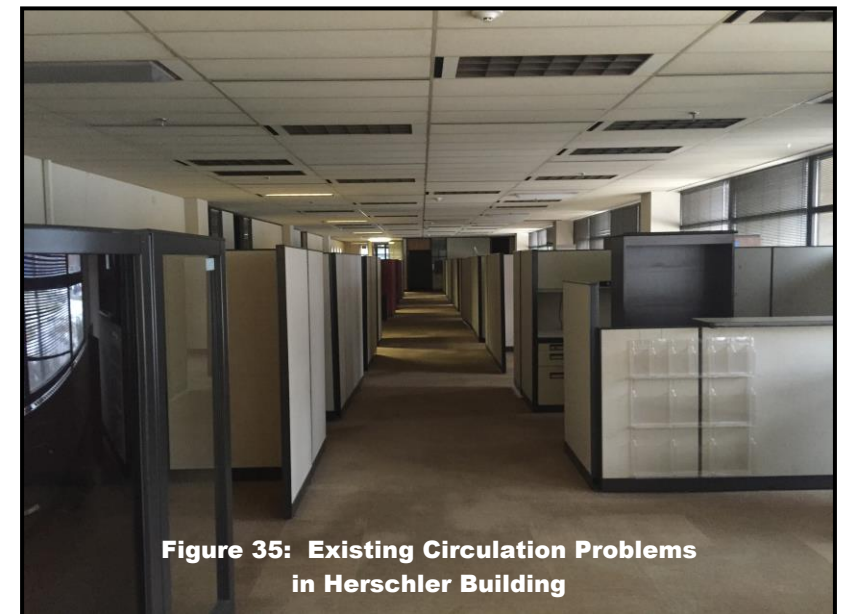
- **Wayfinding is difficult** within the building, because there is a greater distance from building entry points to elevators and stairs than typical.
- Elevators and stairs cannot be seen from the building entries, **making navigation difficult** to upper floors.
- The building's **open floorplan lacks security** and individuals can wander throughout the building.
- The atrium is underutilized and there are **heating and cooling costs** associated with maintaining it. Sound carries throughout the building when there are activities in the atrium, because each floor opens to the atrium.

Figure 35: Existing Circulation Problems in Herschler Building

- The new entries will provide more efficient access into the building, minimizing travel distance to elevators and restrooms, **improving wayfinding** through the building.
- The new configuration will allow agencies to have clearly defined suites, allowing for improved security.
- The new configuration will reduce pedestrian traffic through unrelated agency space and increase the amount of square footage that can be used to house employees.
- Elevators will be added adjacent to the new lobby of the building to improve building circulation and to provide convenient access to the elected officials' staff located on the south side of the building.

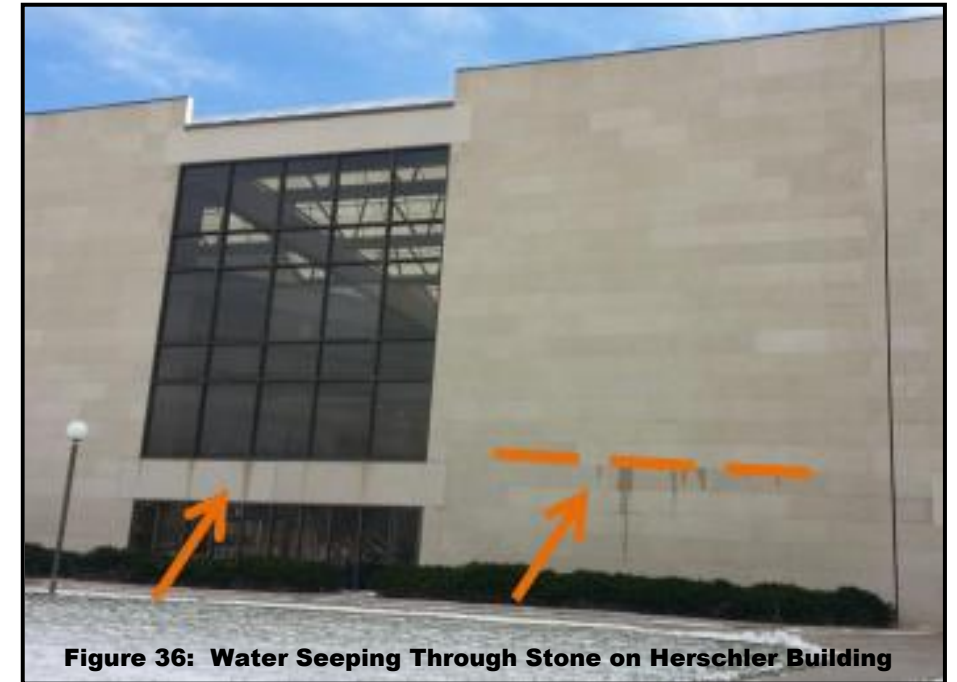
Figure 36: Water Seeping Through Stone on Herschler Building

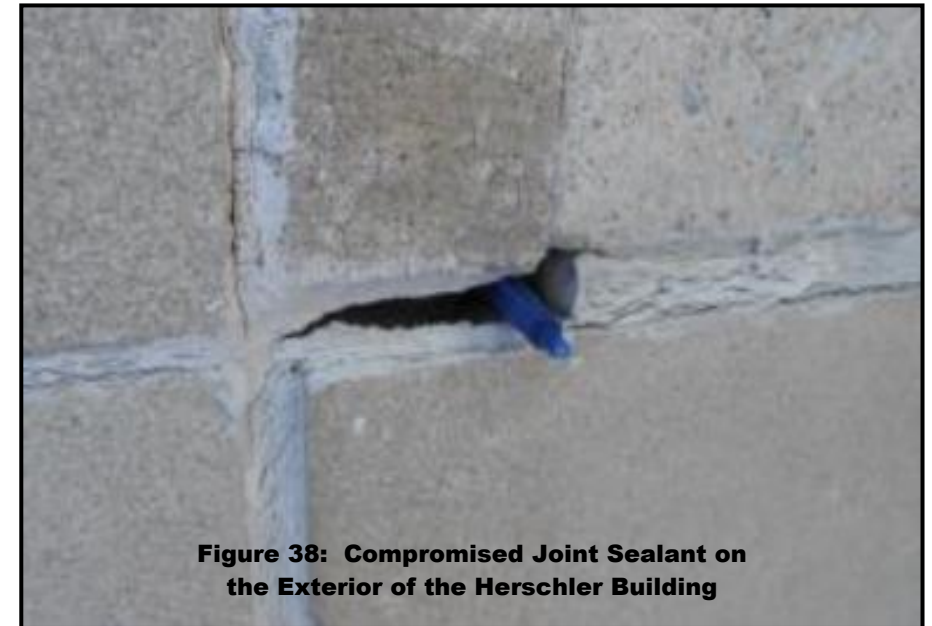
Figure 38: Compromised Joint Sealant on the Exterior of the Herschler Building

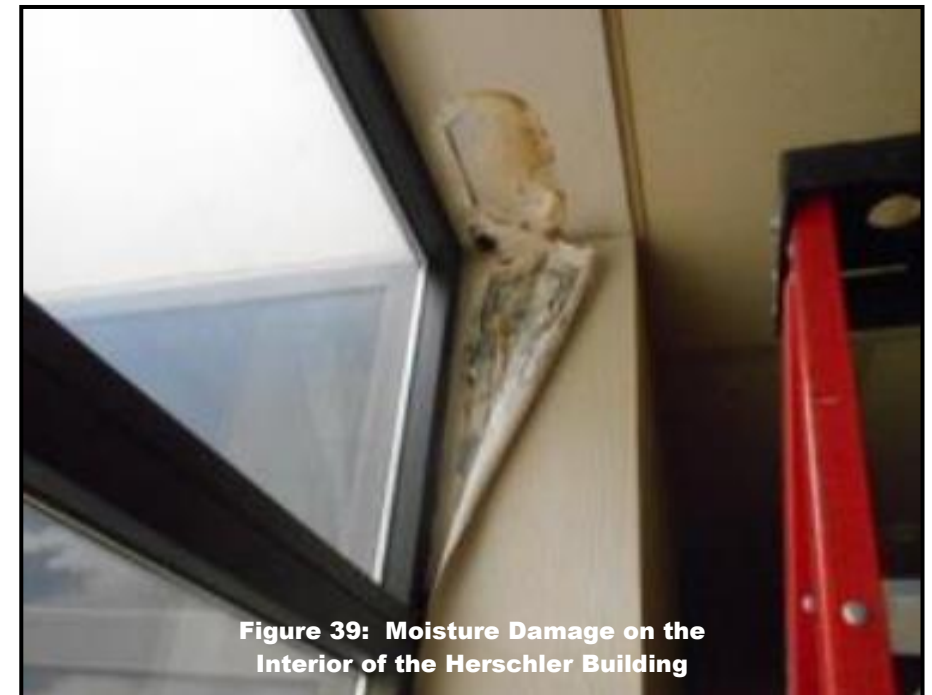
Figure 39: Moisture Damage on the Interior of the Herschler Building
