*Update on
the Wyoming*

**Capitol
Square
Project**

February 2018

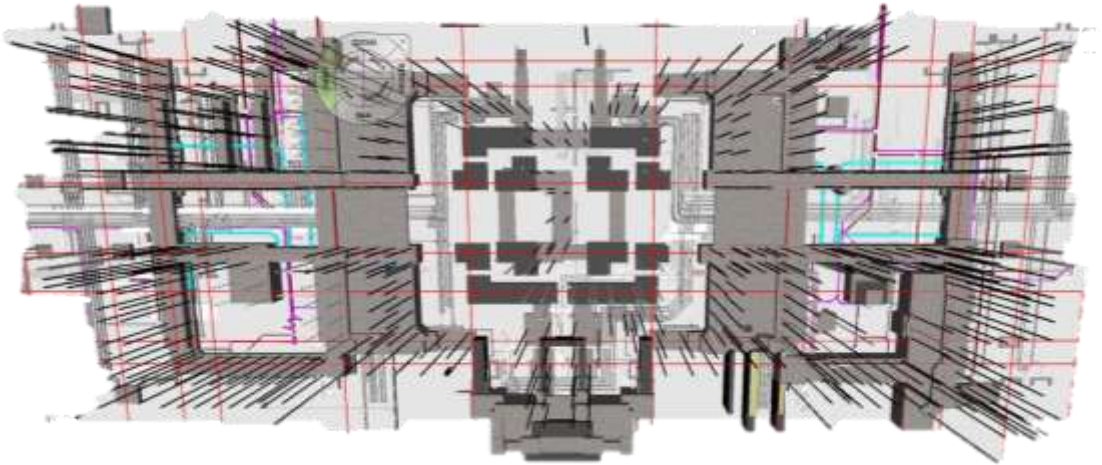
- Underpinning of the foundation has been completed, which strengthened and stabilized the building, and supports the large mechanical ductwork that now runs beneath the garden level.
- The underpinning process utilized micropiles, which are deep foundation elements constructed using high-strength, small-diameter steel threaded bar. A specialized piece of machinery drilled rods through the soil to provide additional structural support for the foundation. As rods were installed, grout was pumped into the hole to encase the rod and create the final micropile of between 8 to 12 inches in diameter and were drilled down 30 to 40 feet.
- The rods and grout were left in place to stabilize the ground and to improve the load-bearing capacity of the building. This allows the new mechanical systems to run under and around the existing foundation footings.

Schematic of Micropile Locations Below the Capitol

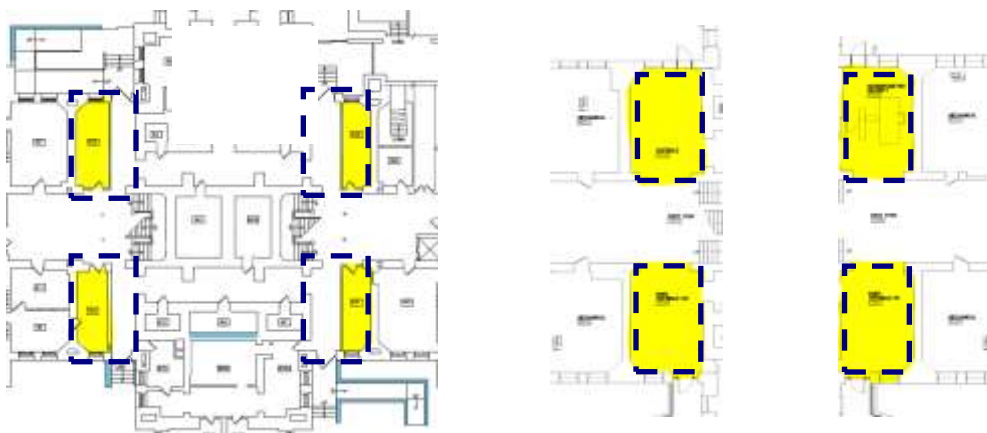
The image above on the left shows the previous configuration of garden-level entrances with small non-historic rooms highlighted that narrowed the entrances. The image above on the right shows the larger entrances after the non-historic walls were removed.

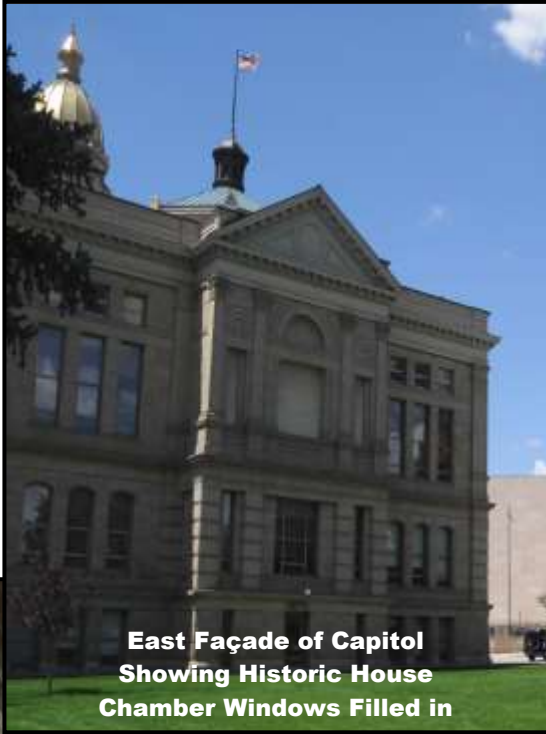
- Three windows that existed on the east side of the House Chamber, but were filled in when the House Chamber was expanded in the 1970s, will be restored.

**East Façade of Capitol
Showing Historic House
Chamber Windows Filled in**

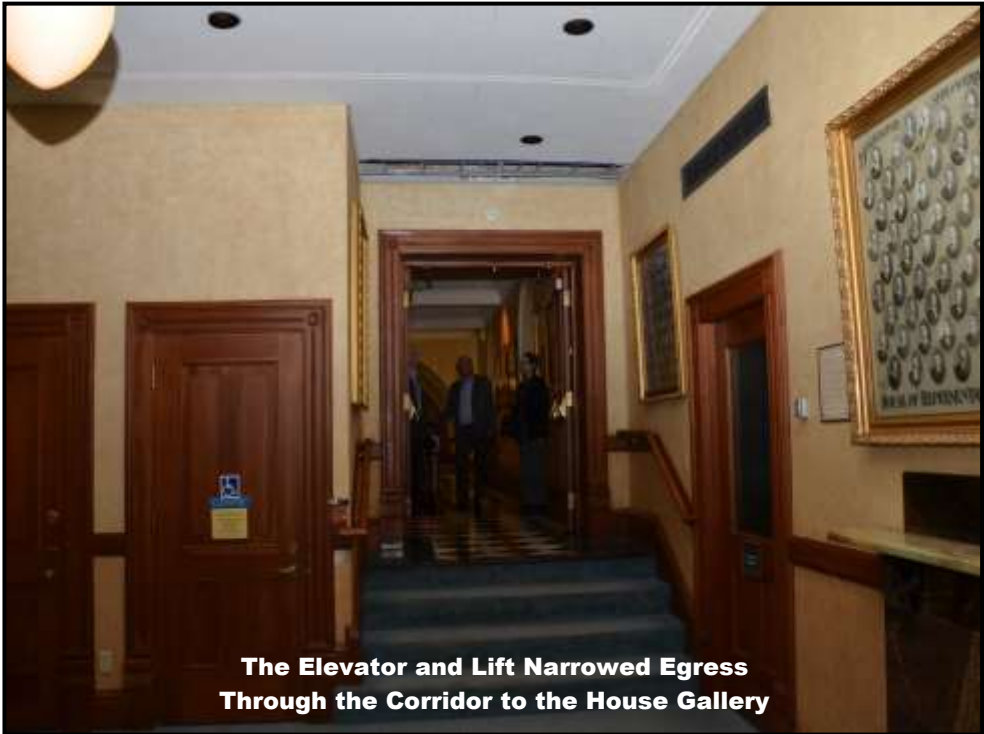
**The Elevator and Lift Narrowed Egress
Through the Corridor to the House Gallery**

- The former elevator locations narrowed the corridors outside the public galleries, impeding ADA access and making it difficult to evacuate crowds.
- Removal of the elevators has created an open corridor, providing a visual connection from the House Gallery Lobby to the Senate Gallery Lobby.

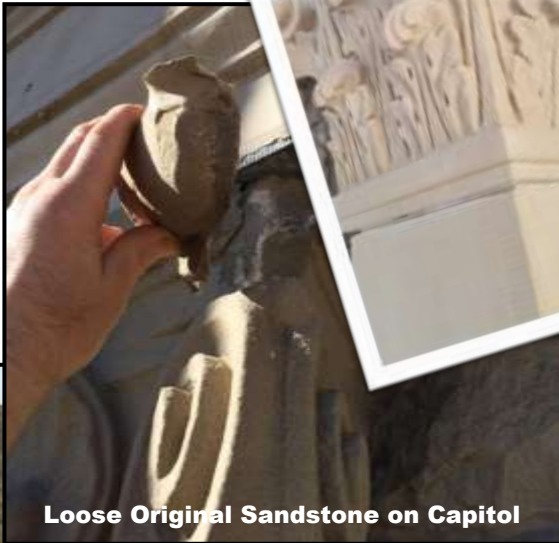
- There were areas throughout the exterior, where the sandstone was loose and posed a life-safety hazard or did not shed water properly. These stones will be replaced. Cracks, spalls and voids, along with blistering, delamination, and erosion were also identified and are being addressed as part of the restoration.
- The sandstone for the restoration efforts was mined at a quarry near Rawlins, Wyoming. Most of the original stone used the Capitol was mined at this quarry in the late 1880s. The current quarry owner, the Anschutz Corporation, allowed the State of Wyoming to harvest the stone for free.

Loose Original Sandstone on Capitol

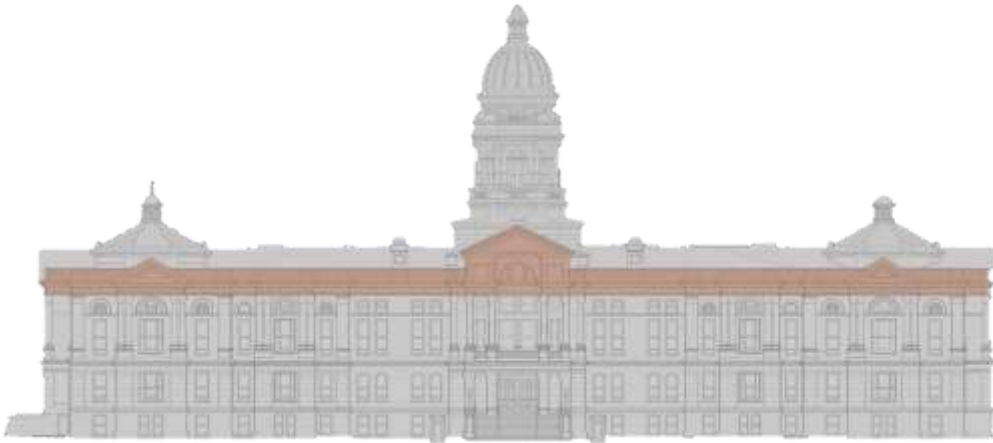
- The entablature, cornice, and pediments at the top of the Capitol exterior are made of metal, not stone. The existing material, most of which is original to the building, is failing and is currently being repaired or replaced.
- Extensive work is needed on the dome and drum of the Capitol to repair and replace many of the failing materials. Scaffold erection for this work is currently underway.

The Metal Entablature on the Capitol was Severely Degraded

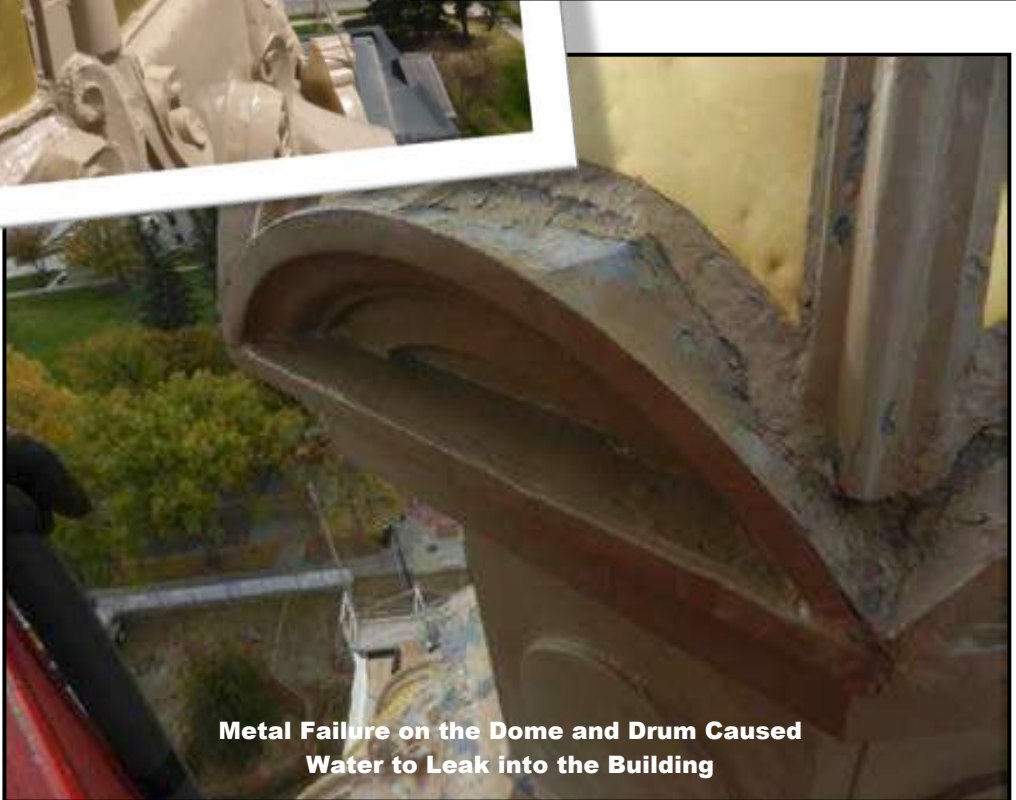
**Metal Failure on the Dome and Drum Caused
Water to Leak into the Building**

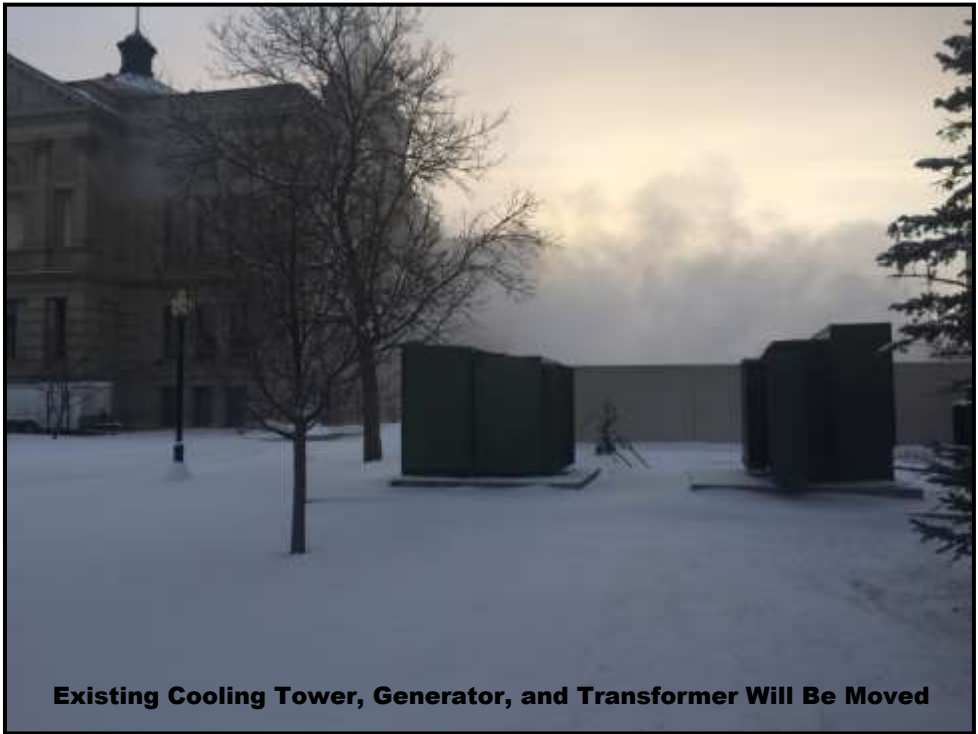
- The cooling tower on the northeast side of the Capitol creates noise and mist on the Capitol grounds. Moisture from the tower has degraded the stone on the Capitol.
- The generator, transformer, and associated switchgear on the northeast side of the Capitol pose a security risk and detract from the appearance of the Capitol grounds.
- These systems will be relocated to the Central Utility Plant and to the fourth floor of the east wing of the Herschler Building.

Existing Cooling Tower, Generator, and Transformer Will Be Moved
