## WYOMING STATE PENITENTIARY Independent Peer Review Study

2900 South Higley Boulevard  
Rawlins, Wyoming 82301

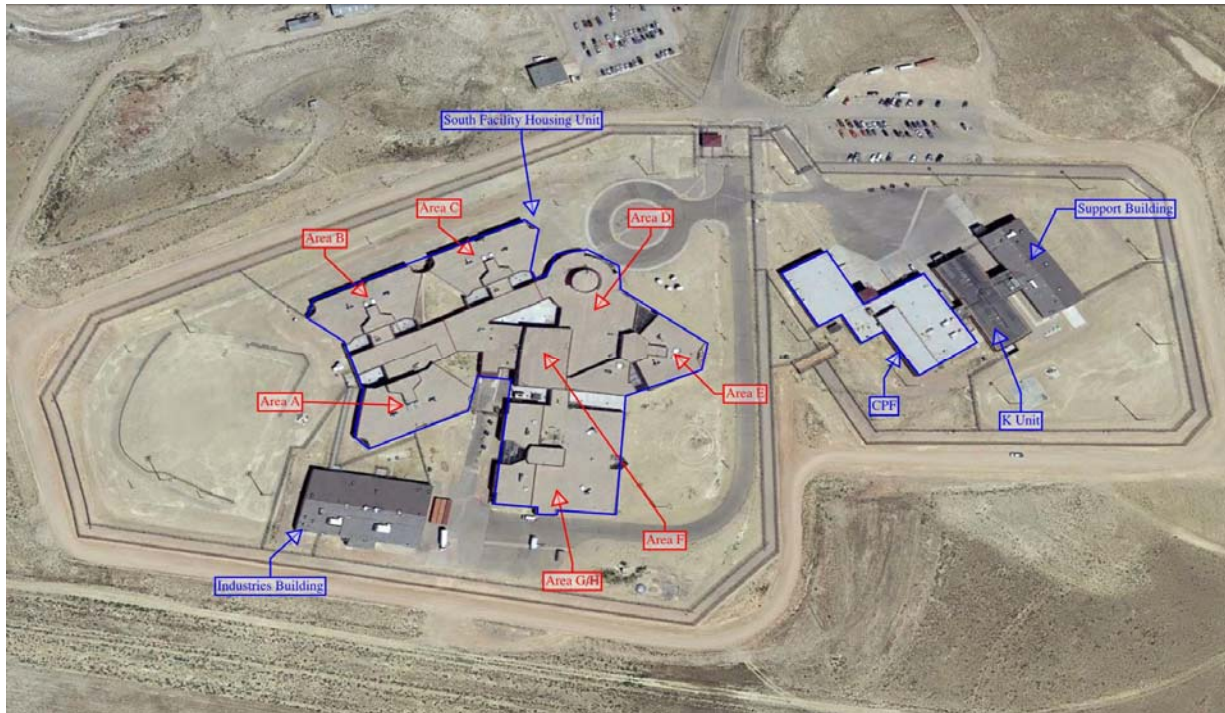
*Figure 1. Building identification, with Areas in the South Facility Housing Unit*

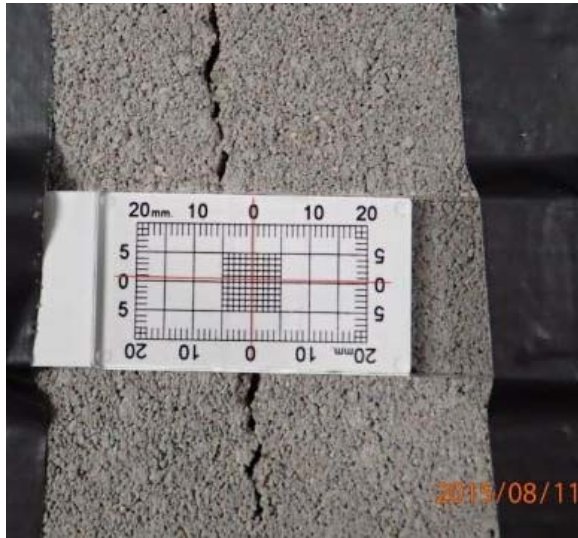
Figure 2A. Crack Gauge 1 - Area F along east wall of Electrical Room F116.  
*M/M WSP Crack Monitor Comparison, page 1 of 4, photo date 8/11/15*

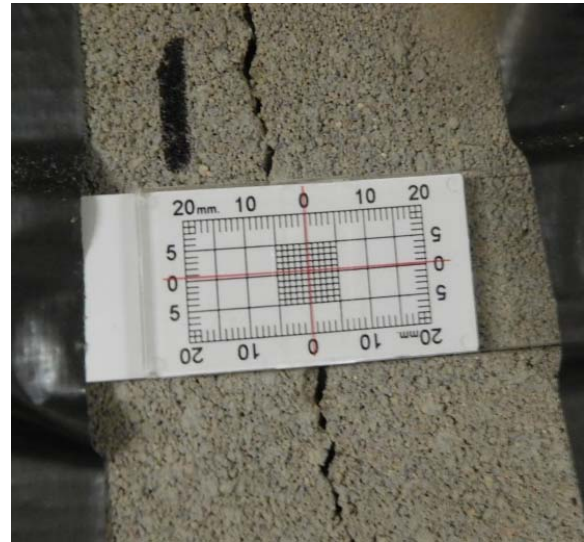
Figure 2B. Crack Gauge 1 - Area F along east wall of Electrical Room F116.

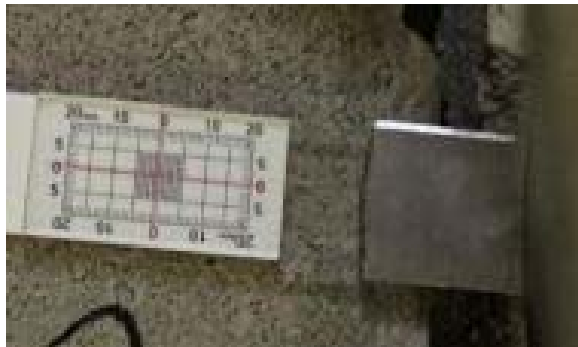
Figure 3A. Crack Gauge 2 - Area F near NW corner of Electrical Room F116.  
*M/M WSP Crack Monitor Comparison, page 2 of 4, photo date 8/11/15*

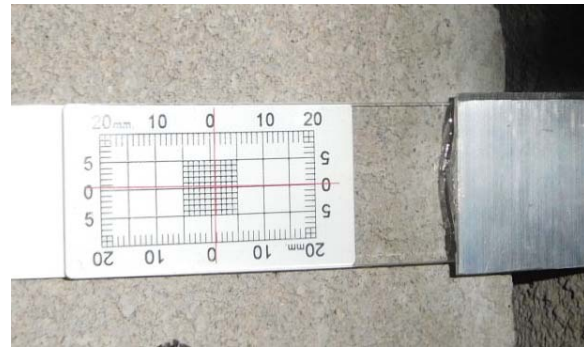
Figure 3B. Crack Gauge 2 - Area F near NE corner of Electrical Room F116.

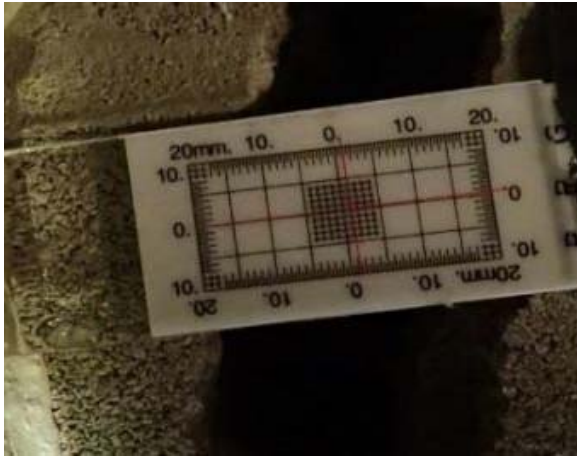
*Figure 4A. Crack gauge 3 - Area F Near NE corner of Electrical Room F116.  
M/M WSP Crack Monitor Comparison, page 3 of 4, photo date 8/11/15*

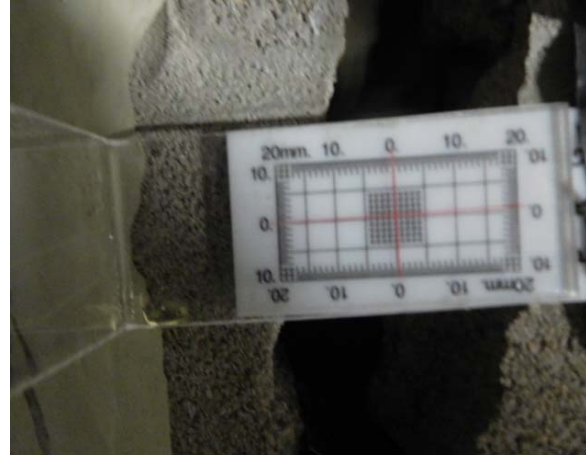
*Figure 4B. Crack gauge 3 - Area F Near NE corner of Electrical Room F116.*

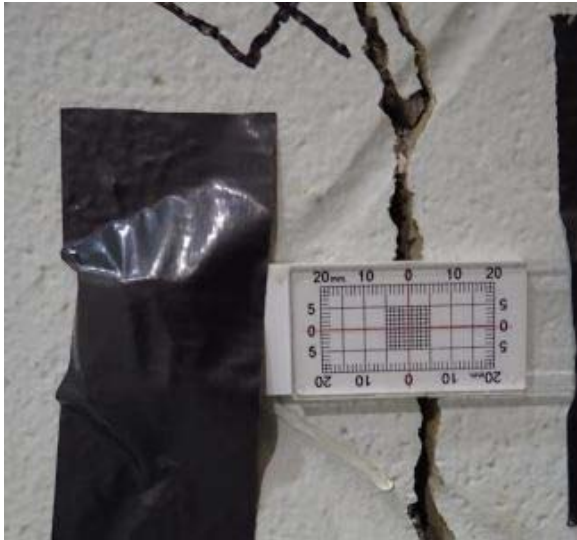
*Figure 5A. Crack gauge 4 - Area F near NE corner of Gymnasium, Room F125.  
M/M WSP Crack Monitor Comparison, page 4 of 4, photo date 8/11/15*

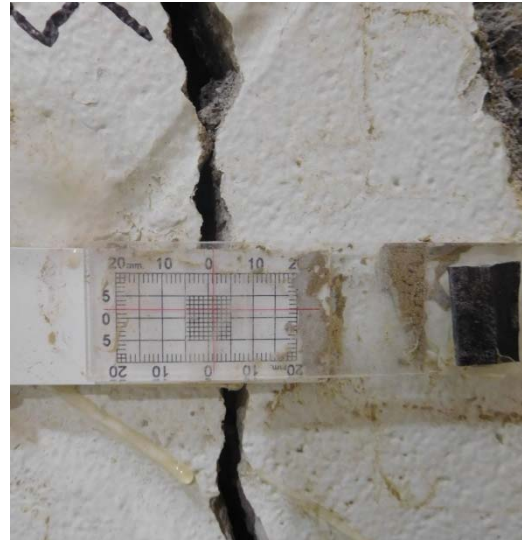
*Figure 5B. Crack gauge 4 - Area F near NE corner of Gymnasium, Room F125.*

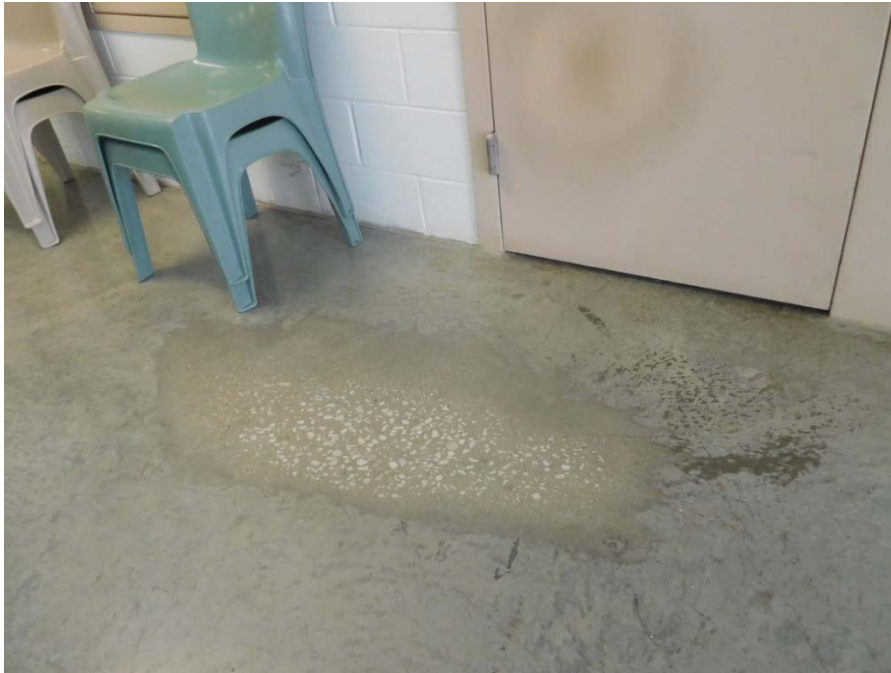
*Figure 6. Indication of past grinding of slab surface to facilitate door operation*

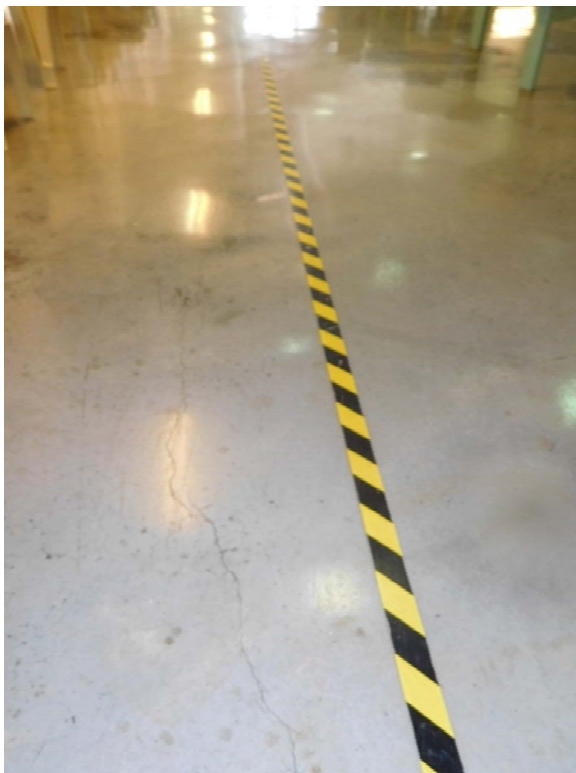
*Figure 7. Slab crack in cell Dayroom parallel to front wall of cells*

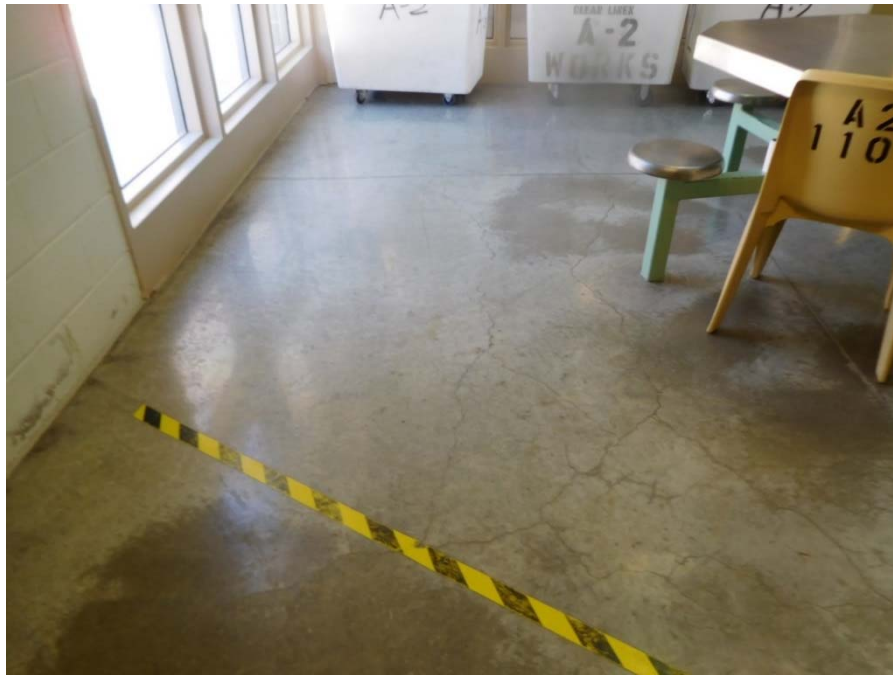
*Figure 8. Interior floor slab cracking in Pod A1 adjacent to courtyard*

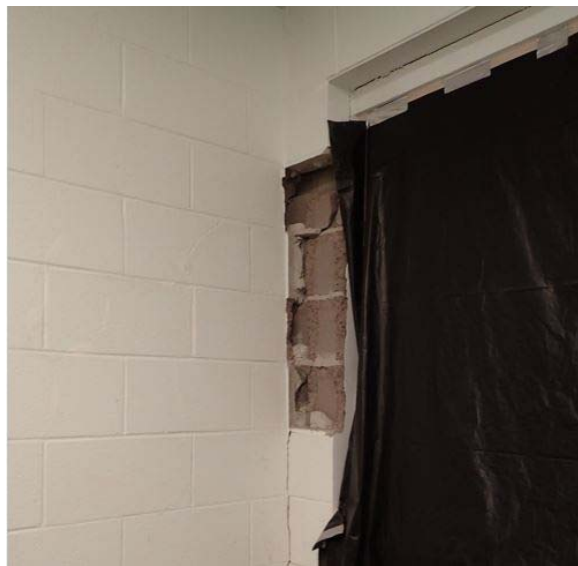
*Figure 9A. Masonry distress at window opening in north wall of Room A164.  
M/M Presentation, slide 12, photo date 1/4/16*

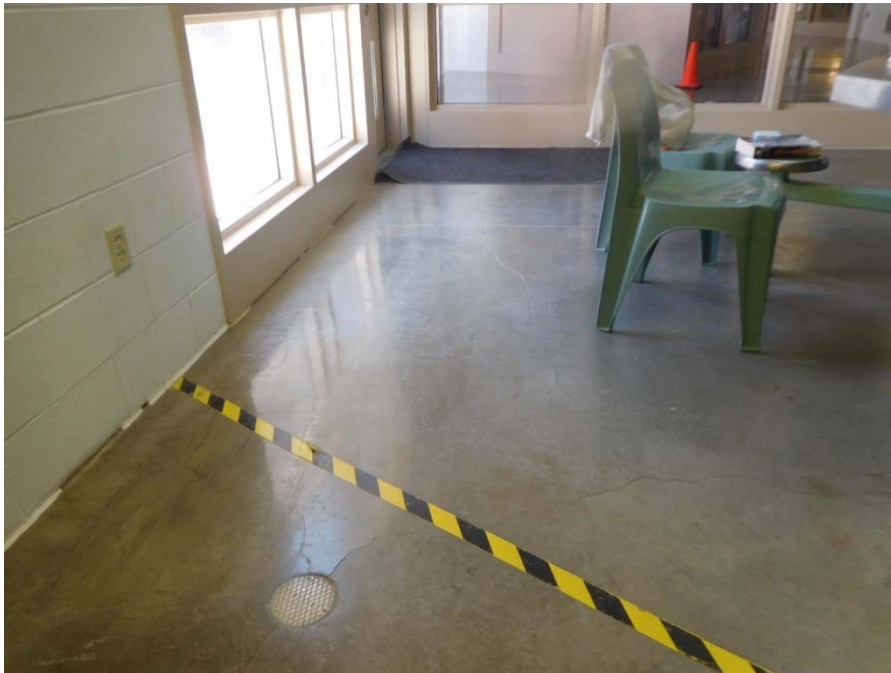
*Figure 11. Interior floor slab cracking in Pod B2 adjacent to courtyard*

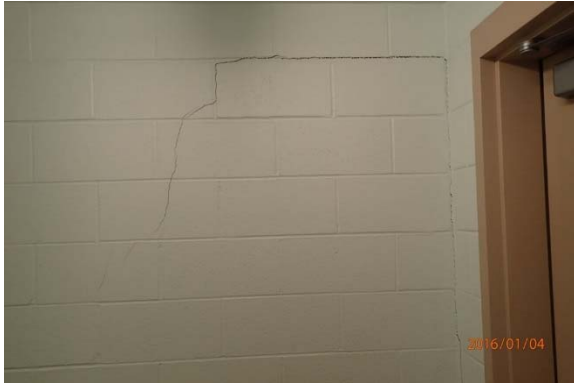
*Figure 12A. Cracking in north bearing wall near joint with non-bearing wall in Room B171. M/M Presentation, slide 17, photo date 1/4/16*

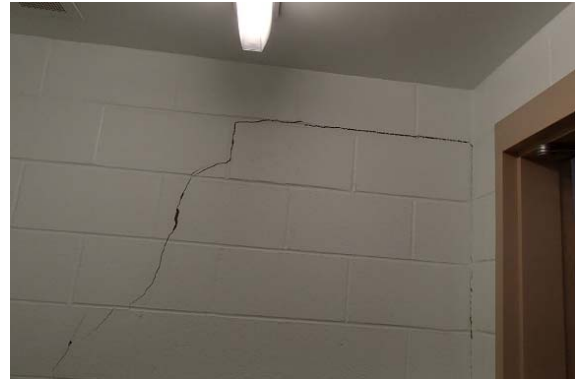
*Figure 12B. Cracking in north bearing wall near joint with non-bearing wall in Room B171. WJE Photo P6150269, date 6/15/17*

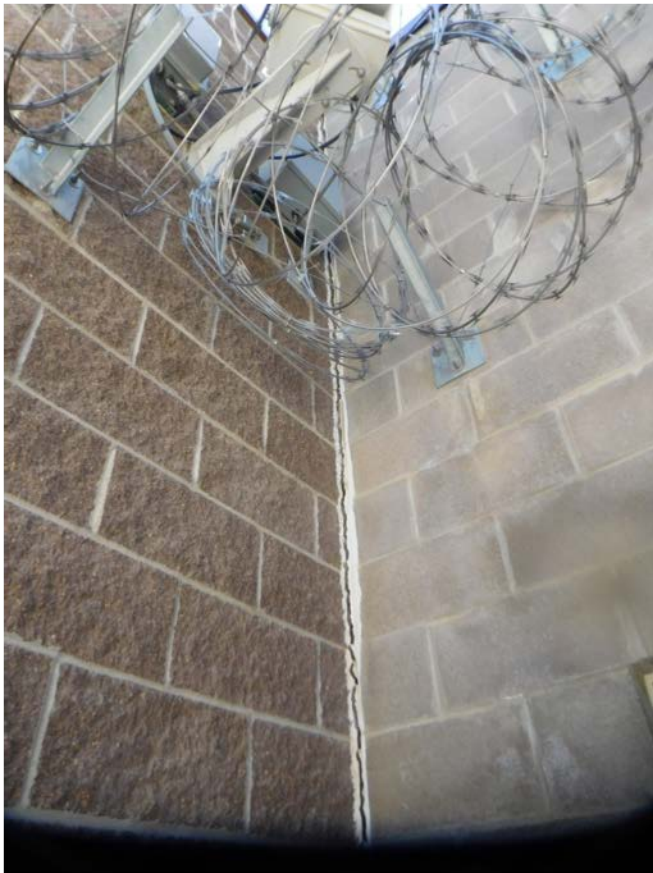
*Figure 13. Control joint sealant failure in courtyard associated with Pod B1*

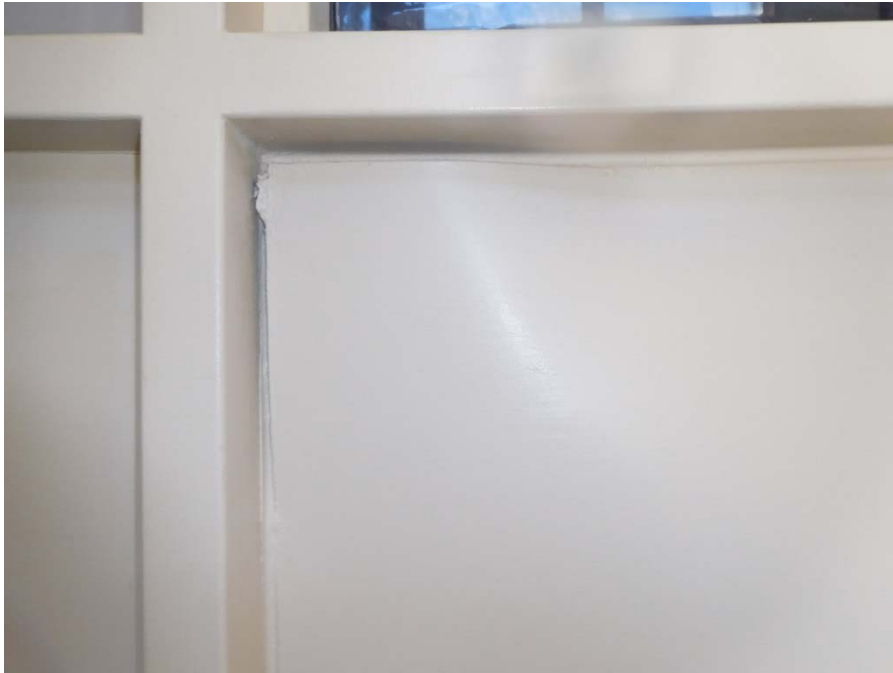
*Figure 14. Broken weld and buckled steel plate at Pod B rotunda*

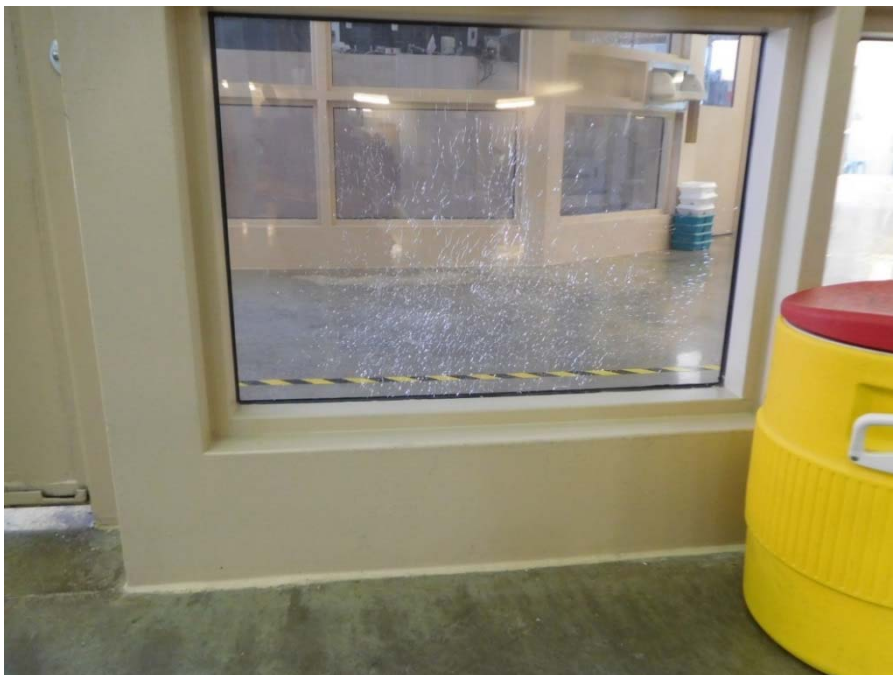
*Figure 15. Broken glass window in Pod B rotunda*

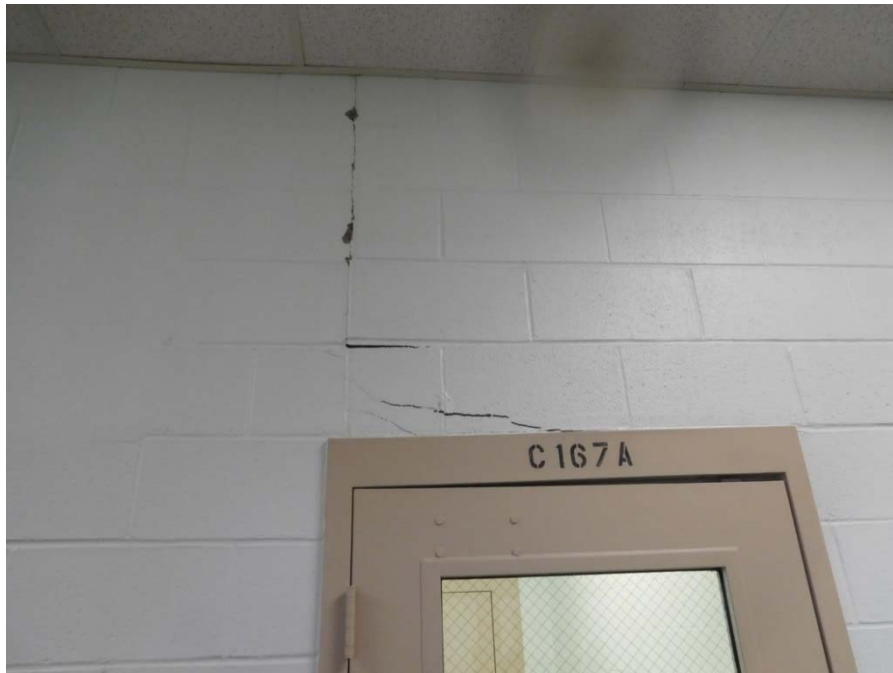
*Figure 16. Racked door and distressed masonry*

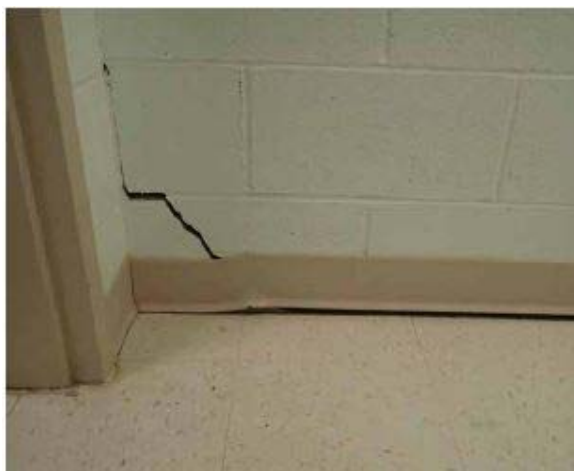
*Figure 17A. Cracking in west non-bearing wall at juncture with bearing wall in Room B167. M/M Rpt. page 36 of 284, photo date 1/27/15*

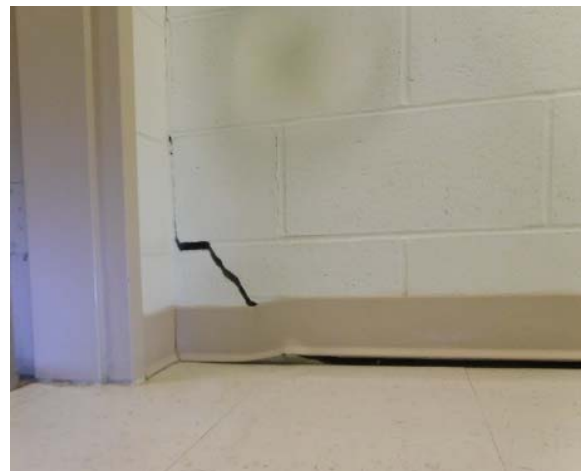
*Figure 17B. Cracking in west non-bearing wall at juncture with bearing wall in Room B167. WJE Photo DSCN1226, date 6/15/17*

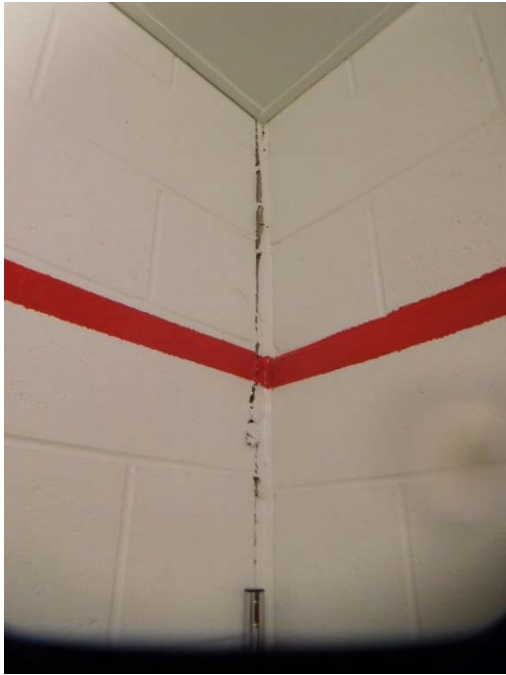
*Figure 18. Vertical crack at intersection of non-bearing partition and bearing wall in Room C161*

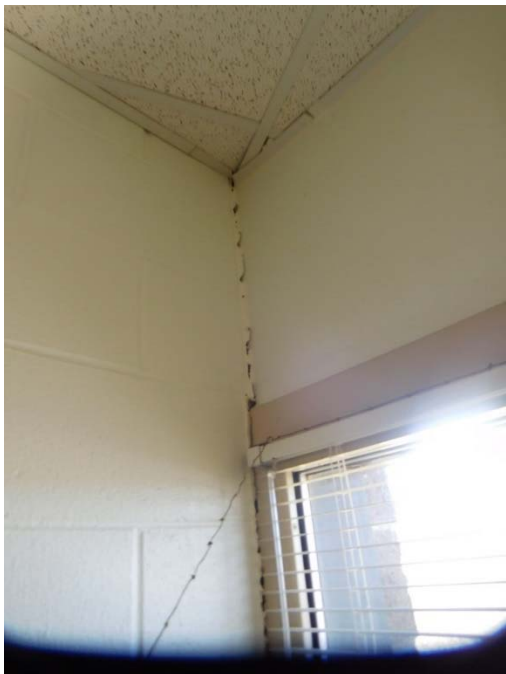
*Figure 19. Vertical crack at intersection of non-bearing partition and bearing wall in Room D173*

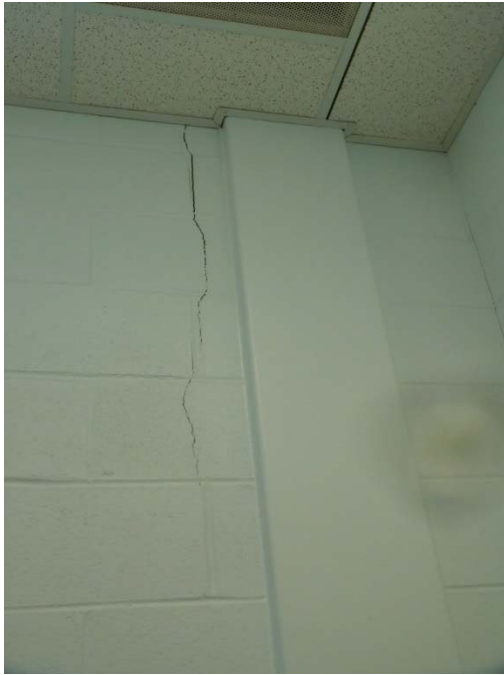
*Figure 20. Vertical crack at intersection of non-bearing partition and column in Room D144*

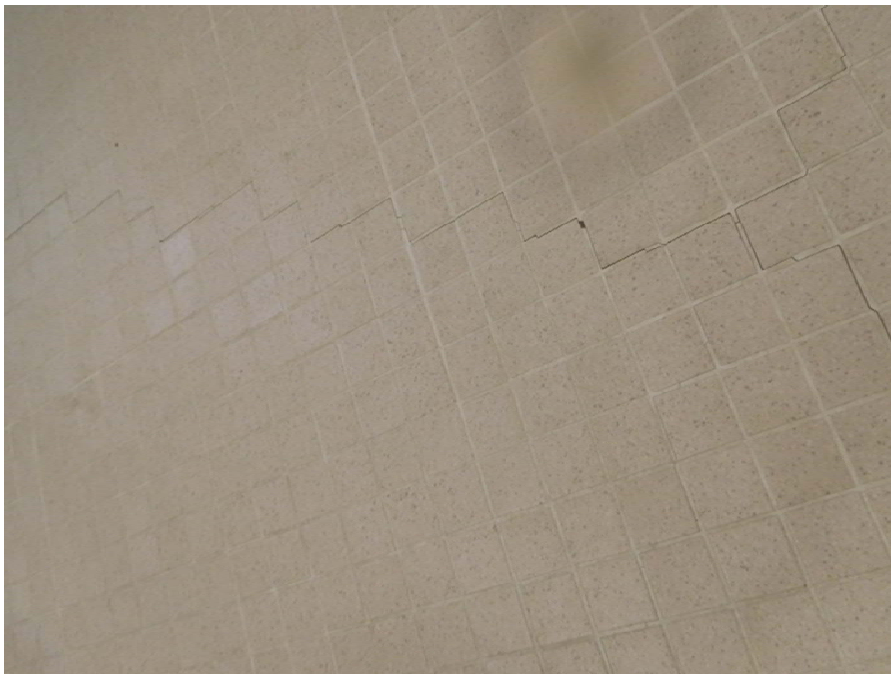
*Figure 21. Floor tile cracking in Waiting Area D108*

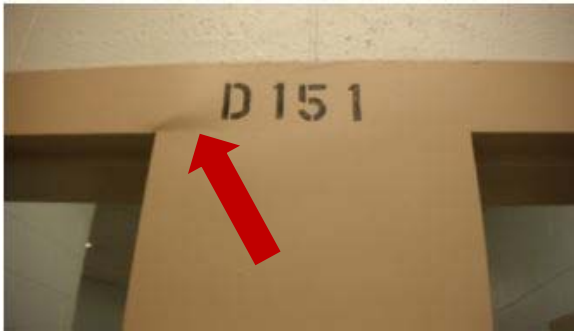
Figure 22A. Buckled metal door frame D151 in Corridor D151.  
WSP Wall Movement History Rpt. March 31, 2015, page 76 of 141, photo date July 2013

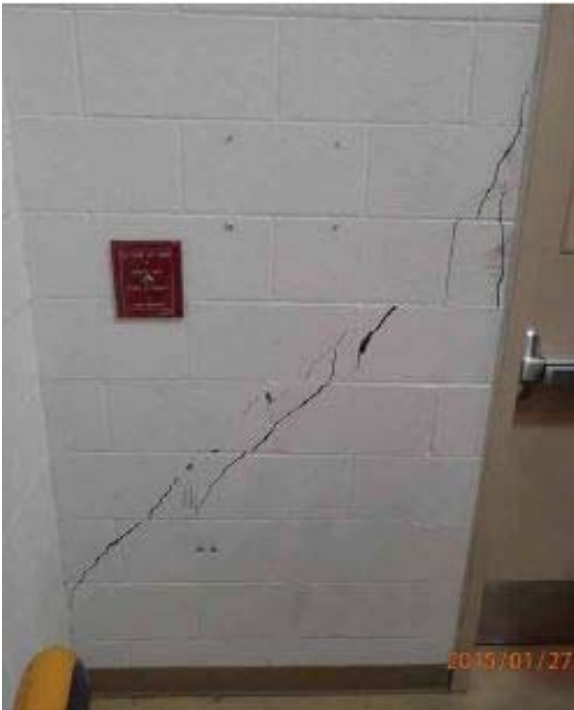
Figure 23A. Cracking in east wall of Gymnasium near NE corner, Room F125.

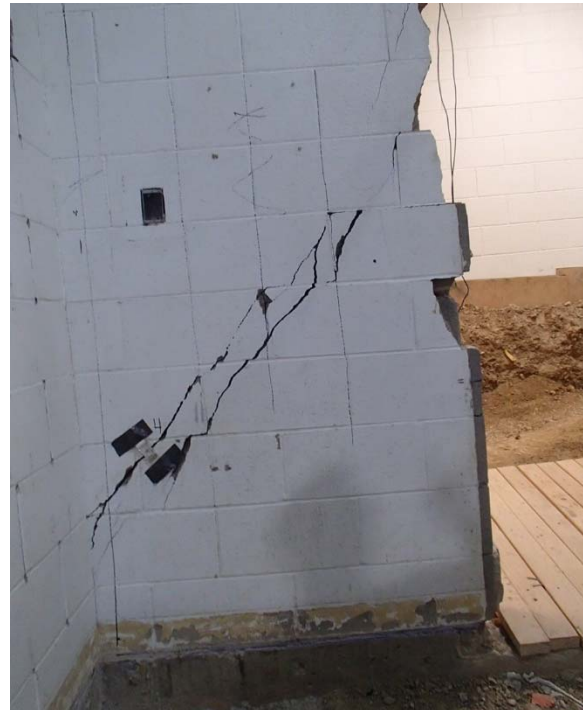
Figure 23B. Cracking in east wall of Gymnasium near NE corner, Room F125. (Note Crack Gauge No. 4 at lower left.)

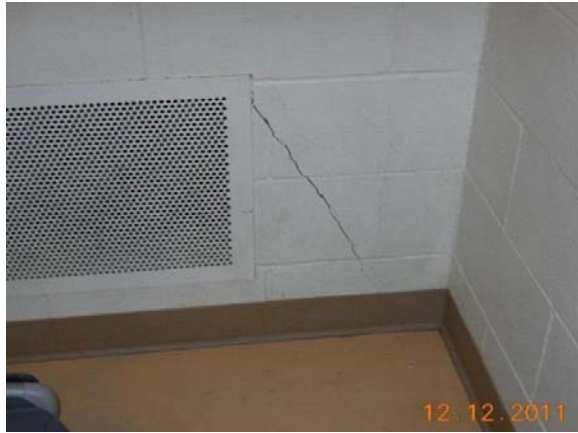
*Figure 24A. Crack adjacent to vent in northwest corner of Gymnasium, Room F125.  
WSP Wall Movement History Rpt. page 67 of 141,  
photo date 12/12/2011*

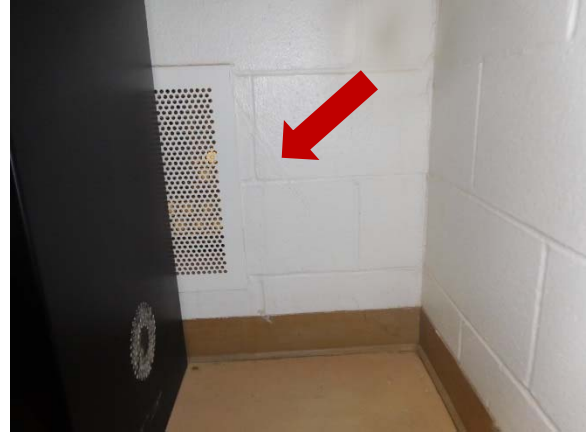
*Figure 24B. Repaired (caulked) crack adjacent to vent in northwest corner of Gymnasium, Room F125.  
WJE Photo DSCN1446, date 6/22/2017*

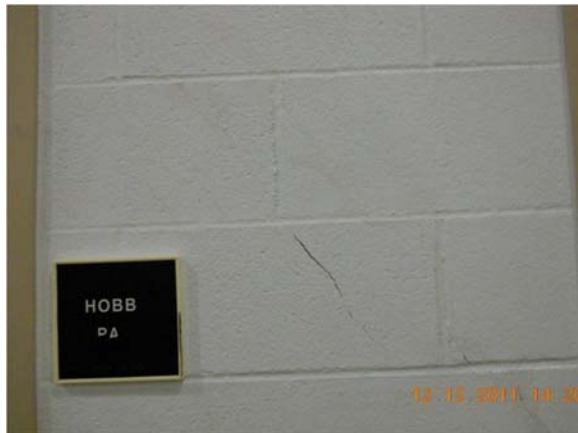
*Figure 25A. Crack in CMU wall at entrance to Hobby/Craft Room F117.  
WSP Wall Movement History Rpt. page 67 of 141,  
photo date 12/12/2011*

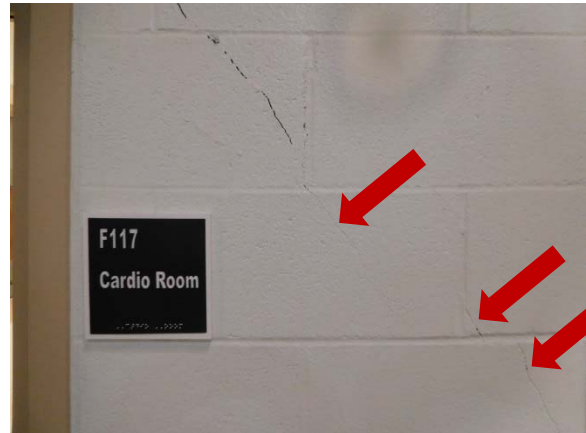
*Figure 25B. Partially repaired crack in CMU wall at entrance to Cardio Room (formerly Hobby/Craft) Room F117 (red arrows denote location of repaired crack in 25A).  
WJE Photo DSCN1435, date 6/22/2017*

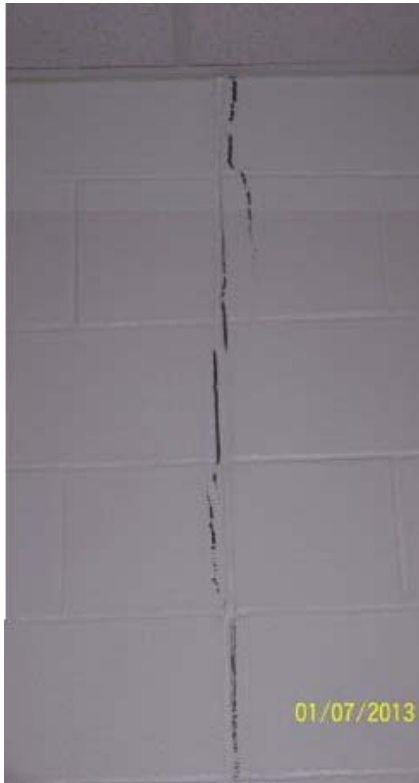
*Figure 26A. Vertical crack in north wall of Gymnasium, Room F125, as viewed from Corridor F127.  
WSP Wall Movement History Rpt. page 67 of 141, photo date 1/7/2013*

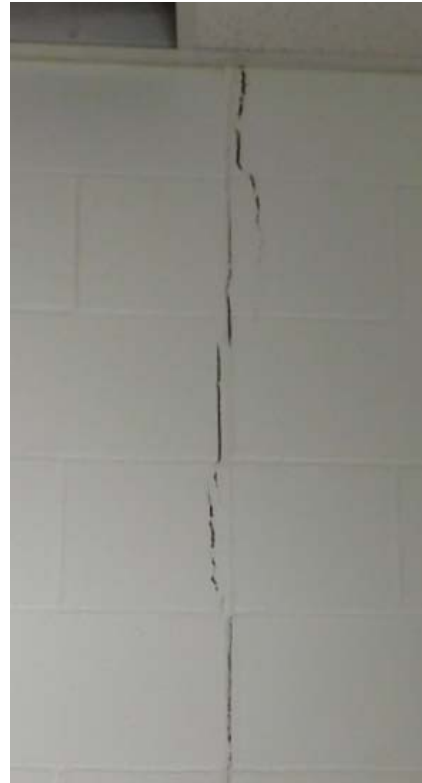
*Figure 26B. Vertical crack in north wall of Gymnasium, Room F125, as viewed from Corridor F127.*

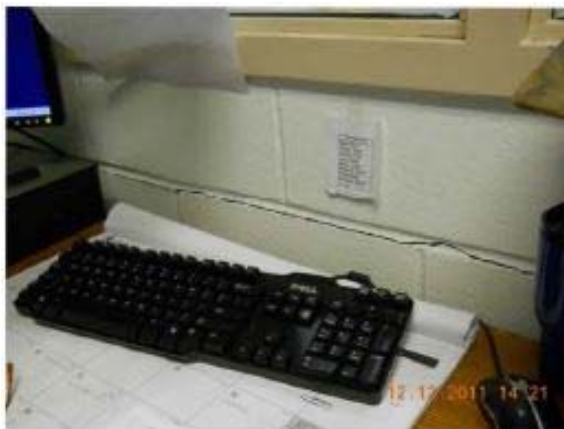
*Figure 27A. Horizontal crack in masonry below window opening in Room F118.  
WSP Wall Movement History Rpt. March 31, 2015, page 3 of 141, photo date 12/12/11*

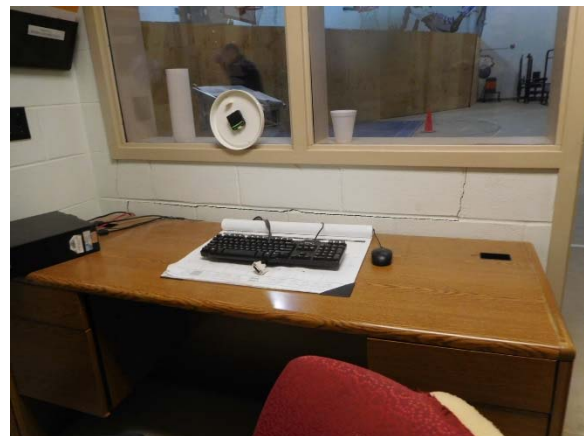
*Figure 27B. Horizontal crack in masonry below window opening in Room F118.*

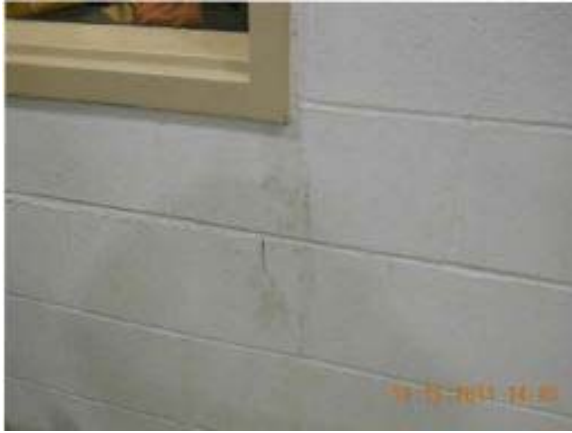
*Figure 28A. Masonry cracking in east wall of Room F117.  
WSP Wall Movement History Rpt. March 31, 2015, page 3 of 141, photo date 12/12/11*

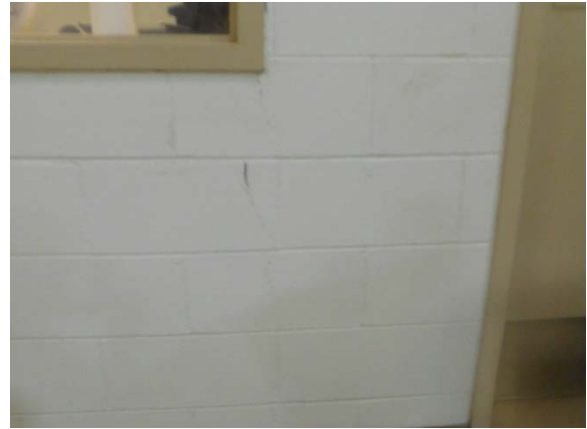
*Figure 28B. Masonry cracking in east wall of Room F117.  
WJE Photo DSCN1267, date 6/15/17*

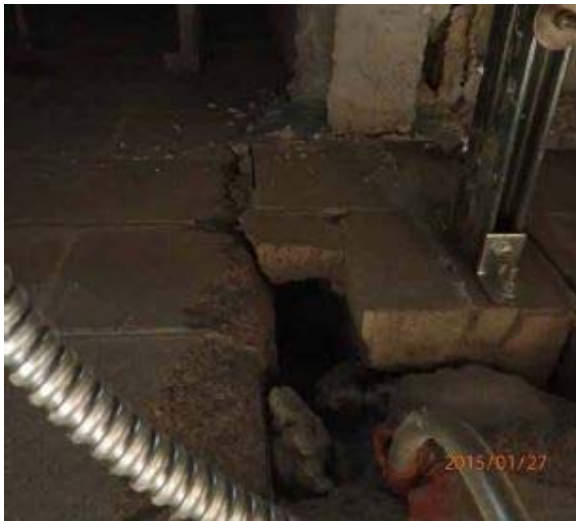
*Figure 29A. Distressed masonry beneath steel beam bearing near new column in Corridor F127.  
M/M Rpt. page 33 of 284, photo date 1/27/15*

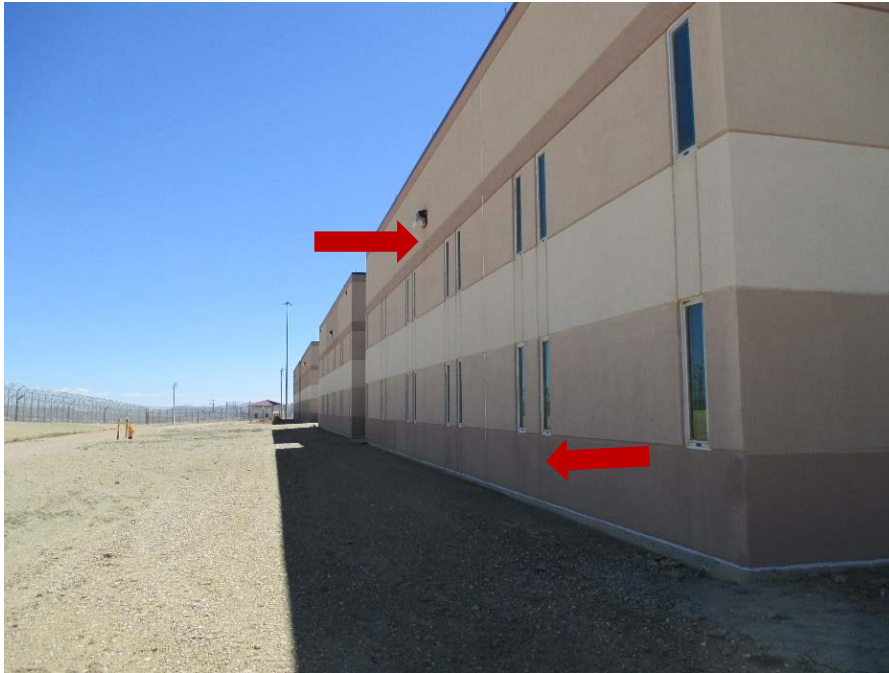
*Figure 30. Water staining below windows and at light fixture.*

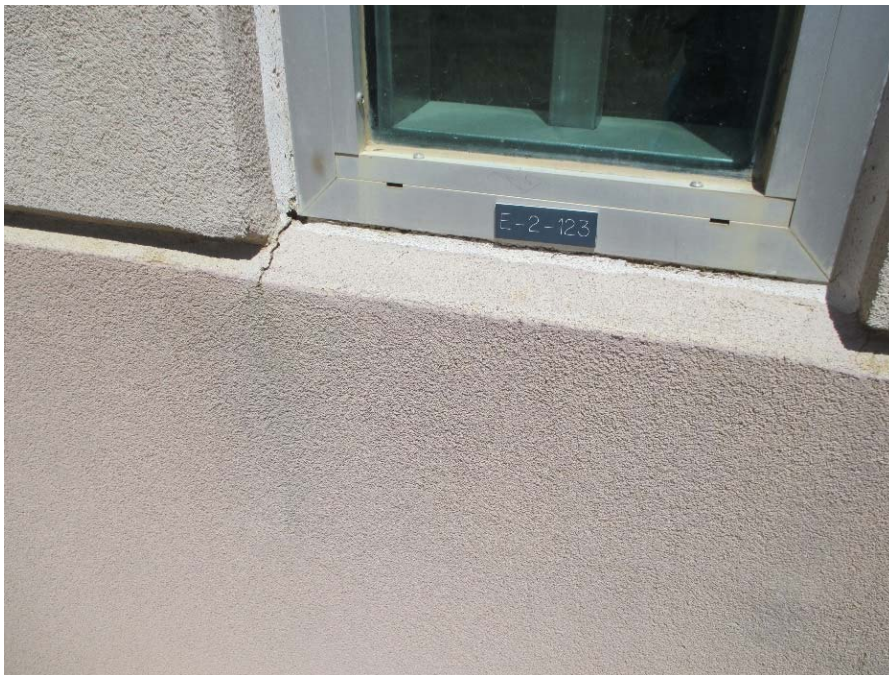
*Figure 31. Crack at lower corner of window.*

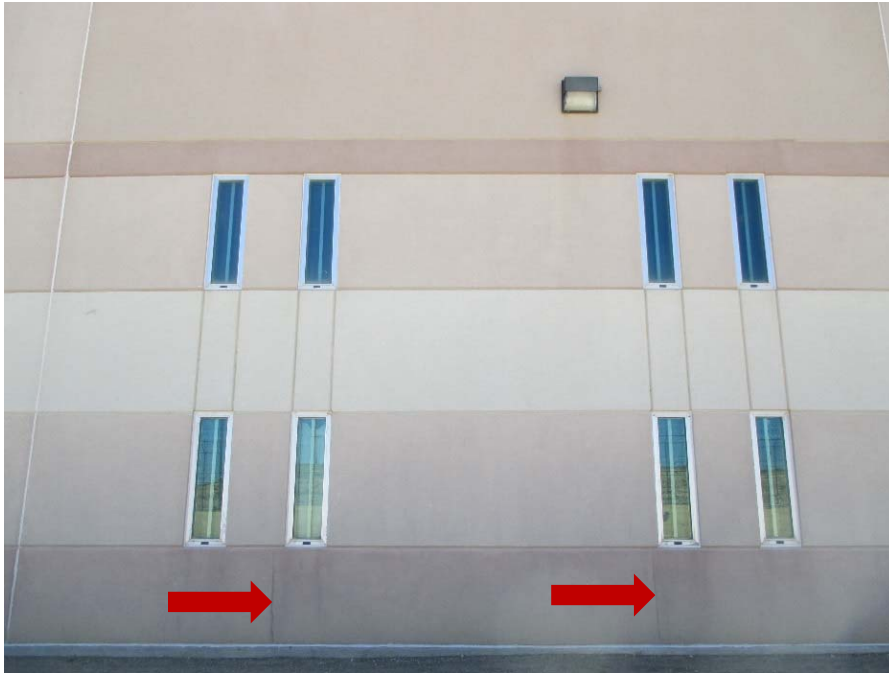
*Figure 32. Vertical cracks in EIFS along exterior of Area B*

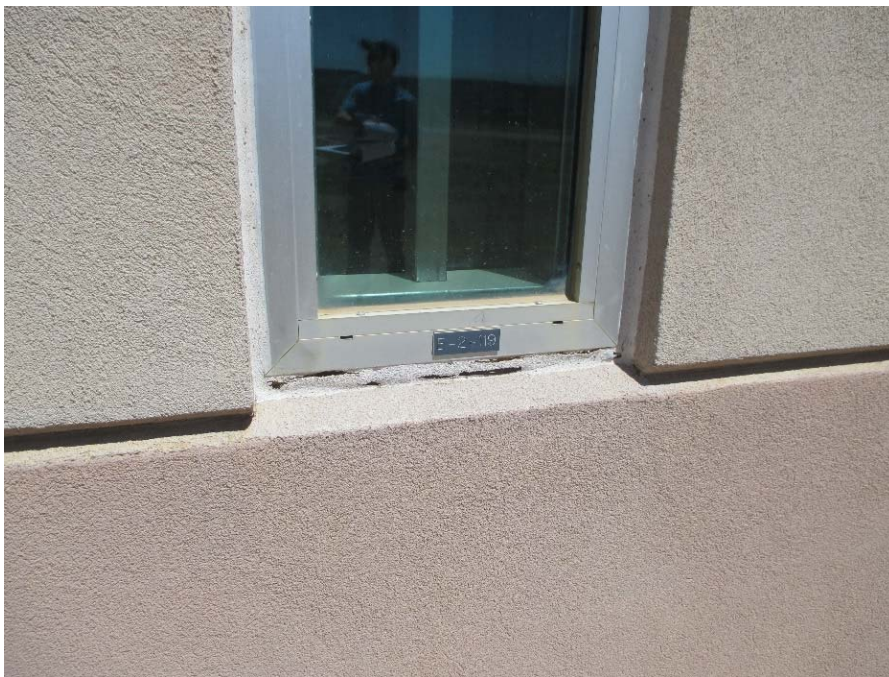
*Figure 33. Failed joint sealant at window.*

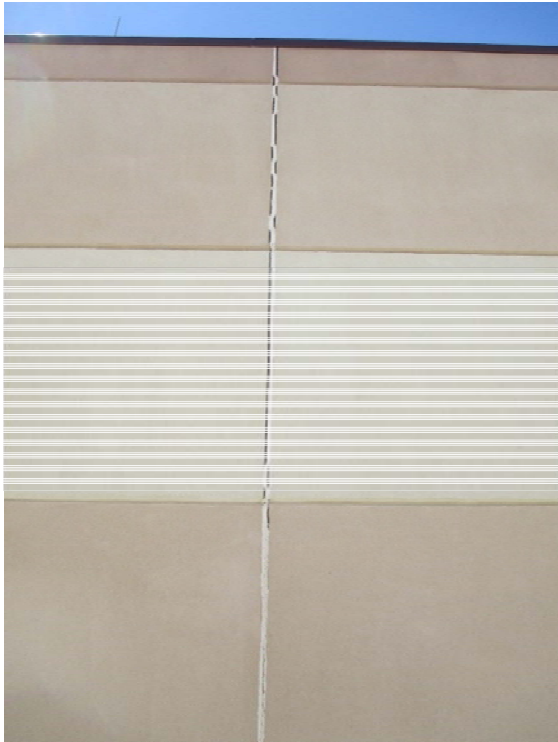
*Figure 34. Failed vertical joint sealant in control joint.*

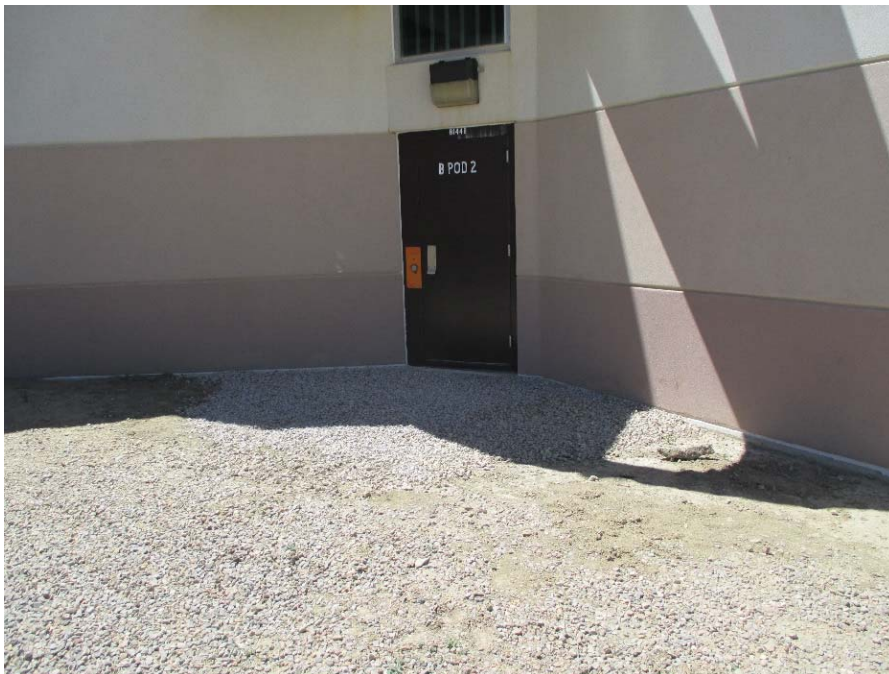
*Figure 35. Location where exterior slab was removed and replaced with gravel.*

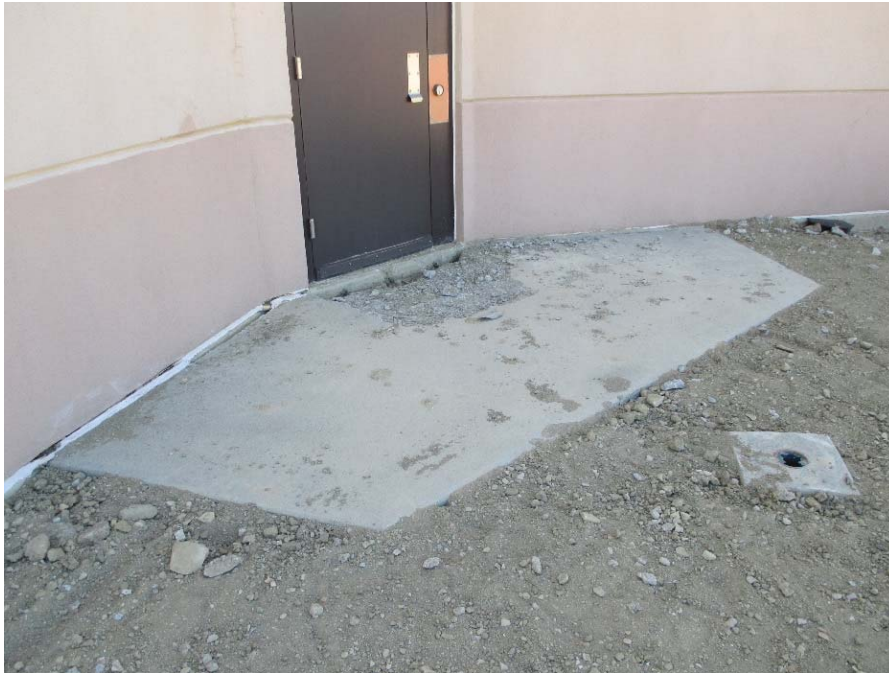
*Figure 36. Exterior slab altered to allow egress door to operate.*

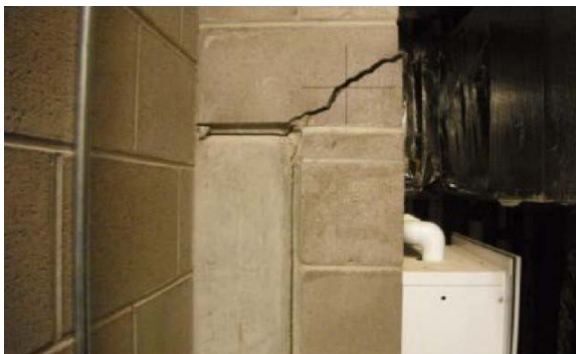
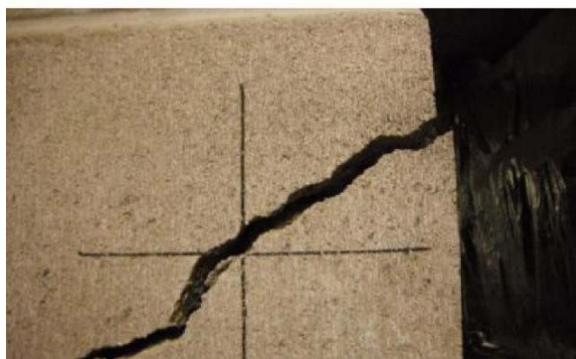
*Figure 39A. Fractured masonry pilaster in Mechanical Room 204 in K Unit.  
WSP Wall Movement History Rpt. March 31, 2015, page 81 of 141, photo date July 2013*

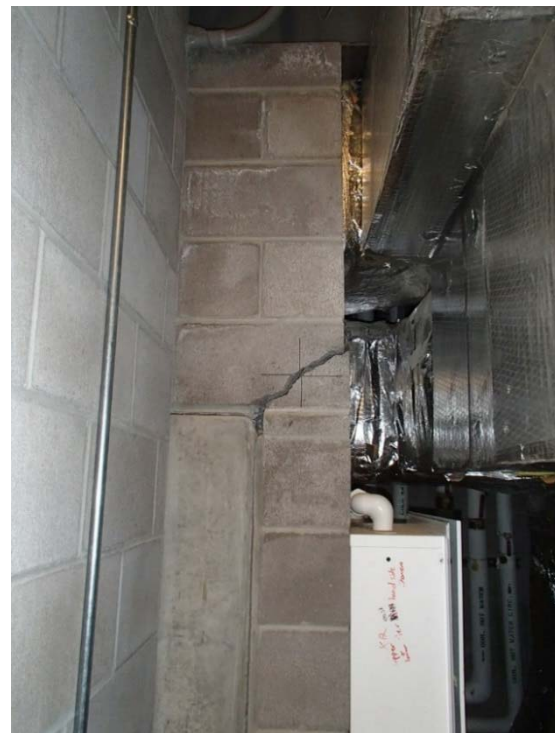
*Figure 39B. Fractured masonry pilaster in Mechanical Room 204 in K Unit.*

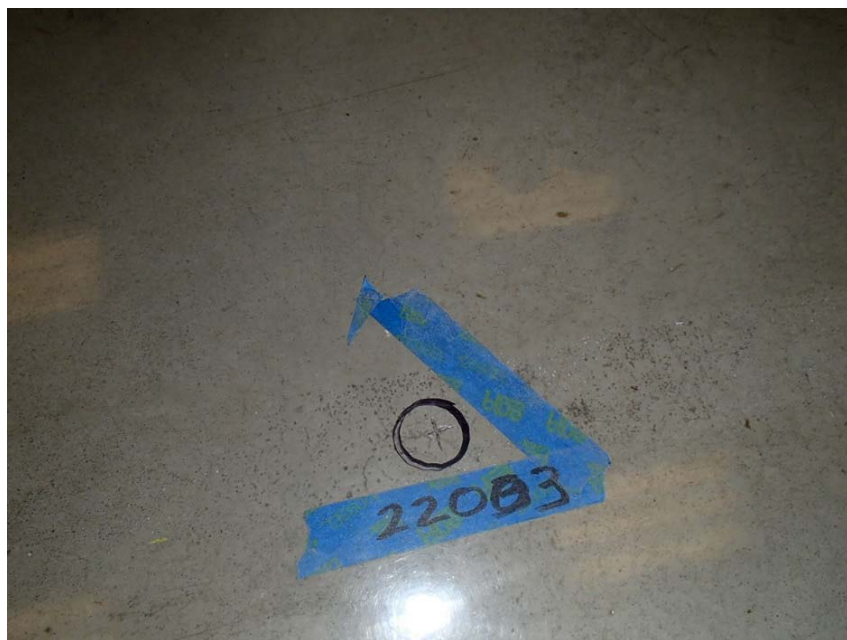
*Figure 40. Typical observed control point within the K Unit/Support Building.*

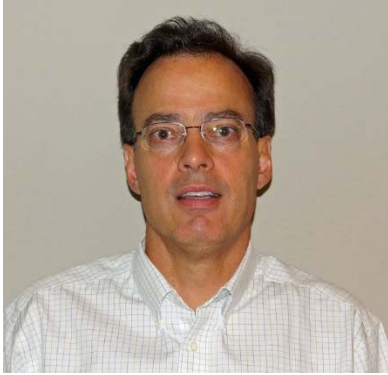
- Columbine Water Treatment Plant - Thornton, CO: Observation of the installation of coatings within several water filters and processing tanks
- Denver Human Services Parking Garage - CO: Observation of the replacement of failed sealant joints and the epoxy injection of cracked concrete members

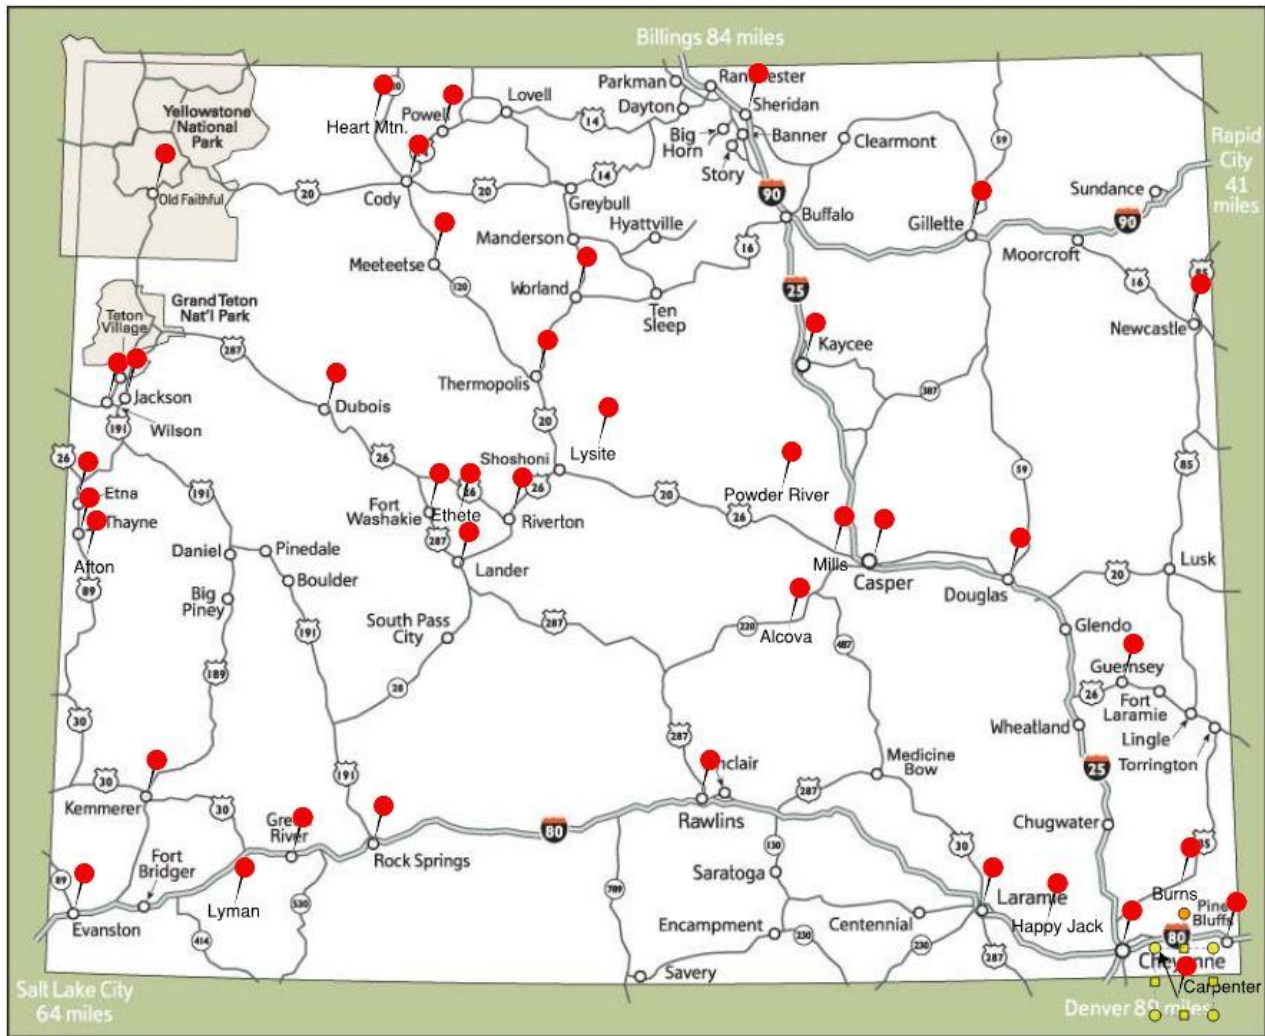
Locations of all WJE services provided in the State of Wyoming

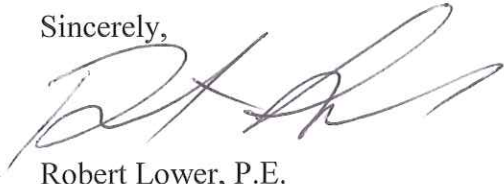
A handwritten signature in black ink, appearing to read 'R. Lower', is written over the word 'Sincerely,'.
