## WYOMING STATE PENITENTIARY Independent Peer Review Study

2900 South Higley Boulevard  
Rawlins, Wyoming 82301

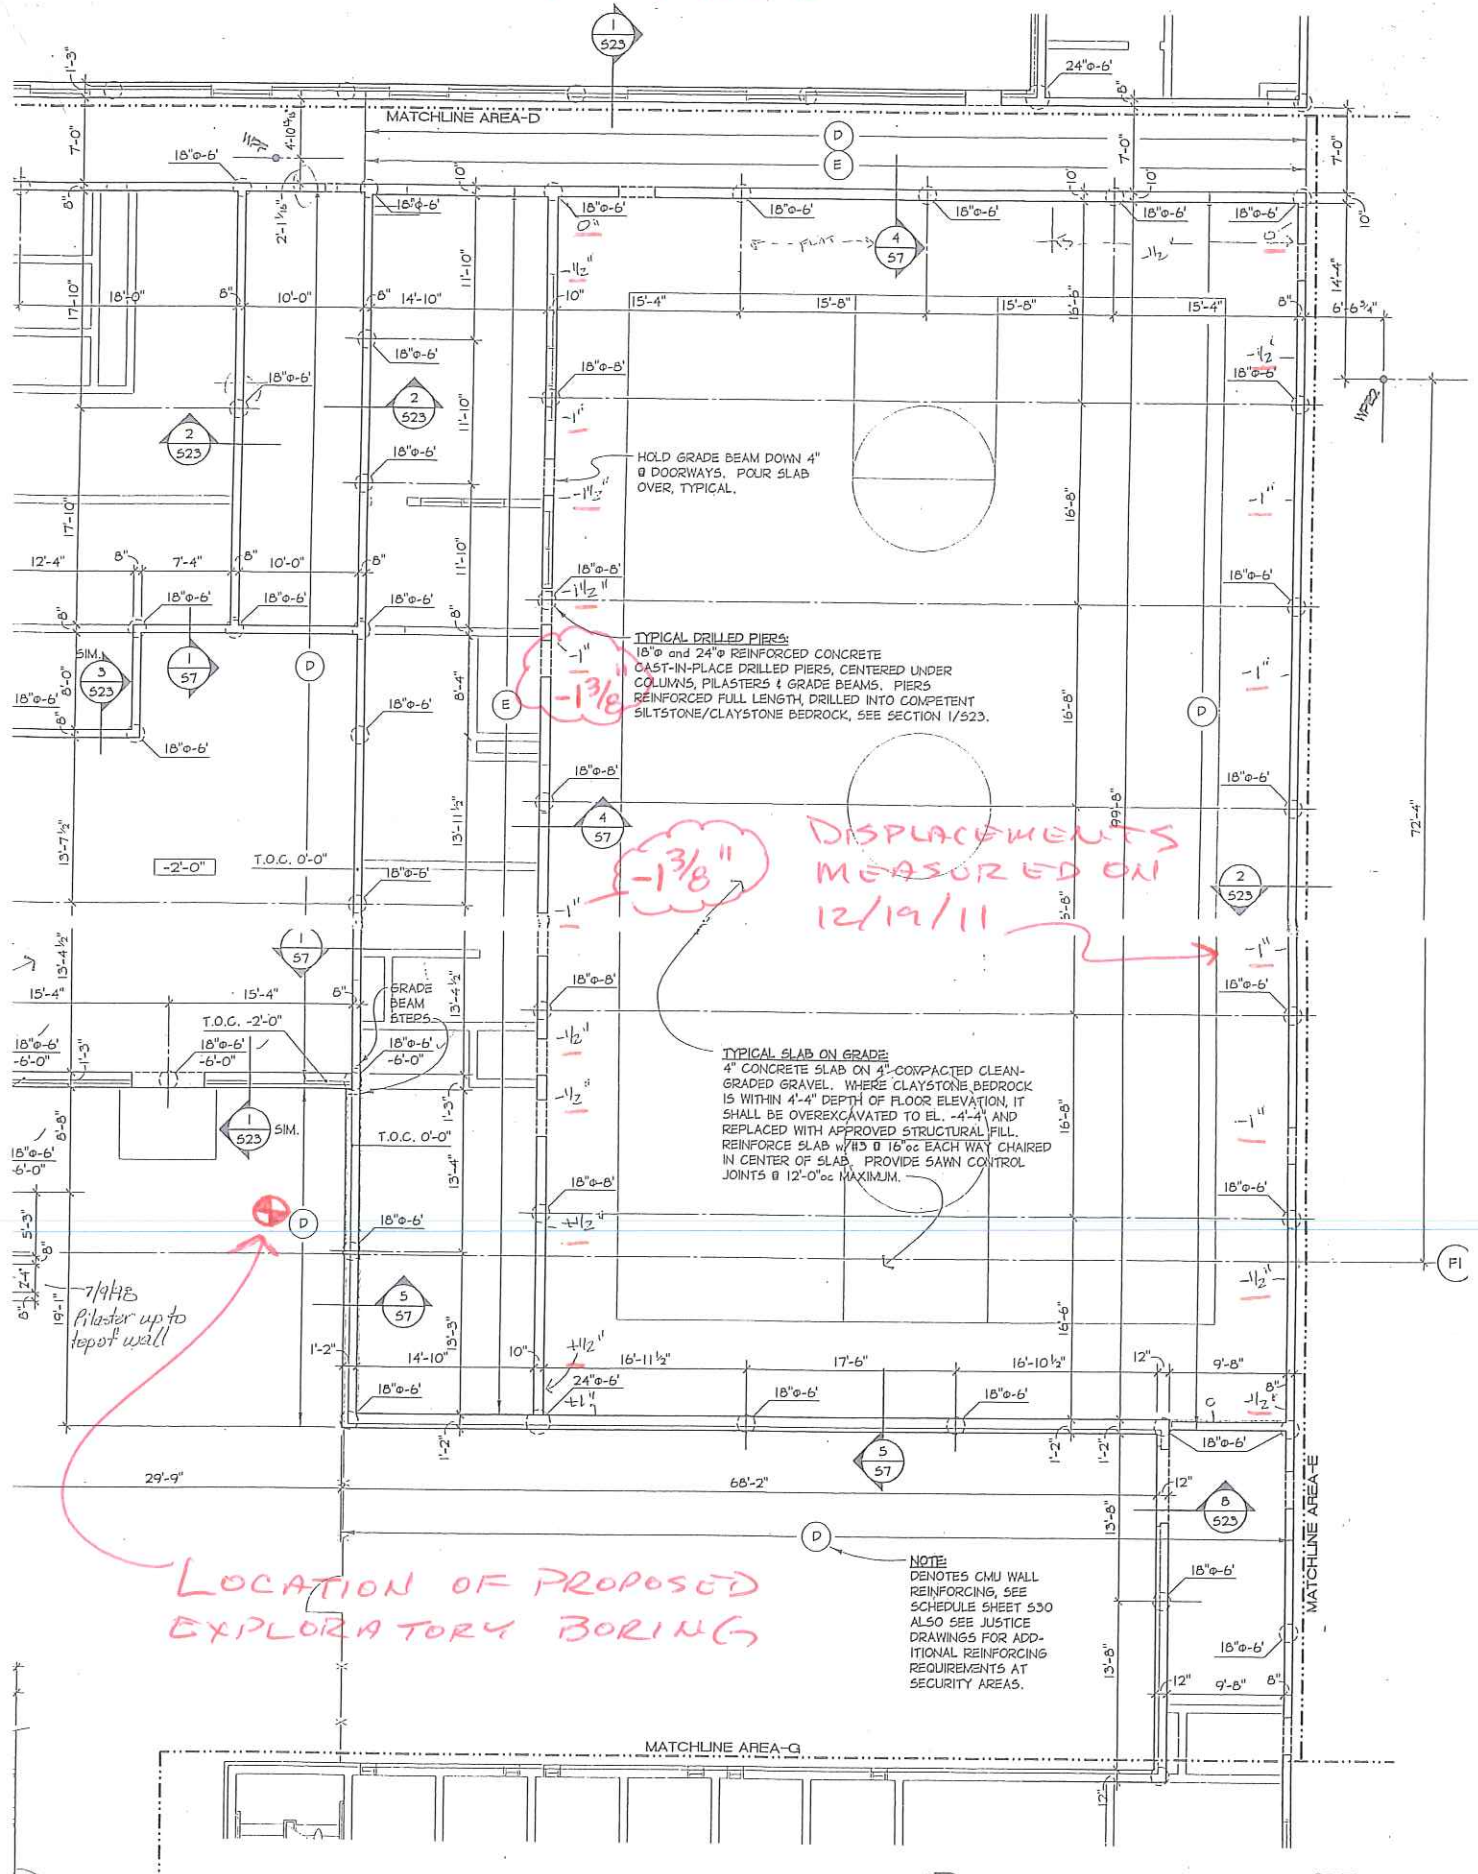
SLAB CROWNED 3/8"  
CENTER DOOR POST

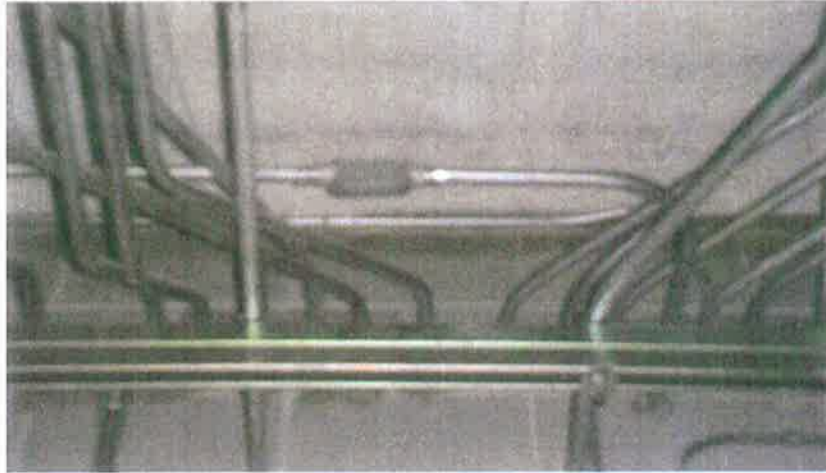
Damaged Bond Beam in Electrical F116

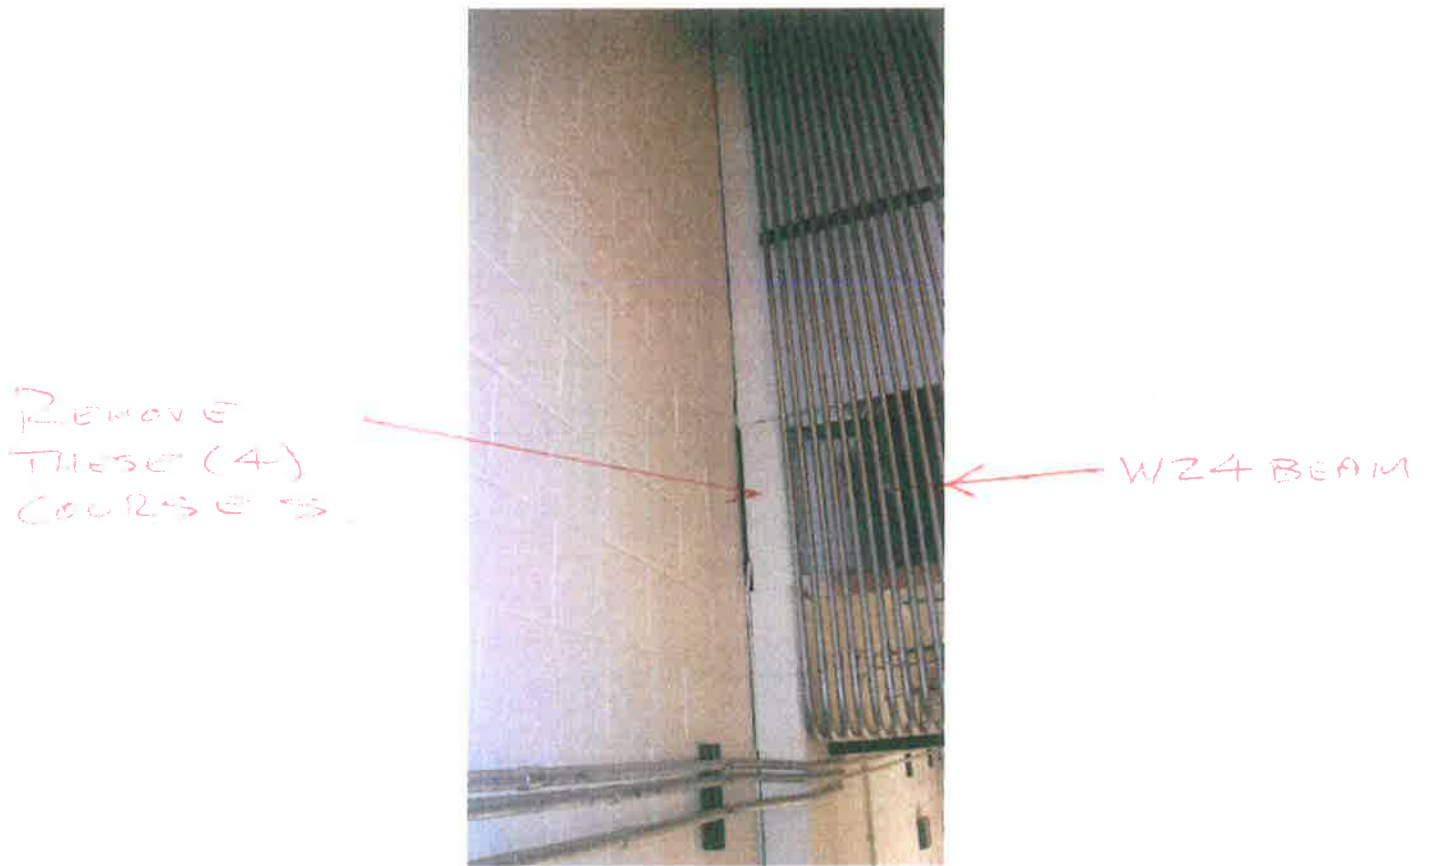
Damaged Column Surround

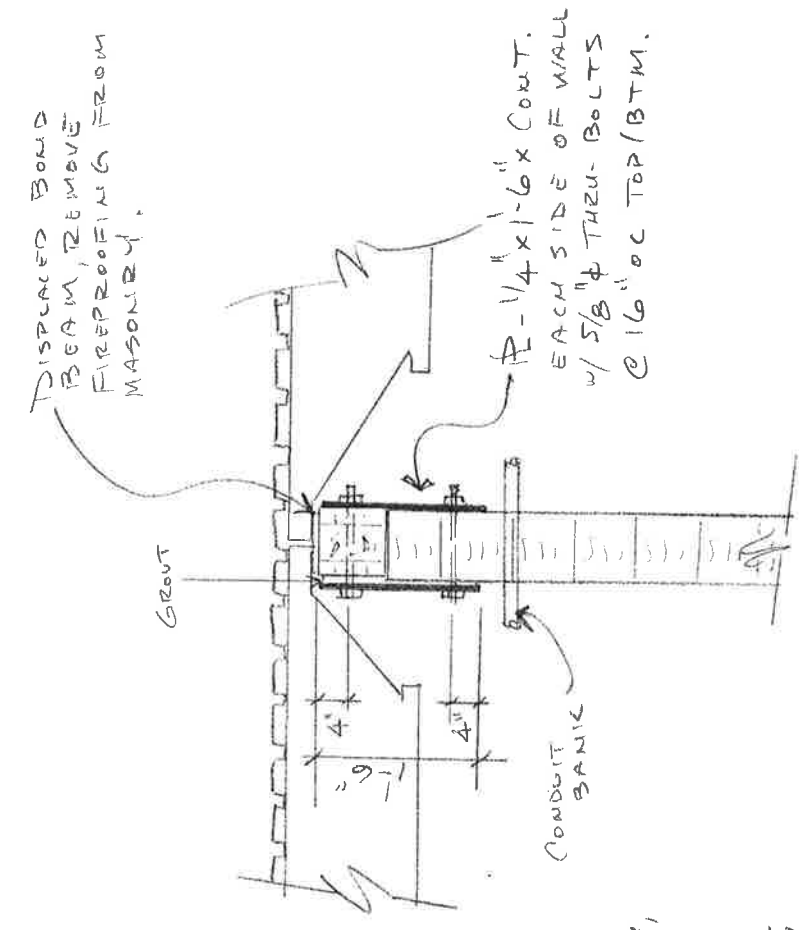
DISPLACED BOND BEAM, REMOVE FIREPROOFING FROM MASONRY.

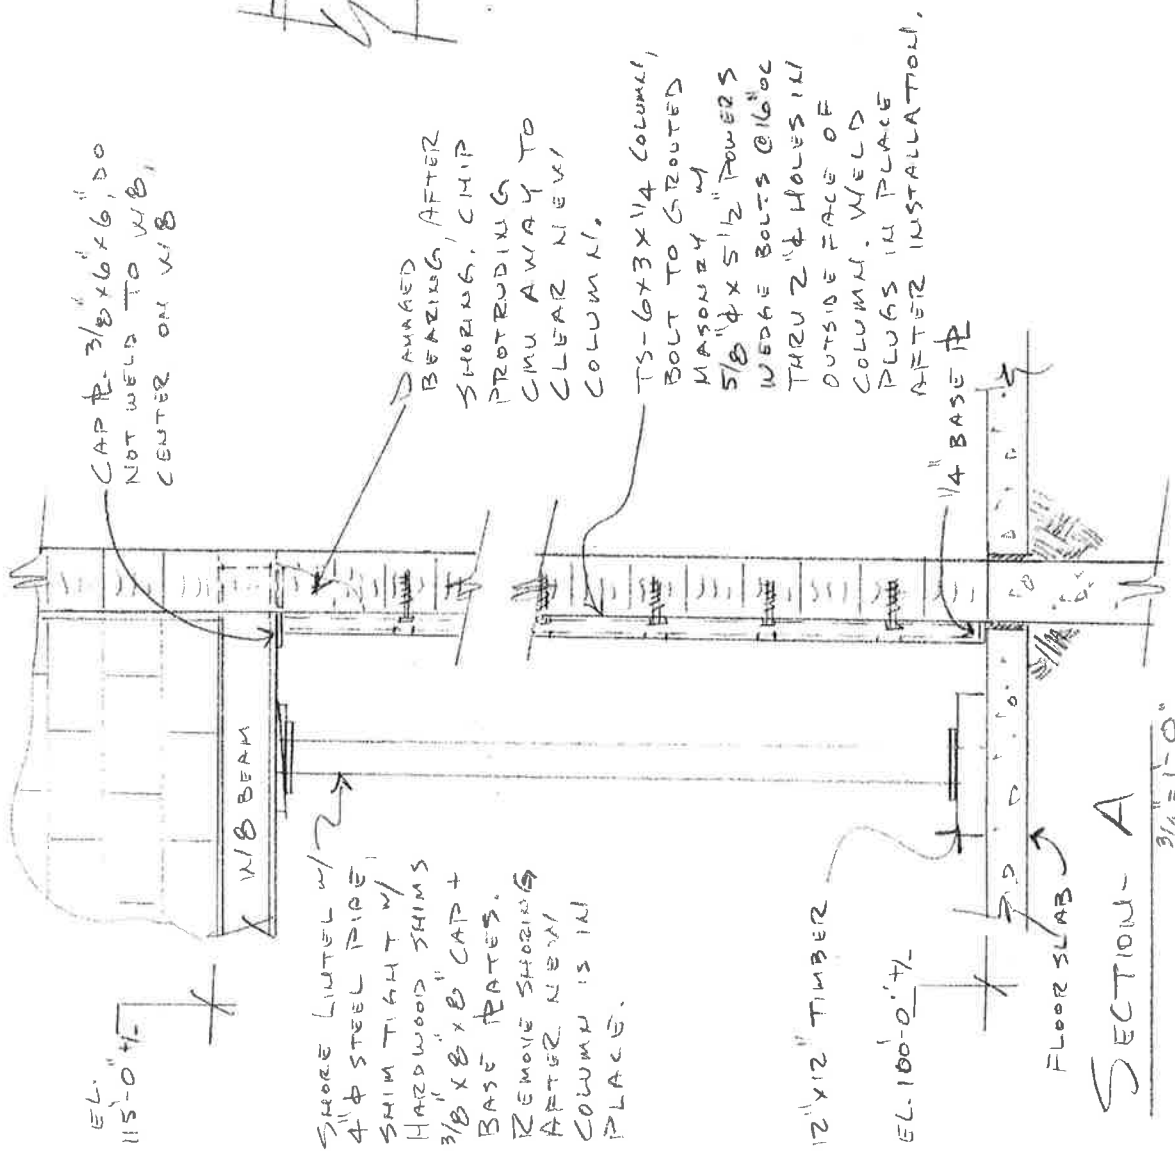
CAP  $\phi - 3/8" \times 6" \times 6"$ , DO NOT WELD TO W8, CENTER ON W8.

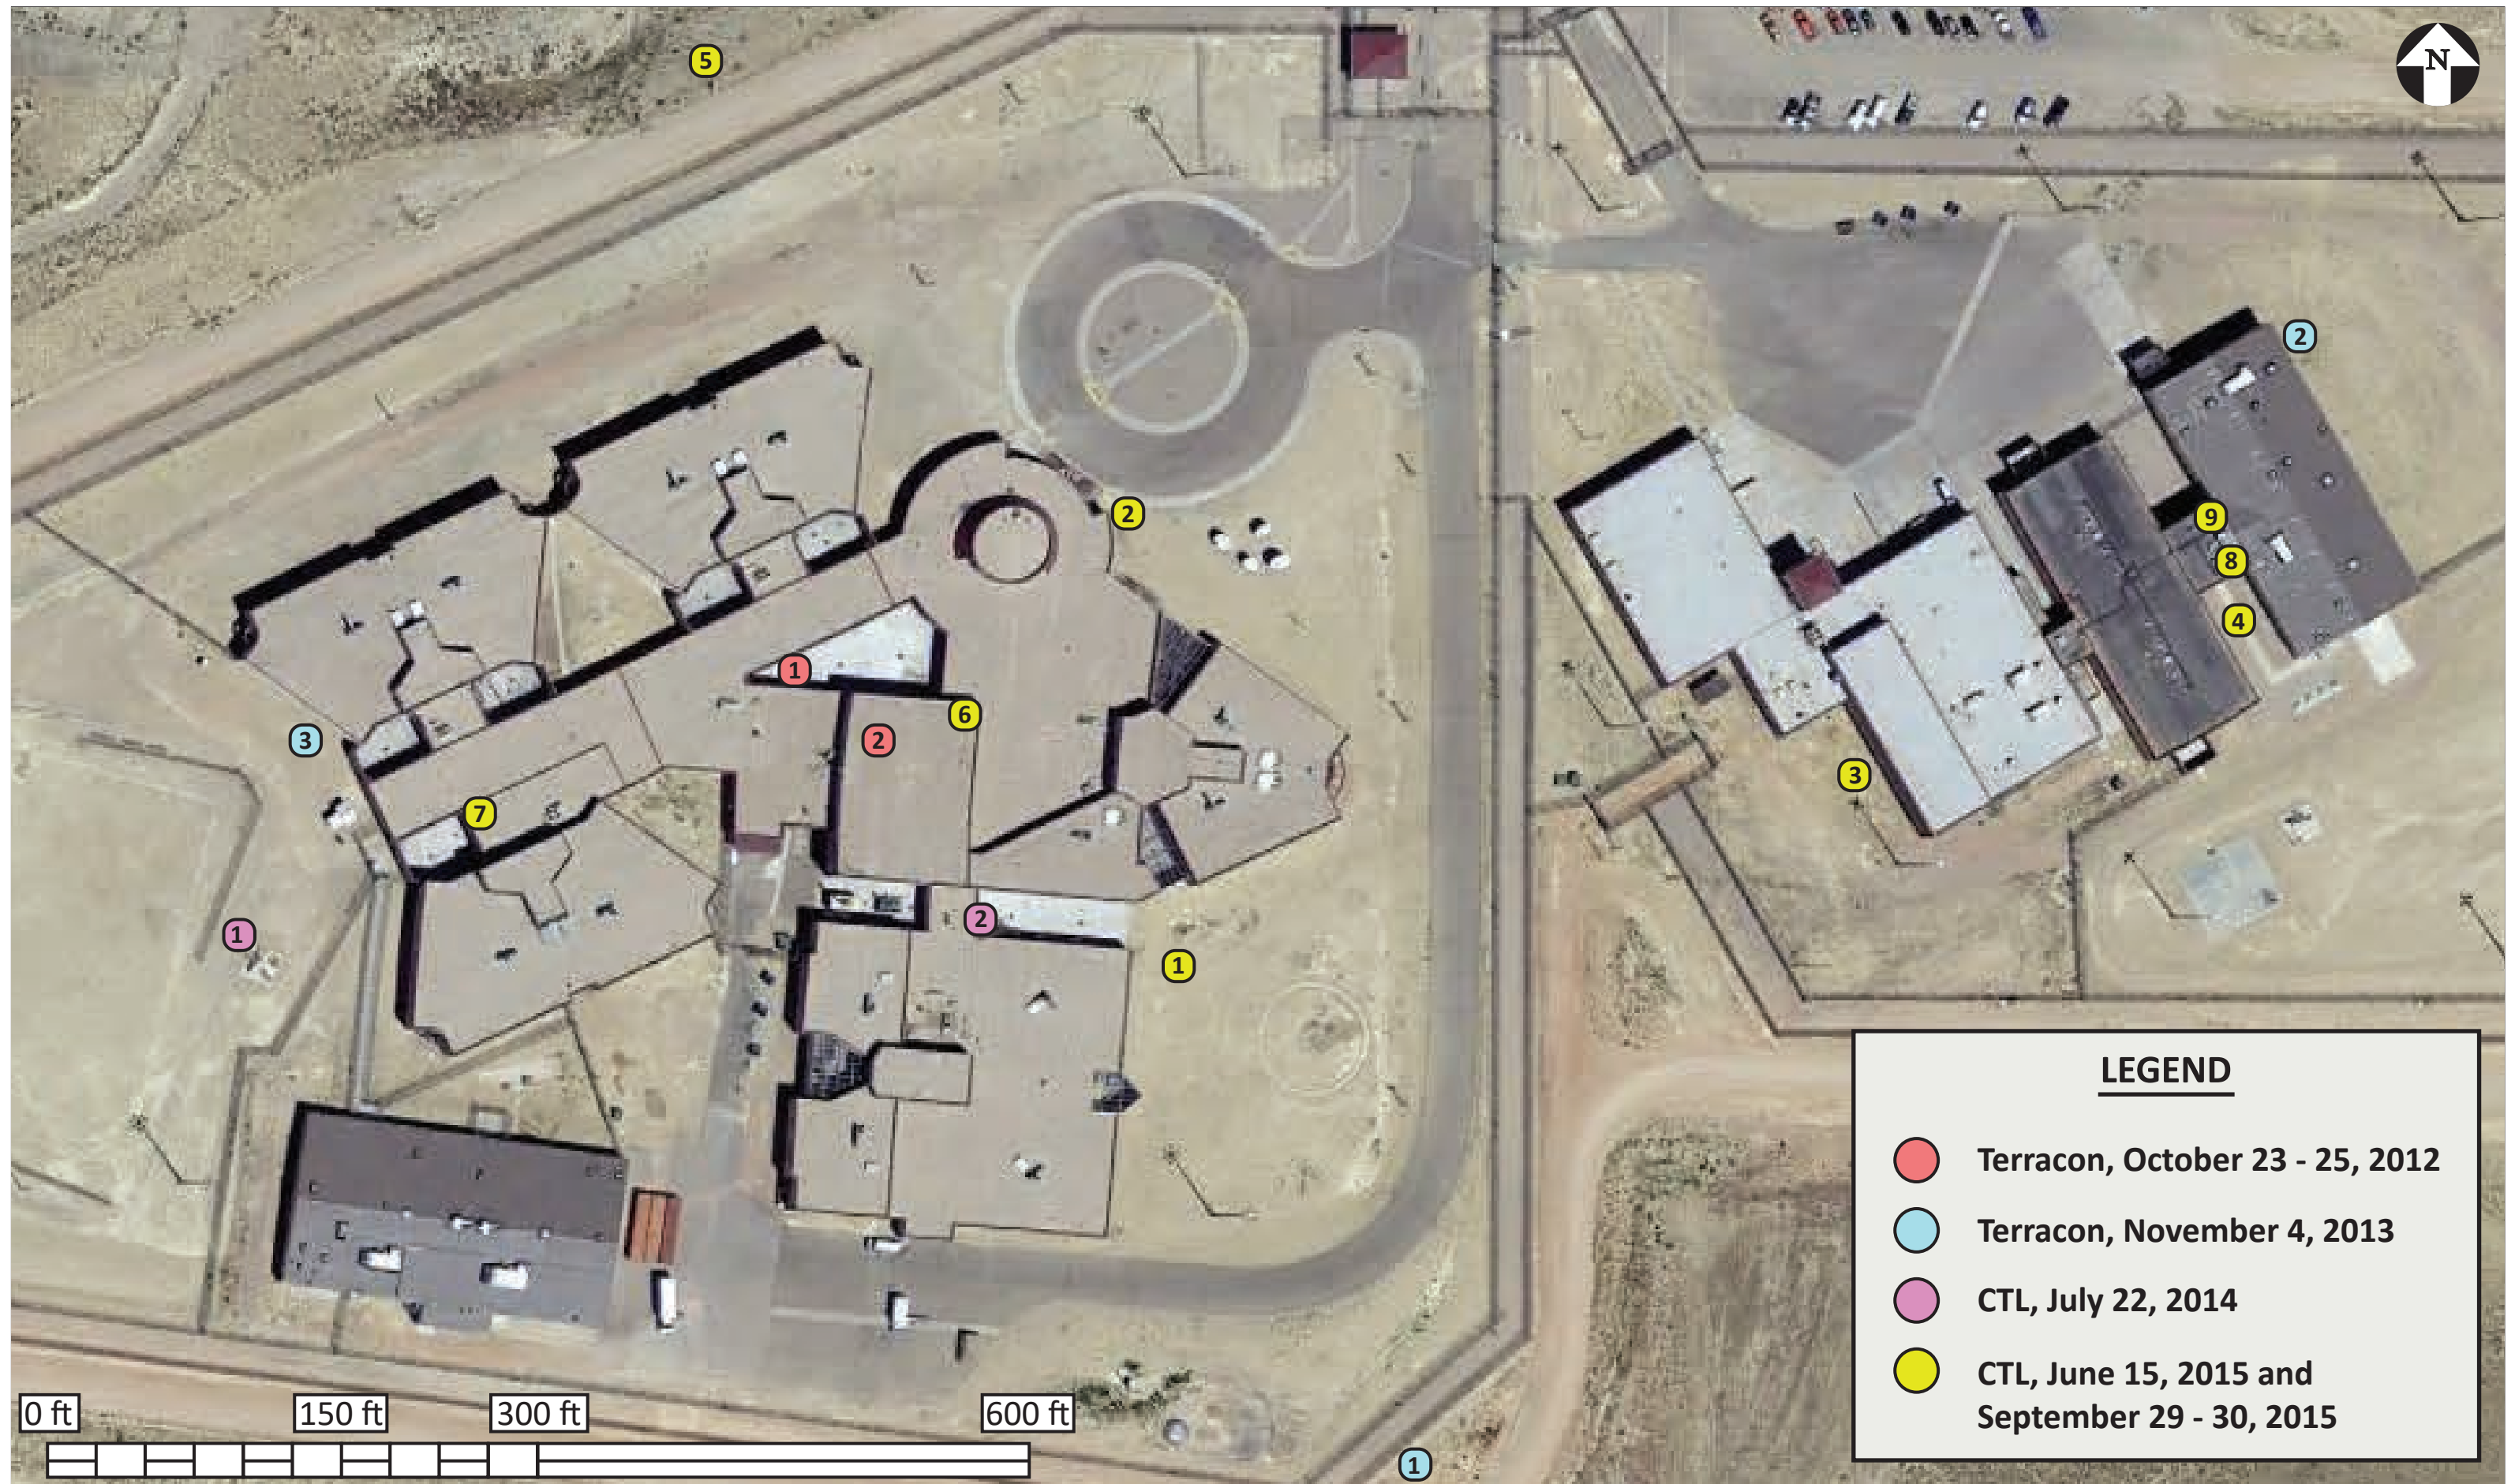
## Wyoming State Penitentiary - South Facility Moisture Content (%) vs Depth (ft)

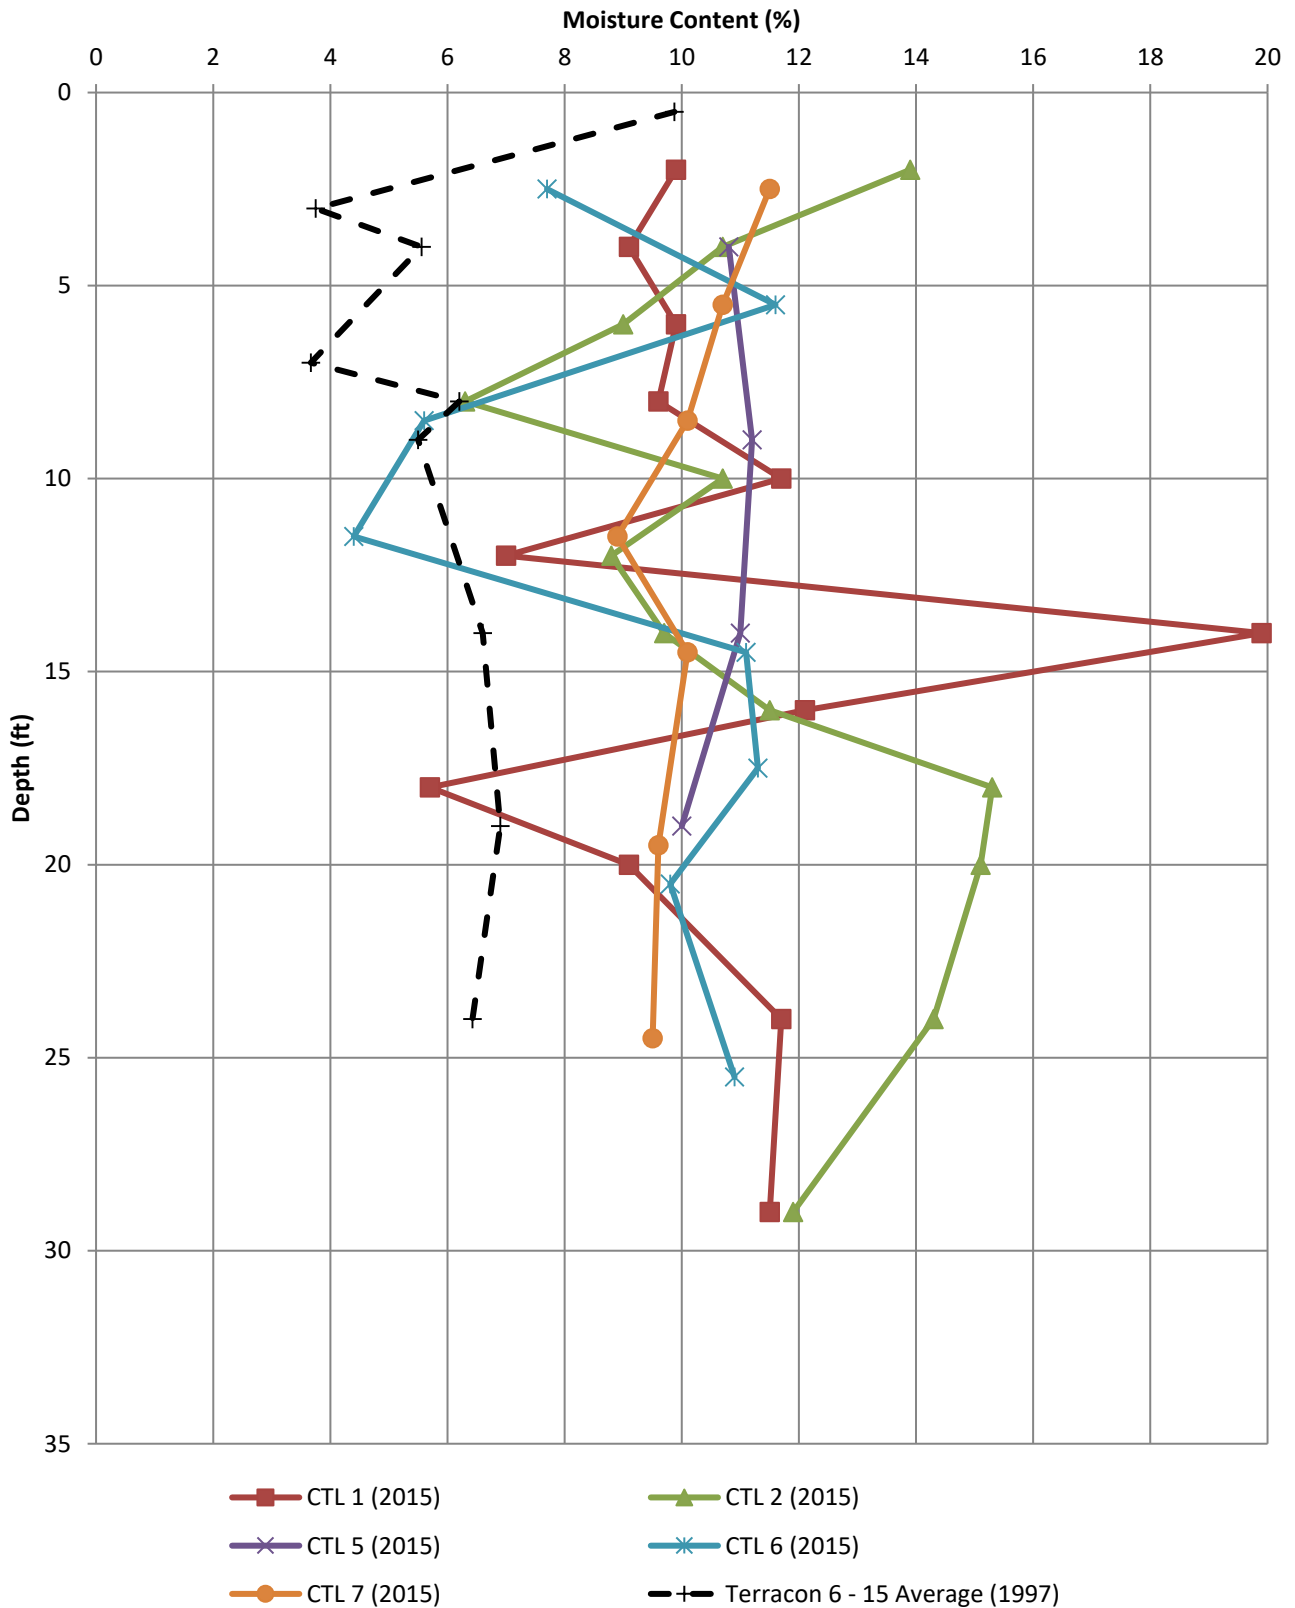
## Wyoming State Penitentiary - CPF and K Units Moisture Content (%) vs Depth (ft)

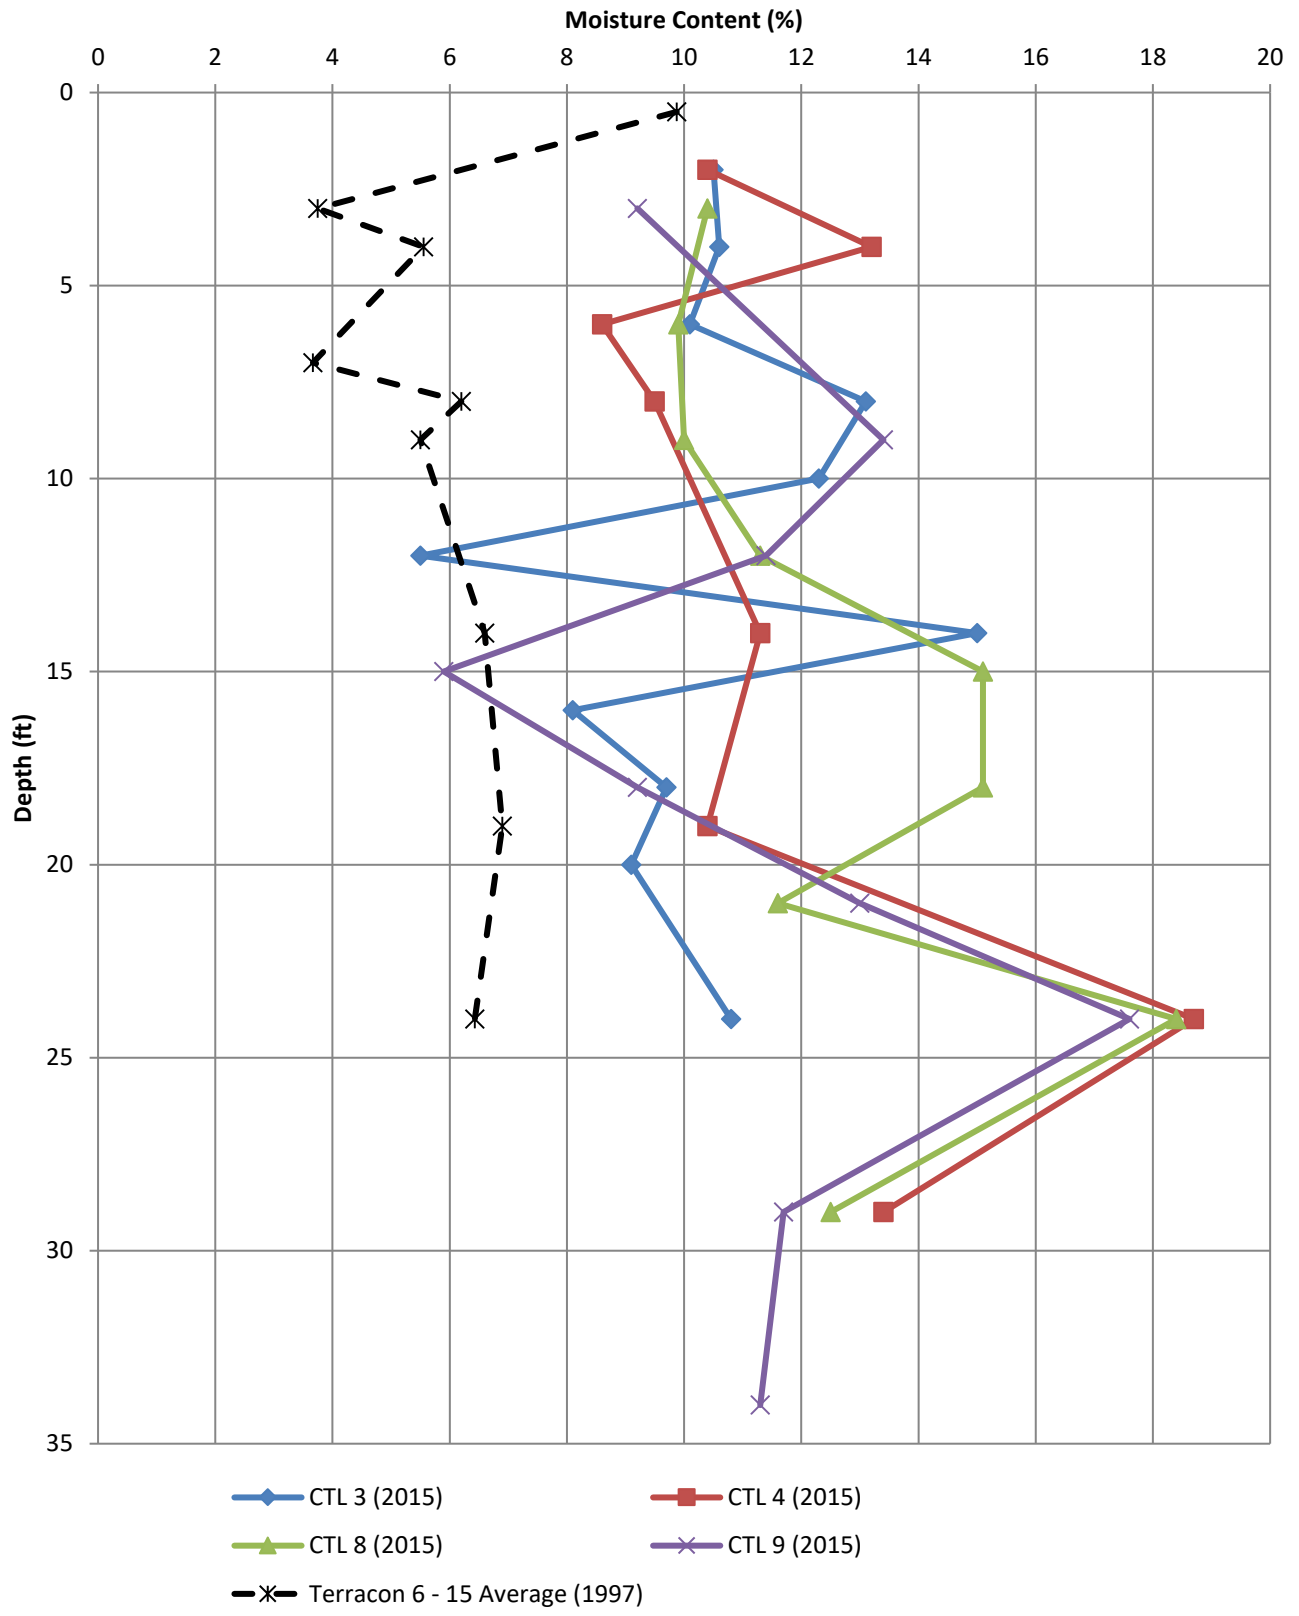
## Wyoming State Penitentiary - South Facility Saturation (%) vs Depth (ft)

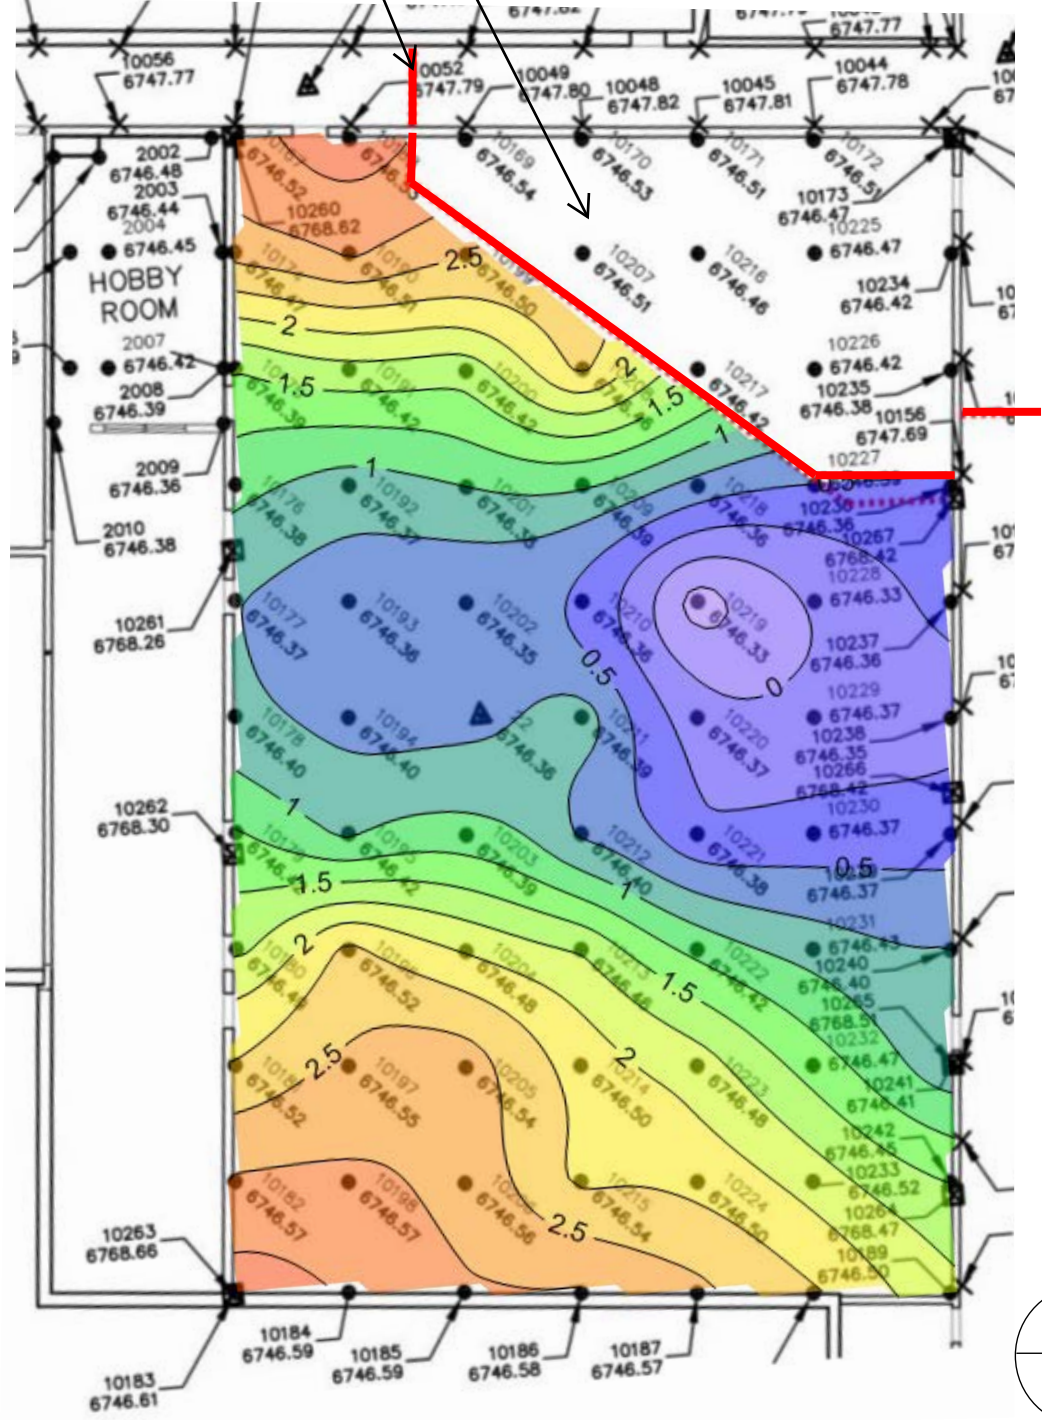
**WJE** ENGINEERS ARCHITECTS MATERIALS SCIENTISTS  
 Wiss, Janney, Elstner Associates, Inc.  
 3609 South Wadsworth Boulevard, Suite 400  
 Lakewood, Colorado 80235  
 303.914.4300 tel | 303.914.3000 fax  
 www.wje.com
