FACILITY ANALYSIS

Pine Bluffs Elementary School

Laramie County
School District #2

July 31, 2013

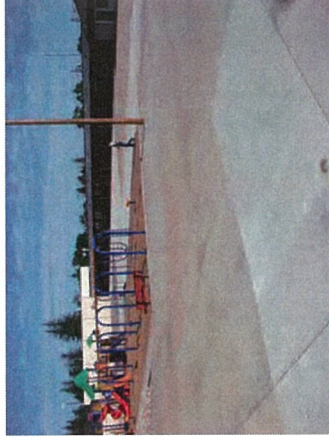
Site: The overall PBES site is not fully compliant with ADAAG requirements. Some of the drainage swales, inlets, and outlets require guardrails or other protection for all populations both able and disabled. Some building entrances/exits are accessible only by means of steps. Some walks are too narrow to be considered compliant. There is no ADA compliant signage on the site.

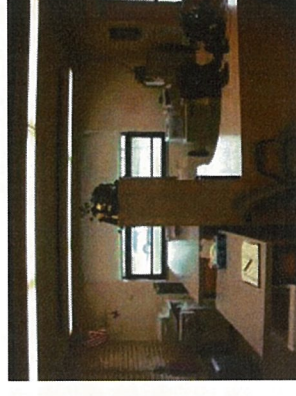
Administration: Small and generally substandard administration spaces are dispersed throughout PBES. The Reception/Waiting area and Nurse Suite are so small as to be nearly non-functional. Counseling is housed in a generous reassigned classroom but is very distant from the administration area. The Conference Room is undersized for the desired capacity of 10 and is also remote from the main office. The Workroom and Staff Lounge share a common reassigned classroom that serves neither function well. Staff Toilets are shared students, and the intended adult toilets in the Administration Area serve all ages simultaneously.

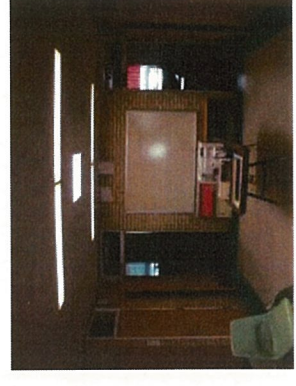
Educational Specifications require a Multi-Use Room for teacher planning, aides, work space, storage, small group teaching, and Title One. All PBES classrooms are served by a Commons that generally fails to meet the criteria for Multi Use Rooms, particularly the requirement that “No doors to the exterior are permitted.” The PBES Common areas provide the only access between classrooms and other areas of the building...through exterior doors.

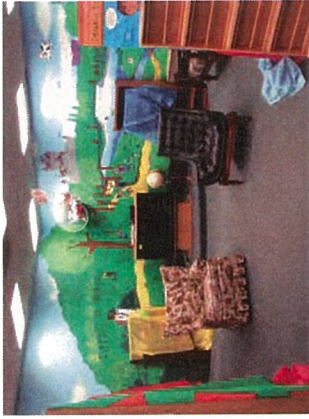
Given the available spaces in the PBES facility, the assigned room is probably the most logical to house the Music program, regardless of the itemized deficiencies. As stated above, its isolation provides acoustical separation from other educational and administrative activities, but almost every other aspect of the space is substandard. The space was originally designed to house kindergarten programs.

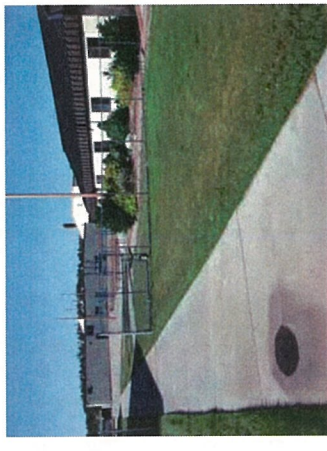
The site is less than optimal for an elementary school. There are lawn areas along the perimeter of the building along Elm Street and East 5th Street. This is the only area of the site with grass and is not suitable or safe for activities. The only available green space for the elementary school students is a small patch of grass between the elementary school and the high school.

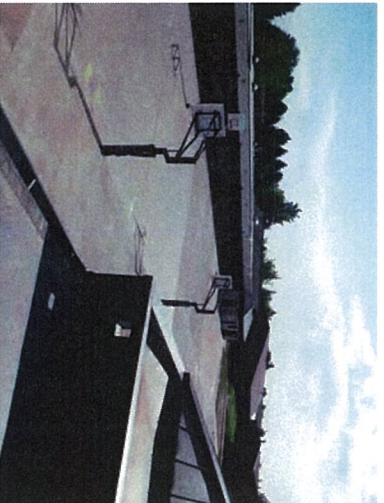
Site Elements: The site is located at the northwest corner of 5th Street and Elm Street. There are no physical separations between parent drop off, pedestrian, walks as well as bus lanes. The facility administration has used the buses to block the through street on Elm to prevent passenger vehicles from passing by. The buses drop off and pick up along the curb at Elm Street while passenger vehicles use the curb on the west side of the street. This creates a situation where children are crossing the street to get to their rides, causing an unsafe situation. Although blocking the street has reduced the danger of driving through, there are still some instances where passenger vehicles perform U turns to get out of the area.

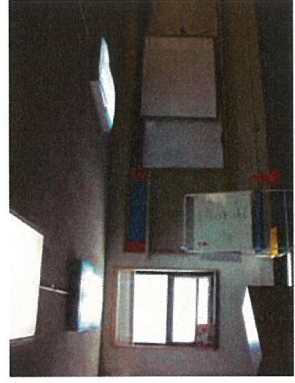
Fenestration is a mix of insulated aluminum windows, original single pane glass and aluminum doors and storefronts. The music room and administration areas are mainly original windows and several small areas throughout the facility are still the original windows. All the new exterior walls within the 2010 remodel program are fitted with aluminum and insulated glass awning window units with insect screens. The 1989 additions have aluminum clad wood casement windows with integral mini-blinds. Although the new exterior walls and doors are believed to be energy efficient, the presence of a vast amount of single pane glass and a moderately insulated roof assembly is considered an issue with the overall mechanical system function. Exterior doors are generally hollow metal with glass lites.

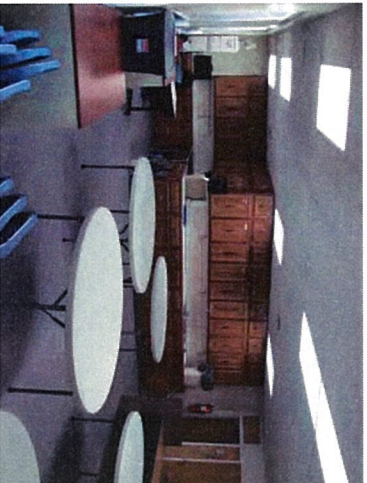
The original doors in the building vestibules are single pane in either aluminum or hollow metal frames. The classroom windows in the south annex have a small window in the corner of the room, which does not comply with current codes or educational standards for natural daylight or natural ventilation.

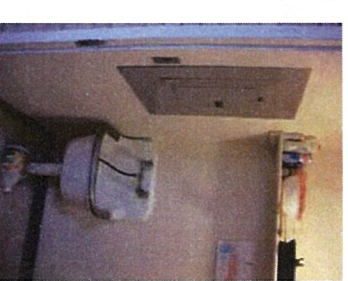
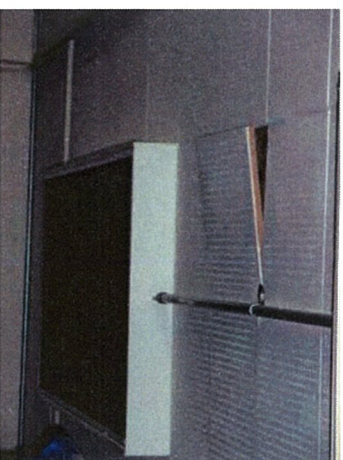
Several areas of the building are in need of upgrades to repair ceilings, expand bathrooms, upgrade lighting, and ADA modifications. The adhesives in the ceiling tiles in the original building are beginning to delaminate, causing tiles to drop. There are concerns with the electrical panels in the janitor closets being directly above the utility sinks.

The bathrooms are too small to comply with current standards. Modification to the bathrooms would be difficult and costly due to the existence of concrete block walls.

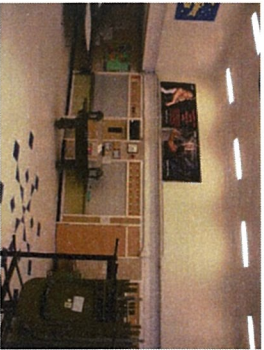
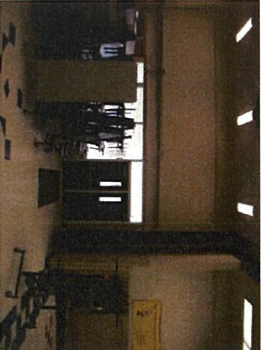
Room Number: 110 Room Name: Commons

| Component | Material | Comments | |
|---|---|--|---|
| Ceiling | 12x12 tile | Ceiling is 18' to 20' high | |
| Walls | CMU/Brick | Exposed electrical conduit throughout | |
| Windows & Coverings | HM | Single pane glass in hollow metal frames | |

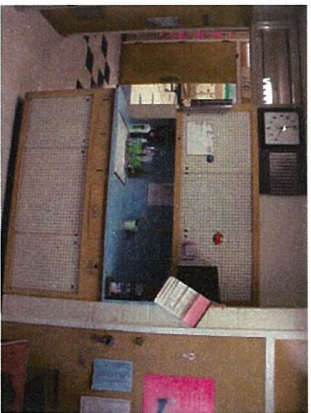
Room Number: 119 Room Name: Nurse's Office

| Component | Material | Comments | |
|---|---|--|---|
| Walls | CMU | Vertical crack in SW corner | |
| Casework | P-lam & wood | Poor condition | |
| Special Note | | Lost and found is located in this area in lieu of a second cot. No fresh air in this area. | |

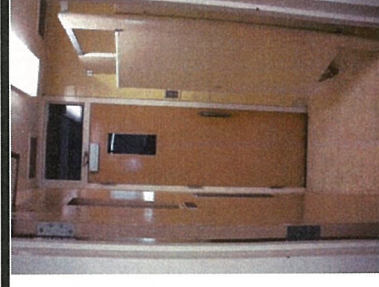
Room Number: 127 Room Name: Boys' Restrooms

| Component | Material | Comments |
|---|---|--|
| Floor | Epoxy | Poor condition, chipped and cracked throughout |
| Special Notes | | No locking hardware on partition, doors have windows in them, leaking faucet |

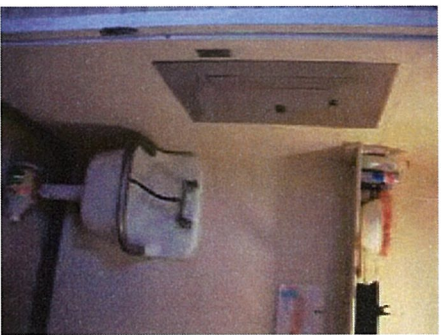
Room Number: 140 Room Name: Kindergarten Classroom

| Component | Material | Comments |
|---|---|--|
| Casework | P-Lam & wood | Toddler size – top edge of counter top is delaminating at sink |

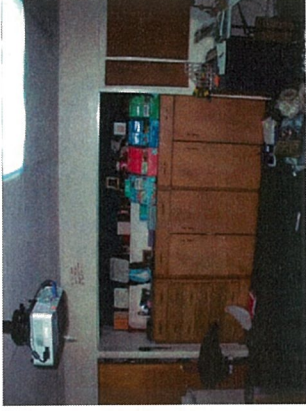
| Component | Material | Comments |
|---|---|---|
| Windows & Coverings | HM | New exterior insulated windows with horizontal blinds |

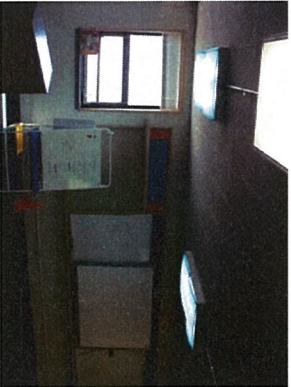
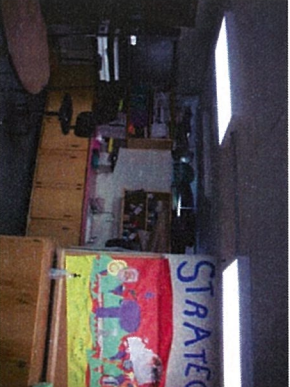
Room Number: A108A Room Name: Storage

| Component | Material | Comments | |
|---|---|---|---|
| Windows & Coverings | Alum & Glass | Aluminum and insulated glass with screens, 1 small window for entire room | |
| Special Notes | | Borrowed lites to room 113 | |

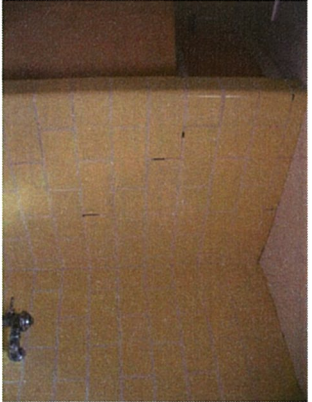
Room Number: A112 Room Name: Boys' Restroom

| Component | Material | Comments | |
|---|---|--|---|
| Ceiling | Gyp Bd | Needs to be refurbished | |
| Walls | Glazed Block | Some cracking at wall near north end of room | |

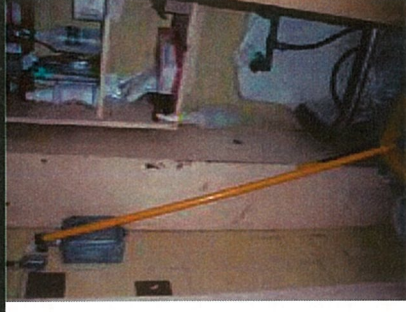
| Component | Material | Comments |
|---|---|--|
| Special Notes | | Vent from plumbing tunnel extends up through roof, Utility sink and electrical shut off switches are located in this area. |

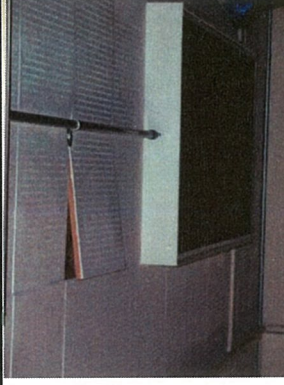
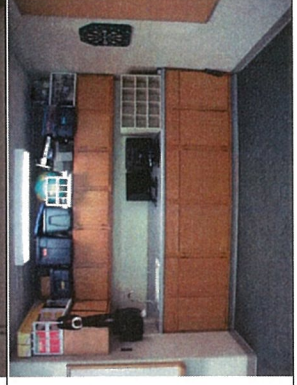
Room Number: A113 Room Name: 5th & 6th Grade Science & Social Studies Classroom

| Component | Material | Comments |
|---|---|---|
| Ceiling | 12x12 tile | 8' high, some tiles are loose and falling |
| Casework | P-Lam & wood | Residential casework |
