Best Western Facility Report

Hot Springs State Park
Facility Condition Assessment Project
November 1st, 2015

**Hot Springs State Park
Facility Condition Assessment Project Index
Best Western Hotel Building
Project #1521**

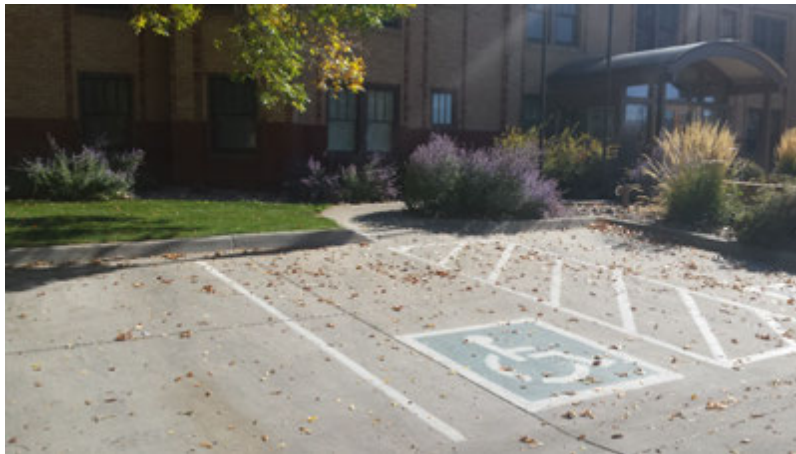
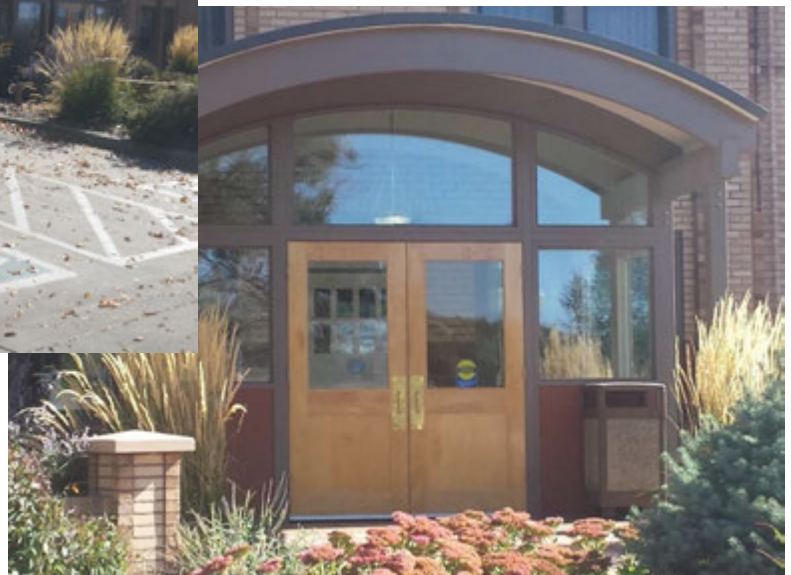
Item A002: Exterior Building Accessibility - Building Entries**Description:**

The main entry doors are accessible and have an automatic operator. The vestibule doors are also accessible. The dimensional requirements for the leading doors is non-code compliant.

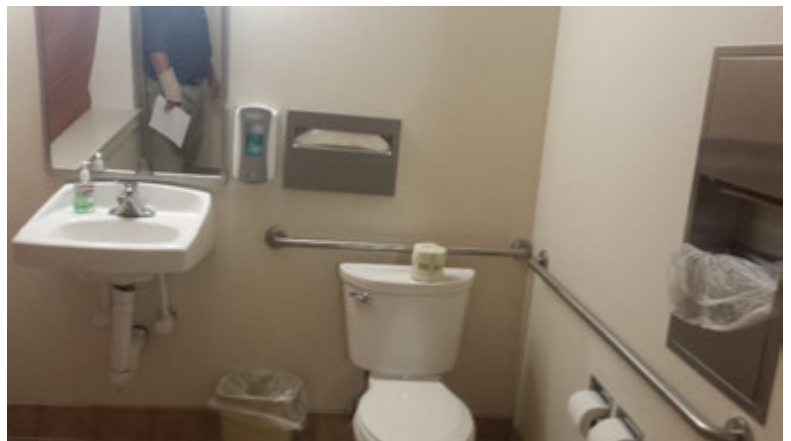
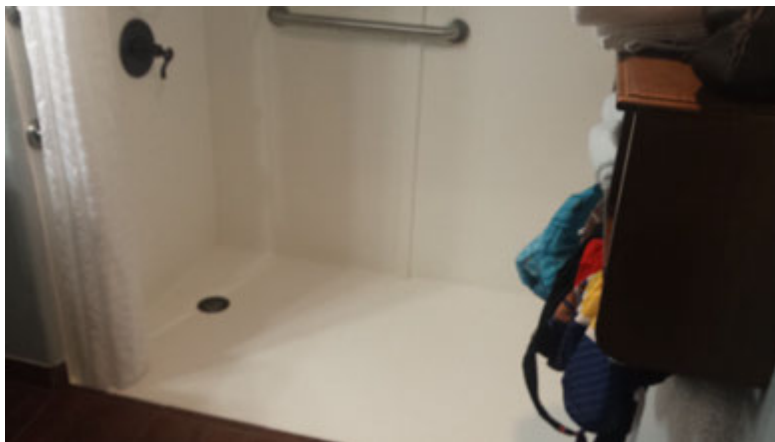
Item A010: Interior Finishes

The primary interior finishes are acceptable, however, are a little dated. There have been replacements of the carpeting and flooring in the recent past. Wall and ceiling finishes are in acceptable condition. The ceilings, for the most part, are inaccessible painted drywall.

A general aesthetic upgrade could be performed to bring the building up improved finish performance. This would benefit the facility and provide better protection from daily wear.

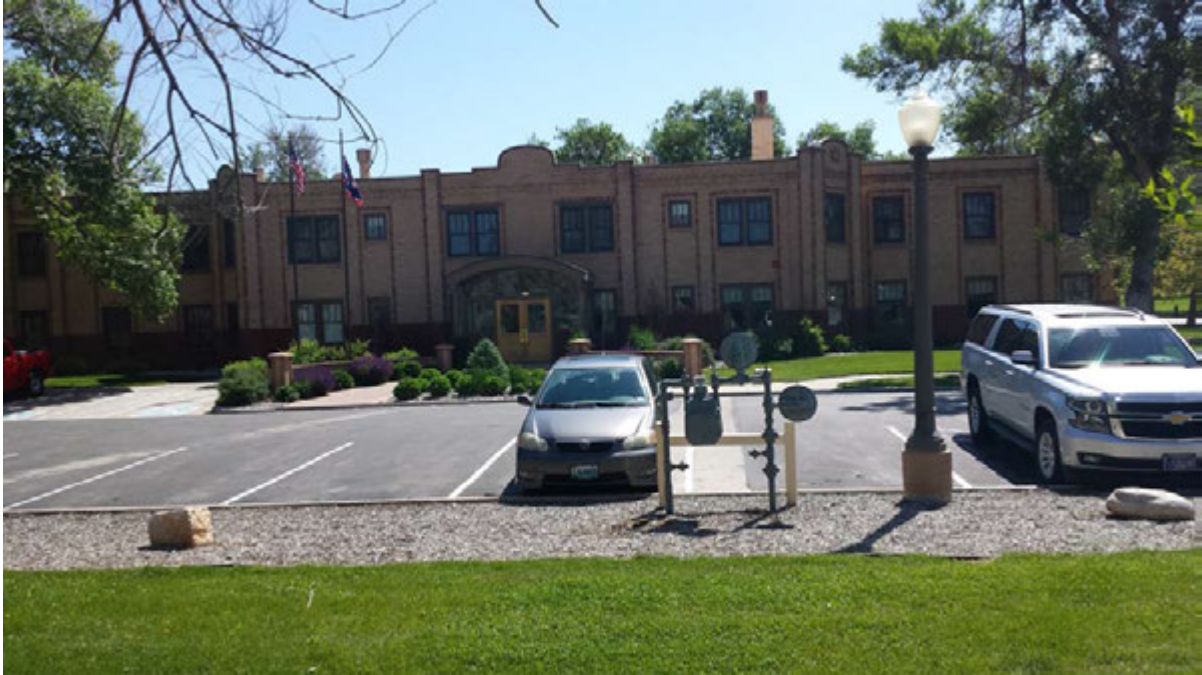
Utility Gas meter

The facility is served by the local utility with natural gas from a meter located across the street from the hotel entry.

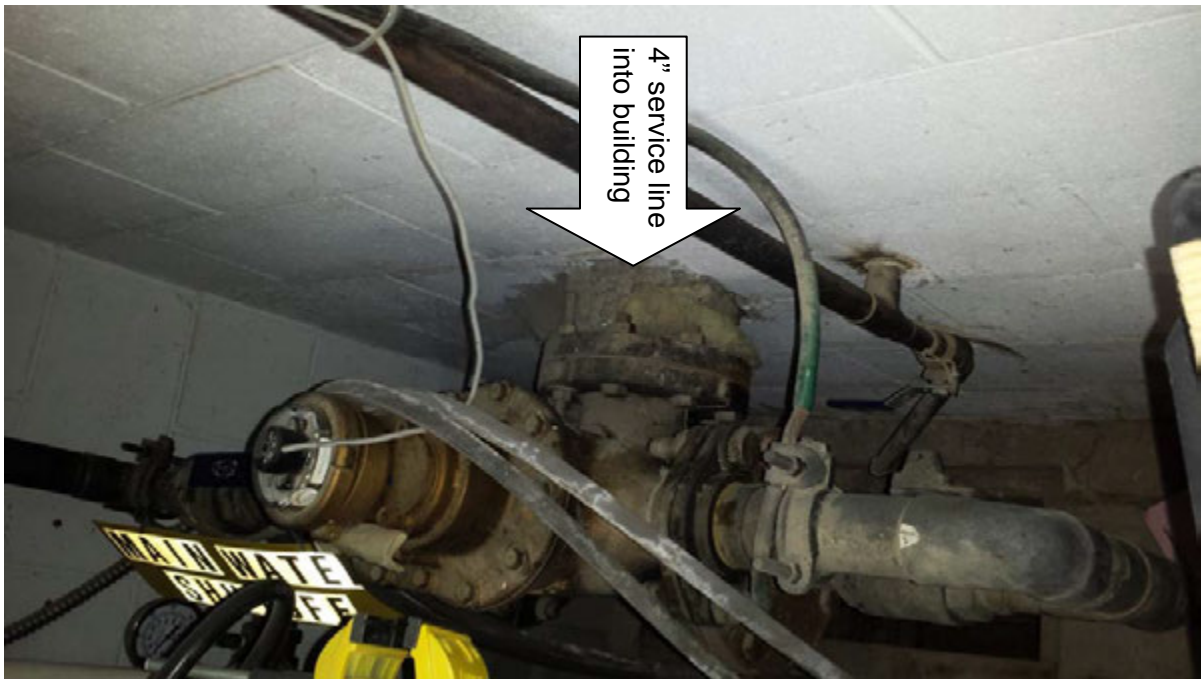
The water system consists of a combined 4" underground water service that splits to serve a 2" domestic cold water line to feed the complex, as well as a 2" fire service to serve the building. The combined service is difficult to access and would be hard to shut off in the event of a line break or other emergency.

Combined water/fire service through basement mechanical room wall

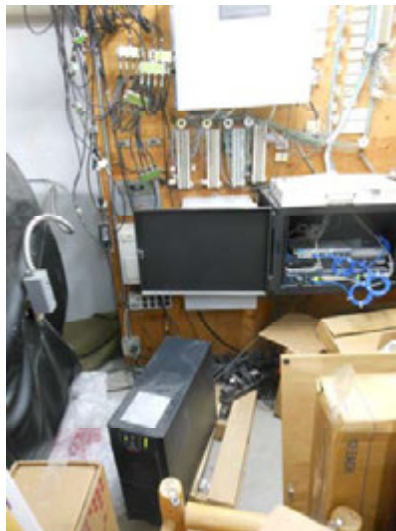
UPS on pallet

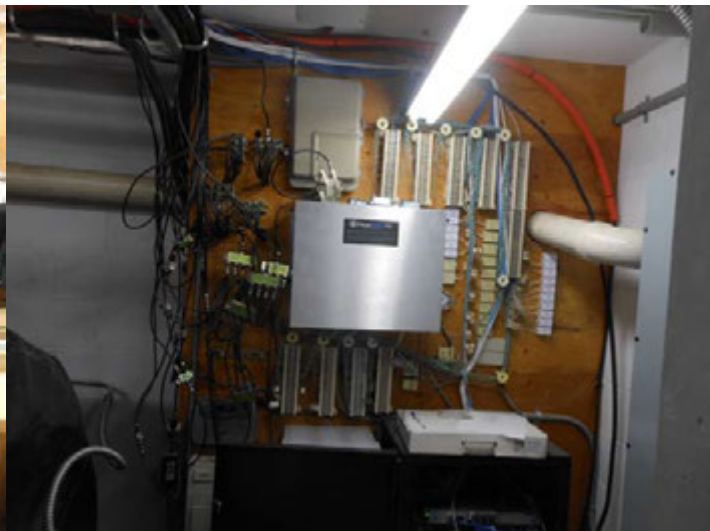
TBB, phone switch and TV splitters

There are many plug strips connected to the back of the UPS which consist of 6 receptacle plug strip units. The plug strips should be eliminated and new data rack style power distribution units should be installed on the TBB and connected to the UPS to clean up the quantity of devices connected to the UPS and to better organize the items plugged in.

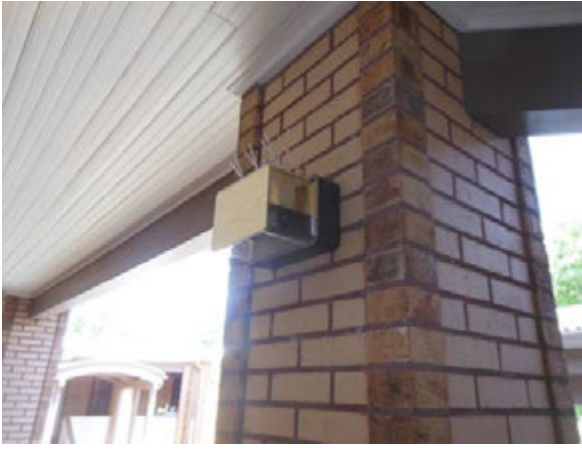
Building Mounted Light

The exterior lighting runs on time clock only function. This function could be improved by integrating a photocell to allow the lighting to turn on at dusk and off at dawn to reduce energy consumption. Or the better update would be to replace the entire time clock with a astronomical unit that allows lighting control that automatically adjusts with sun rise and set while still allowing lights to operate with a owner determined offset, I.e.: 30 minutes before dusk and after dawn.

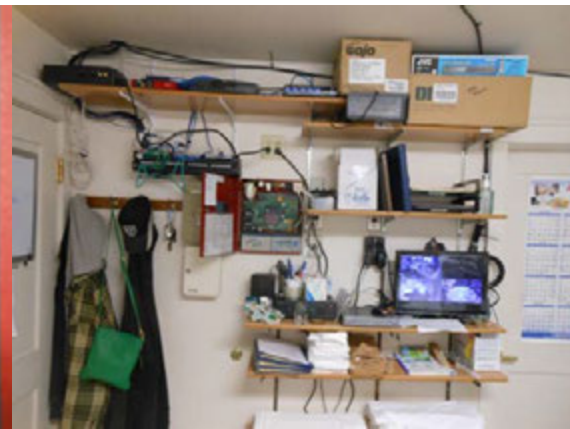
Fire Alarm Panel

Fire alarm panel location with building internet
