MEMORANDUM

Subject: Departments of Health and State Construction's response on the Veterans' Home of Wyoming

This report provides a high level assessment of Structural, Architectural, Mechanical, Plumbing, Electrical, Information Technology, and Civil systems for the buildings and grounds. This assessment includes a high level assessment for compliance with Building Code, the American Disabilities Act, and Clinical standards. Finally, the buildings were reviewed for their capability to be adapted to meet requirements or accommodate renovations. Below is a summary of the assessment work, with very general classifications of "Good," "Fair," and "Poor." An overall "General Building Condition" is provided based on the team's collective comments (Table 1.1.1). This assessment is weighted for the building's purpose. Example: if the boilers are in "Poor" condition for a building dedicated to boilers, but the structure and architecture are "Fair" condition, the overall building condition will give priority to the boilers and the building will be marked as "Poor." An asterisk denotes information that is not available. Admittedly highly subjective, additional information on these assessmen

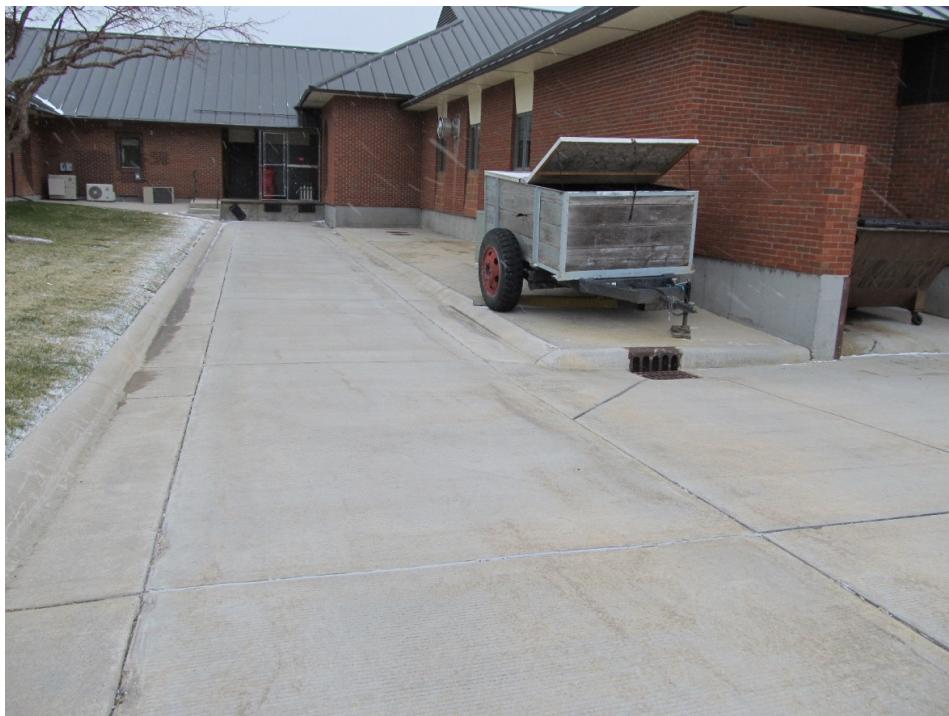
Figure 2.1.2: VHW Loading dock area near kitchen

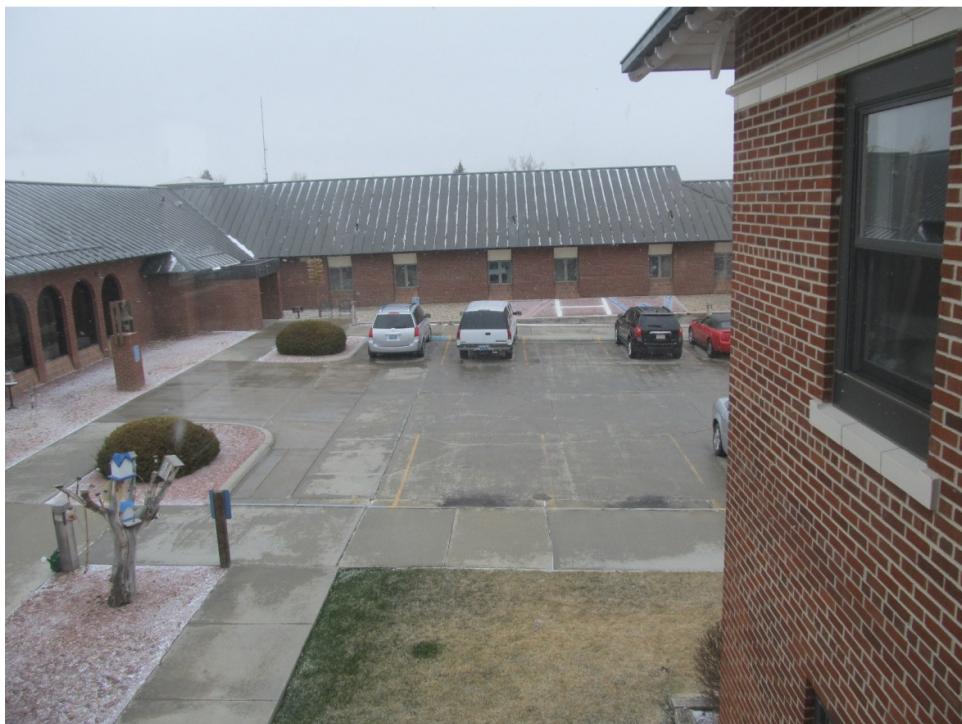
Figure 2.1.6: VHW Concrete parking lot at administration area

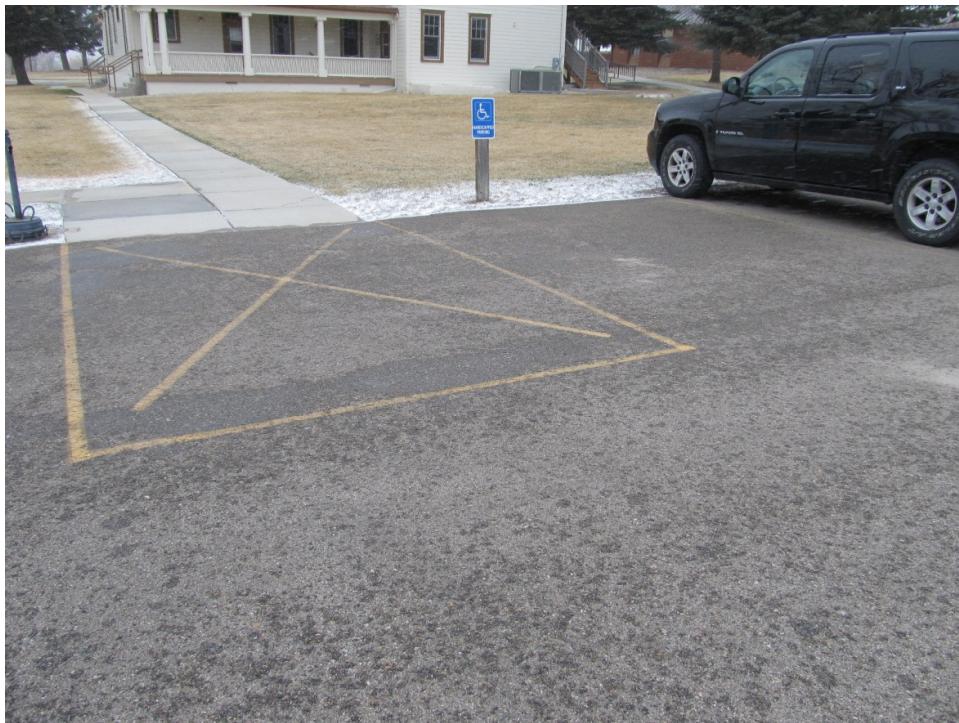
Figure 2.1.7: VHW Parking lot north of historic hospital building

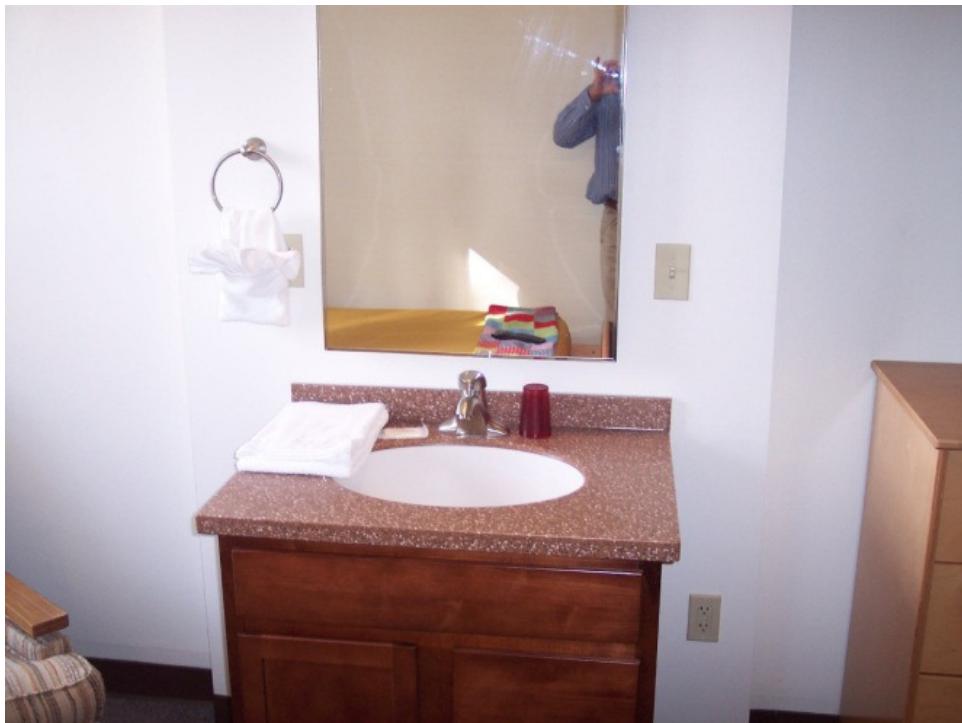
Figure 3.2.1: VHW New vanities in resident rooms from 2009 remodel

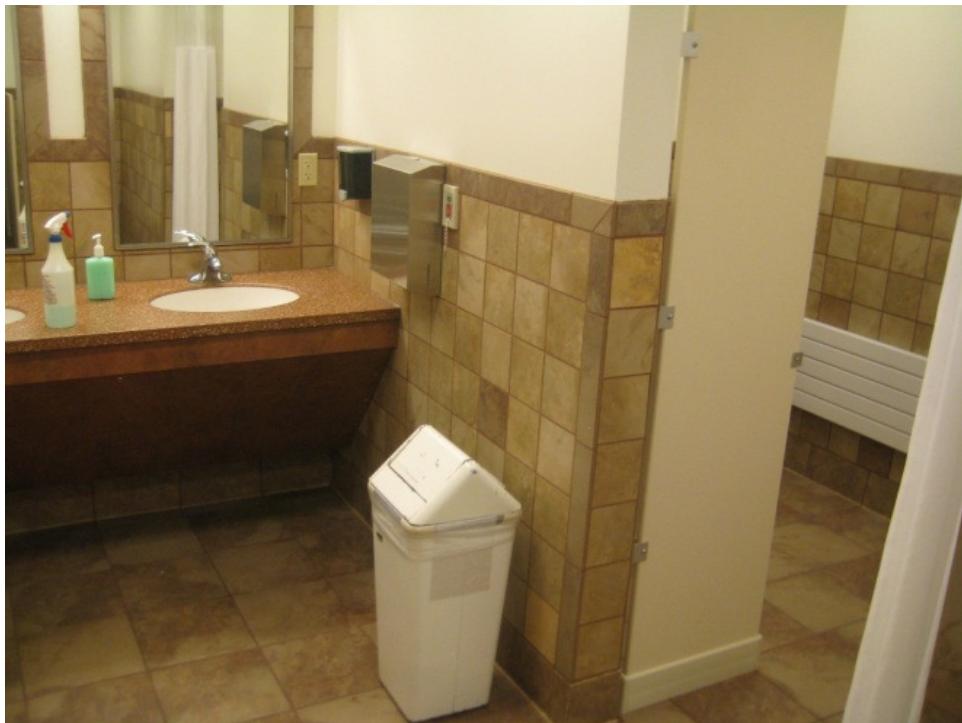
Figure 3.2.1: VHW Recently renovated resident toilet rooms

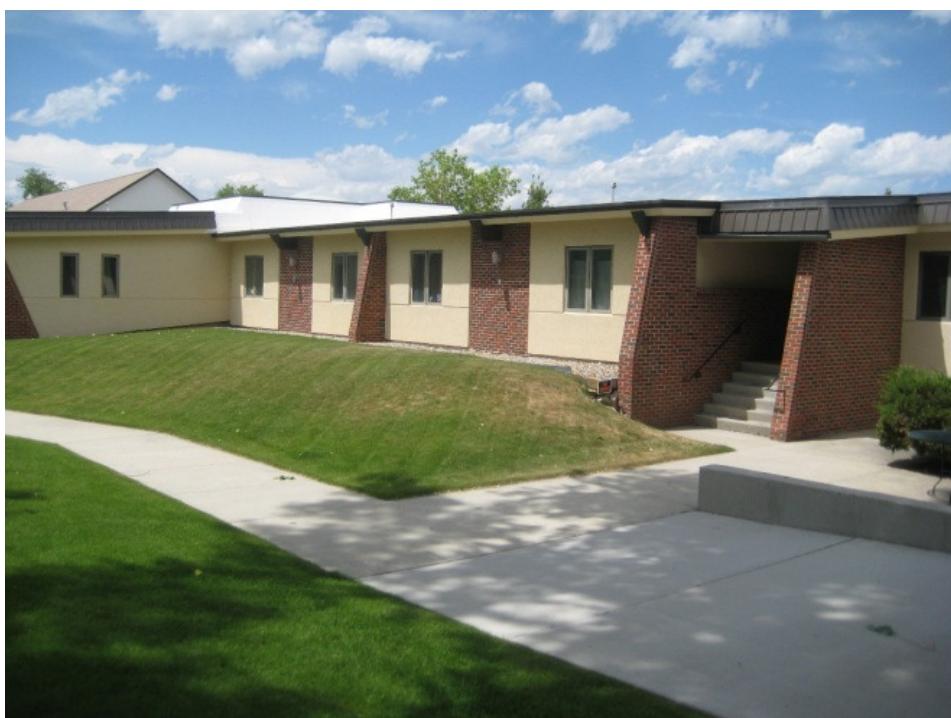
Figure 3.2.1: VHW 1973 Building

There is handicapped access to this building with the use of external doors at grade and internal corridor systems. The toilets in this facility are shared between two resident rooms, and are not in full compliance with ADA requirements. Review of ADA compliance of the resident rooms should be undertaken and possible retrofit actions be taken as appropriate. The interior ramps also need to be reviewed for ADA compliance.

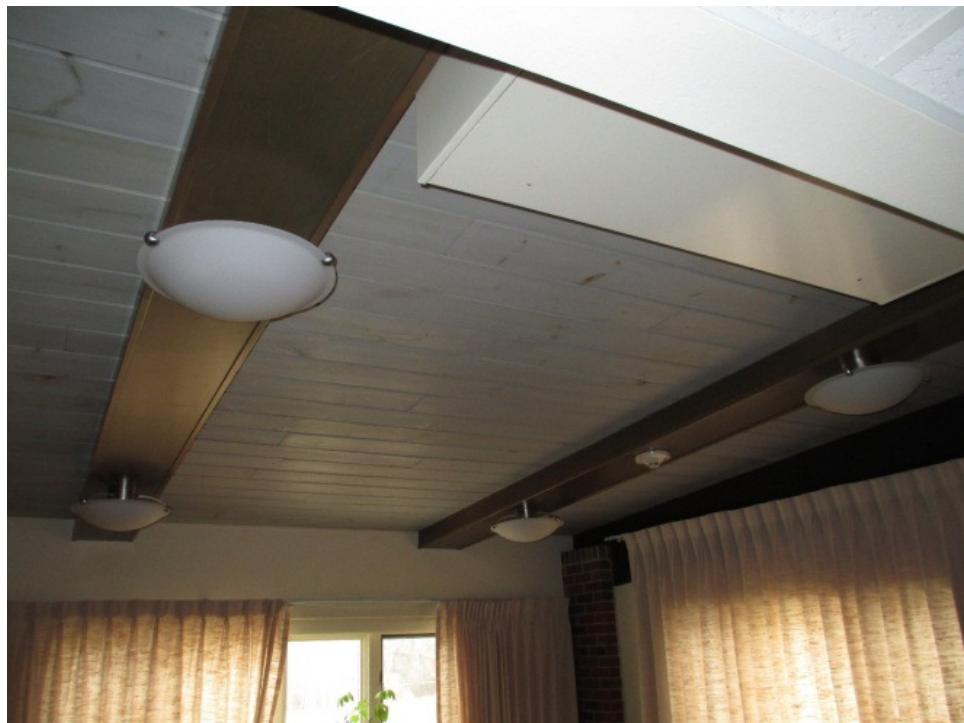
Figure 3.2.8: VHW wood ceilings

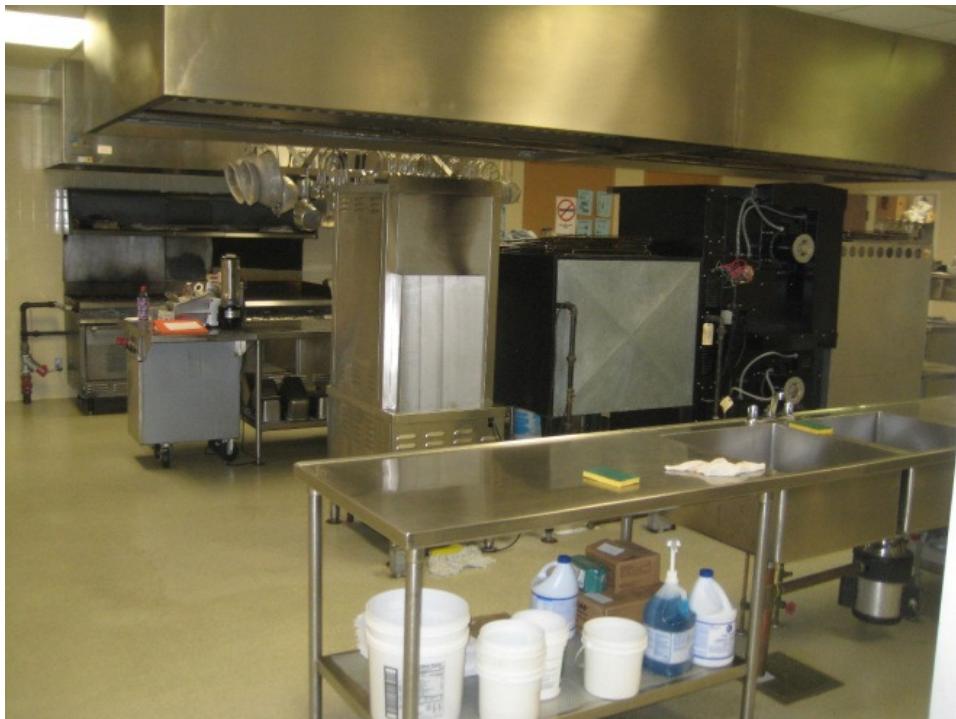
Figure 3.4.6: VHW Kitchen facility

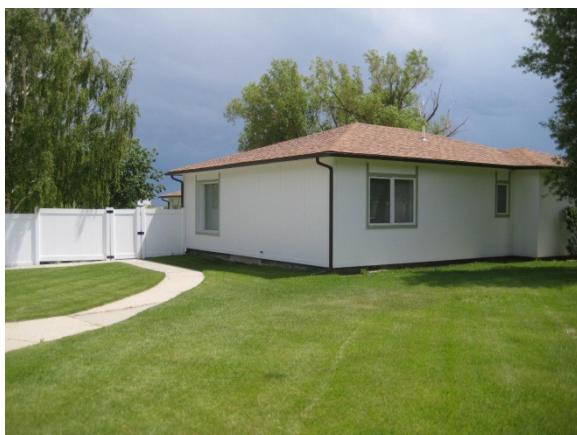
This building is not handicapped accessible. There is a step at the front door, there is a full basement with no accessibility, the toilets are not ADA compliant, kitchen casework and appliances are non-ADA. It is built as a typical residence, with no attempt to achieve ADA accessibility.

Figure 3.7.1: VHW Superintendent's Residence
